**Geophysical Survey of Subsurface Conditions for Placer Exploration**

Candace Creek  
Yukon

PLACER CLAIMS P-508833-508842 AD05937  
LEASE ID 00934  
LEASE ID 01054  
LEASE ID 01050

**June 20, 2013**

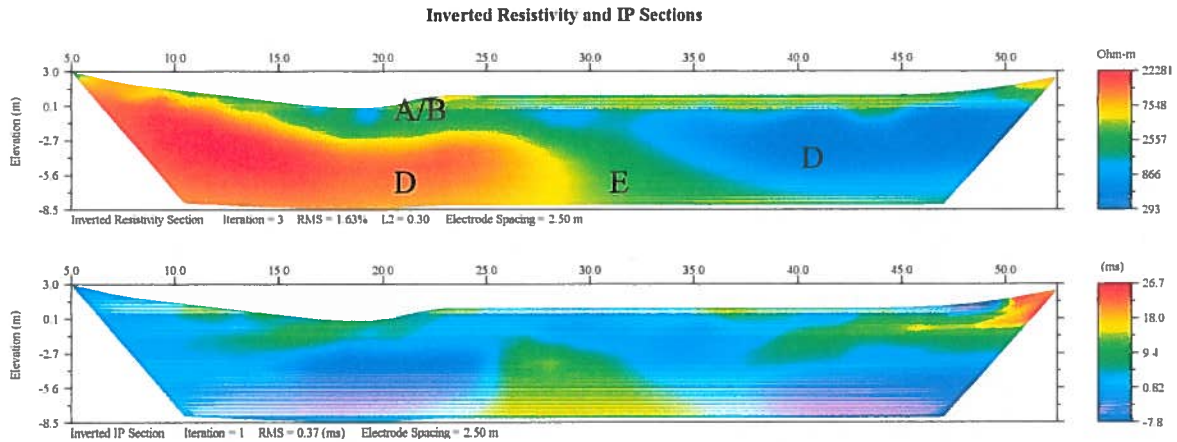
Line CC3

This image shows gravel to approximately 3.0 m depth. Permafrost and a fault structure obscure some of the detail in this image. However, a significant difference in the bedrock resistivity appears to exist, as well as an IP and resistivity signature consistent with faulting at (E). In this location, depths to bedrock may be up to 5.0 m deep. As this may be deep weathering of fault material, the location is a good drill target.

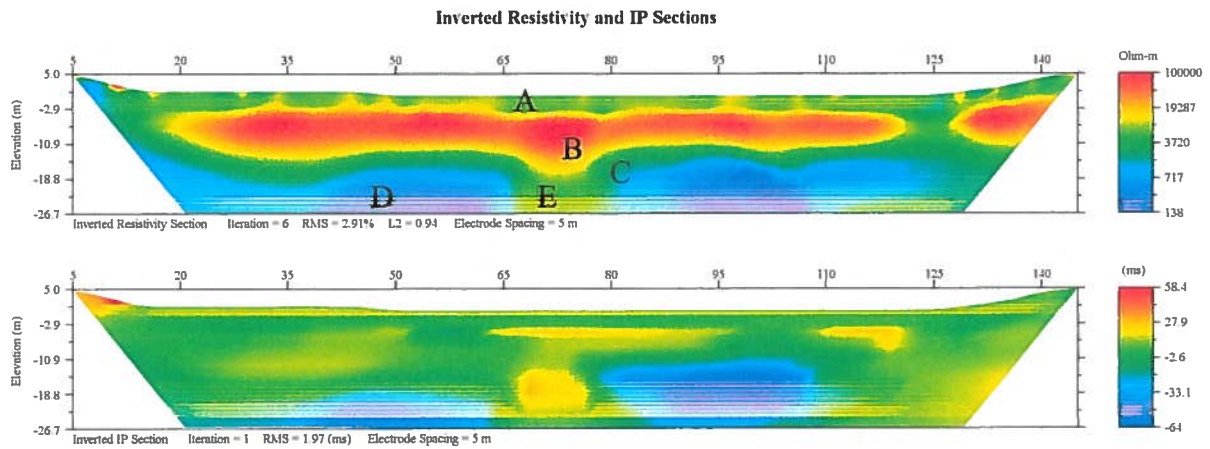
Line CC7

This cross-valley image shows decomposed bedrock at 10 m depths, gravel at 3.0 m depths and a possible fault structure at 70 m horizontal that corresponds with a deepening of the gravel. Low RMS error and clear, continuous boundaries give this image a high degree of confidence. A drill target at 75 m horizontal is suggested.

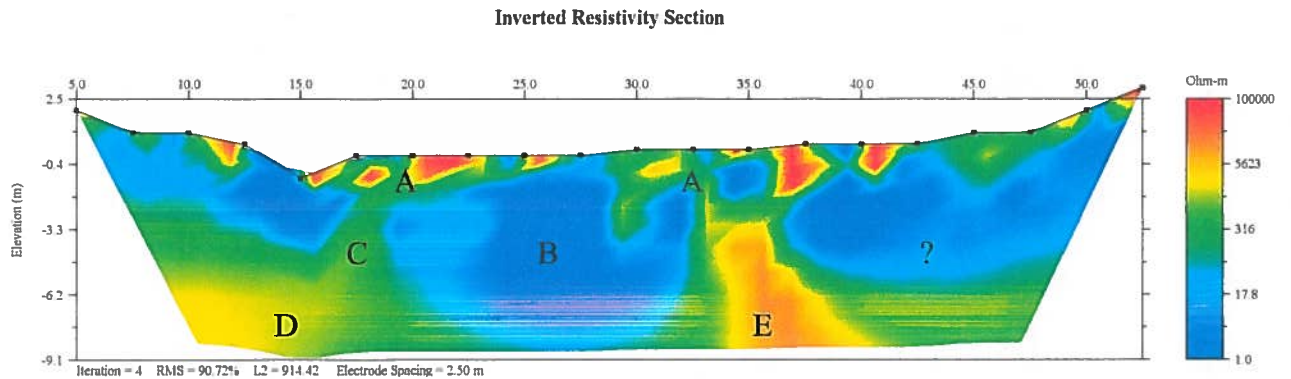
Line CC1

This image was taken through thick surface icing, and the data needs to be verified before an analysis can be conclusively conducted. A deep channel of thawed material to 9.0 m appears to be present. However, a high RMS error makes this data unreliable. Further geophysics and drilling are required.

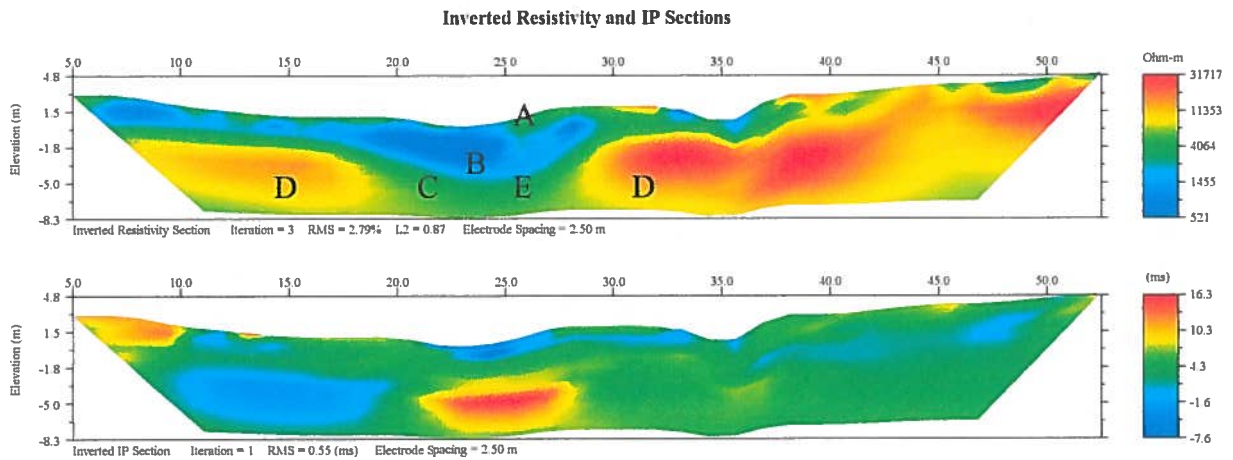
#### Line CC4

This image crosses the Candace Creek valley at the lower end of Lease 01050. The transect cuts diagonally across the valley. At (B), an area of sands and gravels appears to extend to 4-5.0 m depth, overlain by up to one meter of silt and sand. There may be a fault structure in the valley bottom at (E).

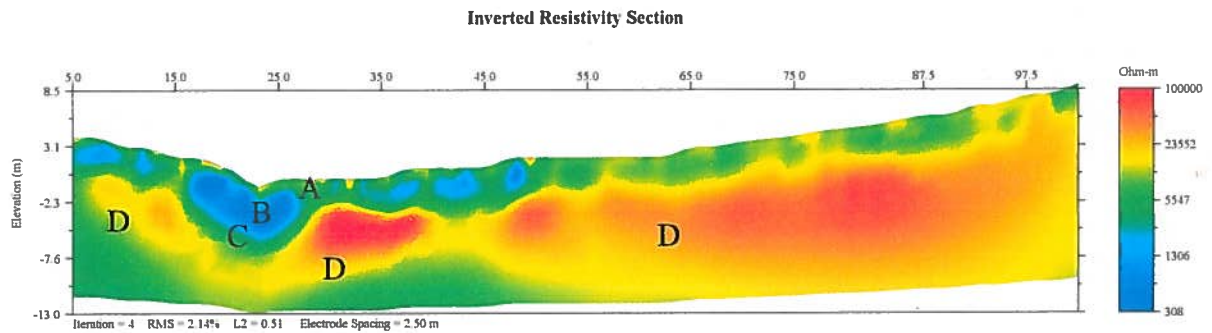
#### Line CC5

This image extends across the valley diagonally downstream of the previous image, but extends further up the hillslope to determine the presence or absence of perched bench

deposits, none of which were apparent. As with the previous image, gravels appear to be present at (B) to 4-5.0 m depths. Scales are different between the two images.

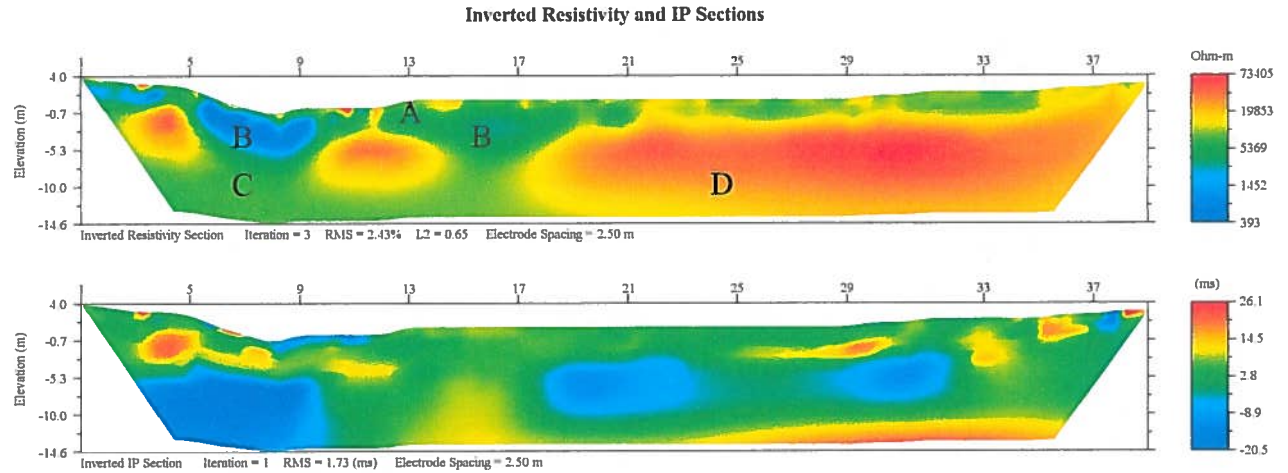
Line CC6

This image extends perpendicularly across the valley bottom on Lease 01054. Two potential channels with gravel infill likely occur at (B), which extend to 5.0 m depth. The channel to the left of the image is the most promising drill target.
