## Assessment Report

## Logjam Property

Swift River, Watson Lake Mining District, Yukon, Canada

January 31, 2019

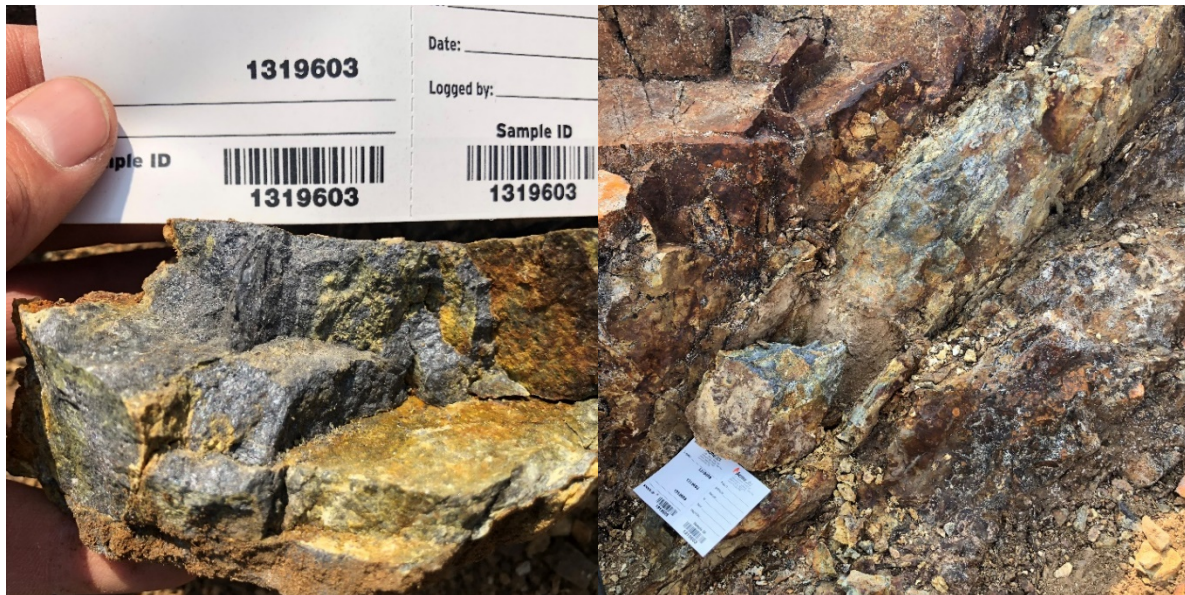
The traverse along the ridge crest took place entirely within diorite intrusive. The best results for Au came from the #5 and #6 veins on the crest of the ridge with values of 7.5 g/t and 3.7 g/t respectively (Figures 4.1 – 4.2). Ag values were over 1,000 g/t and over 10% Zn in sample 1319603 after a second re-assay.

Figure 4.1 Close up of sample 1319603 and #5 vein in situ.

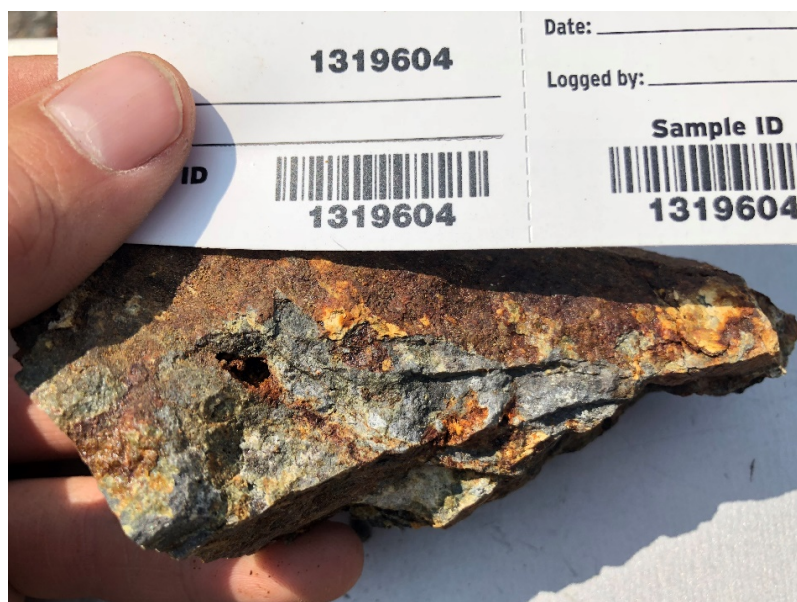
Figure 4.2 Sample 1319604 from the #6 vein.

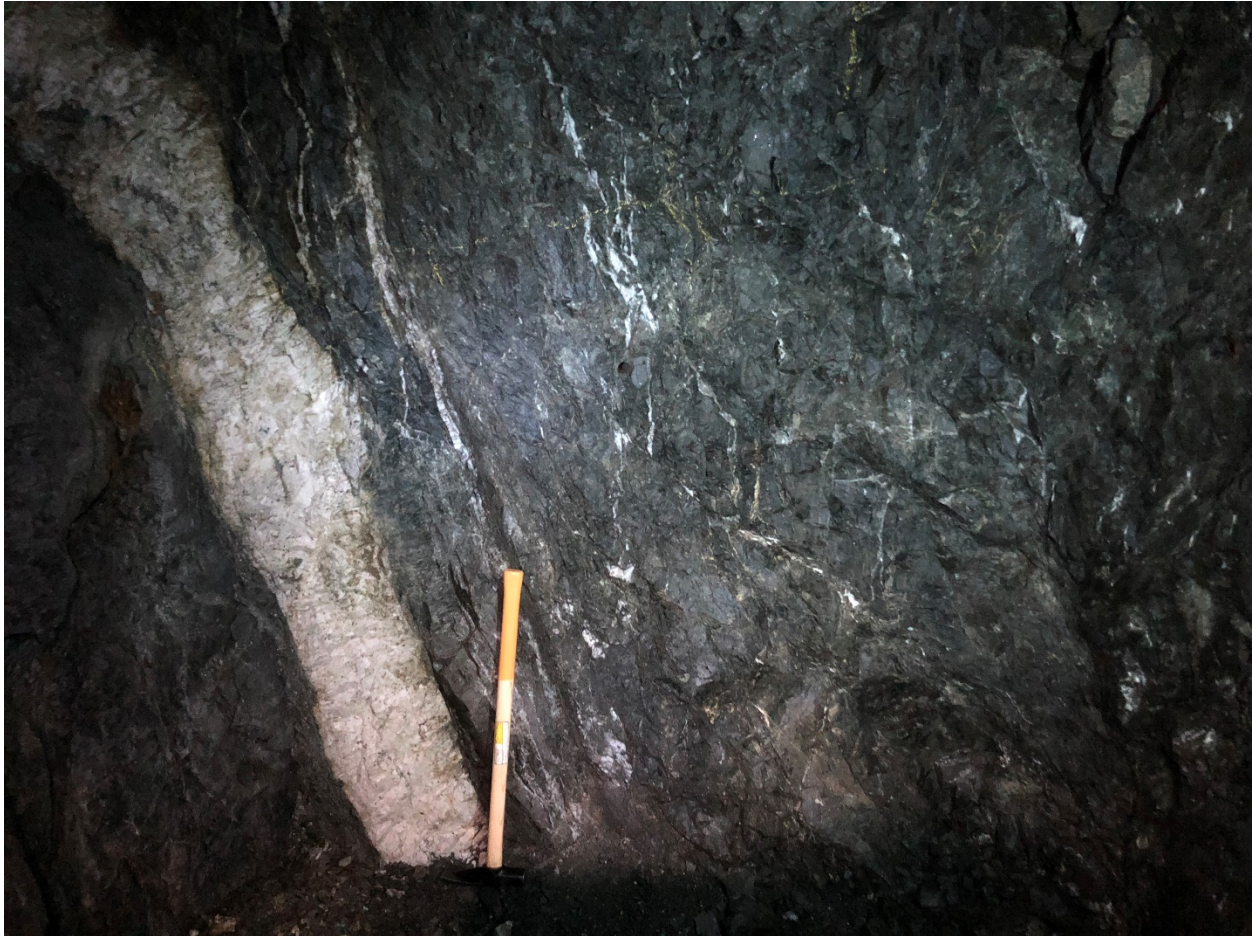
The face of the #4 vein drift has a distinct 30cm wide carbonate vein within metasediments (Figure 4.3). The hanging wall contains abundant sulphides with assay results showing elevated Zn (4173 ppm) and Pb (6350 ppm) values. The total mineralized width is approximately 2m. It is expected that grades will increase in this drift as it approaches the contact with the diorite.

*Figure 4.3 #4 vein drift showing a distinct 30 cm wide quartz-carbonate vein.*

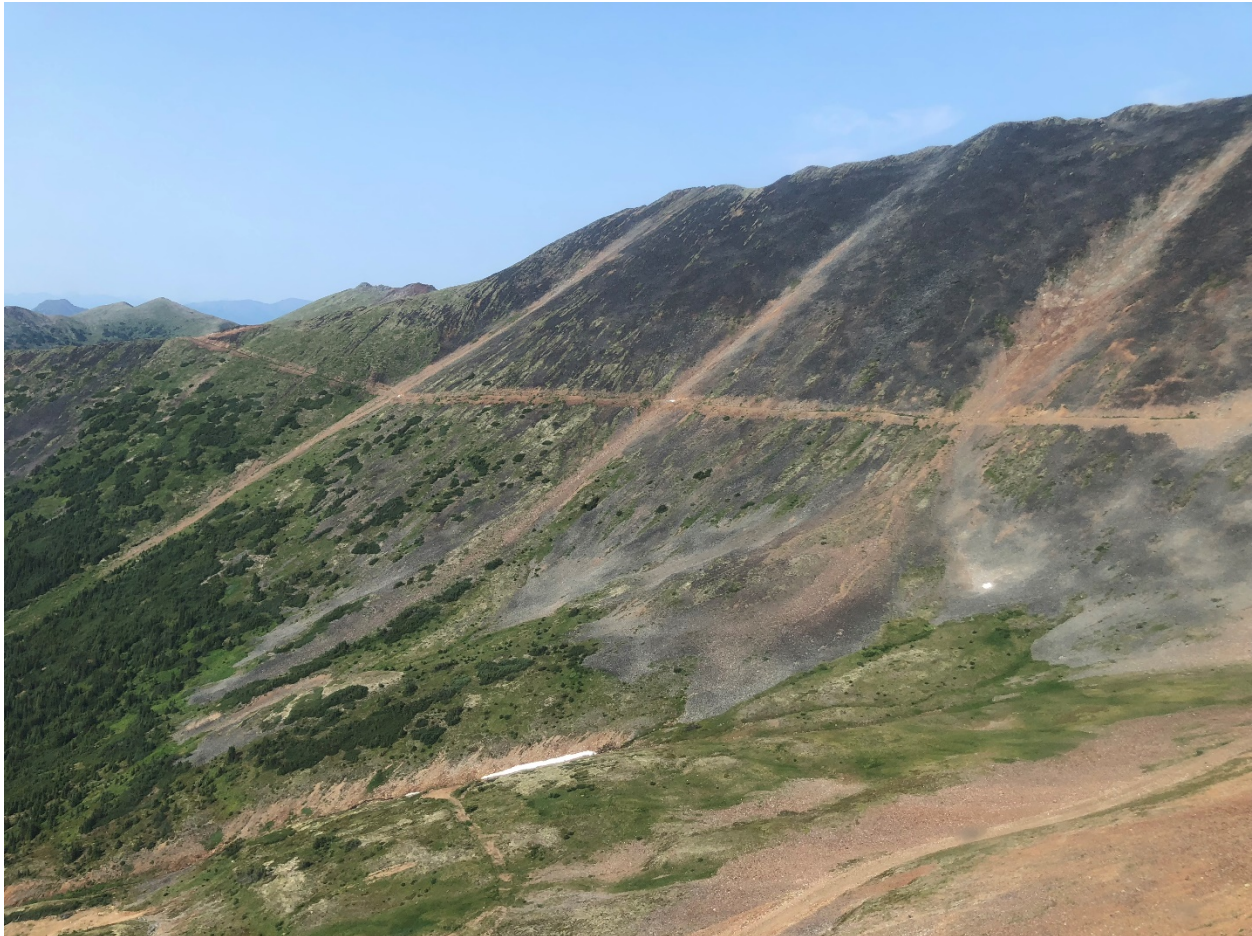
A 13km road connects the camp area of the adjacent Logtung Project to the Alaska Highway. From there, a bulldozed trail hugs the south facing slope before passing crossing the crest onto the Logjam Property (Figure 4.5). The access road to Logtung was driven by the Author later in the season and was found to be in good shape. The trail over the ridge crest was not inspected, however it should be passable by ATV at a minimum, and by 4x4 pickup truck with minimal work. This road has not been passable during previous winter programs.

*Figure 4.5 Trail leading from the Logtung camp site over and onto the Logjam Property.*

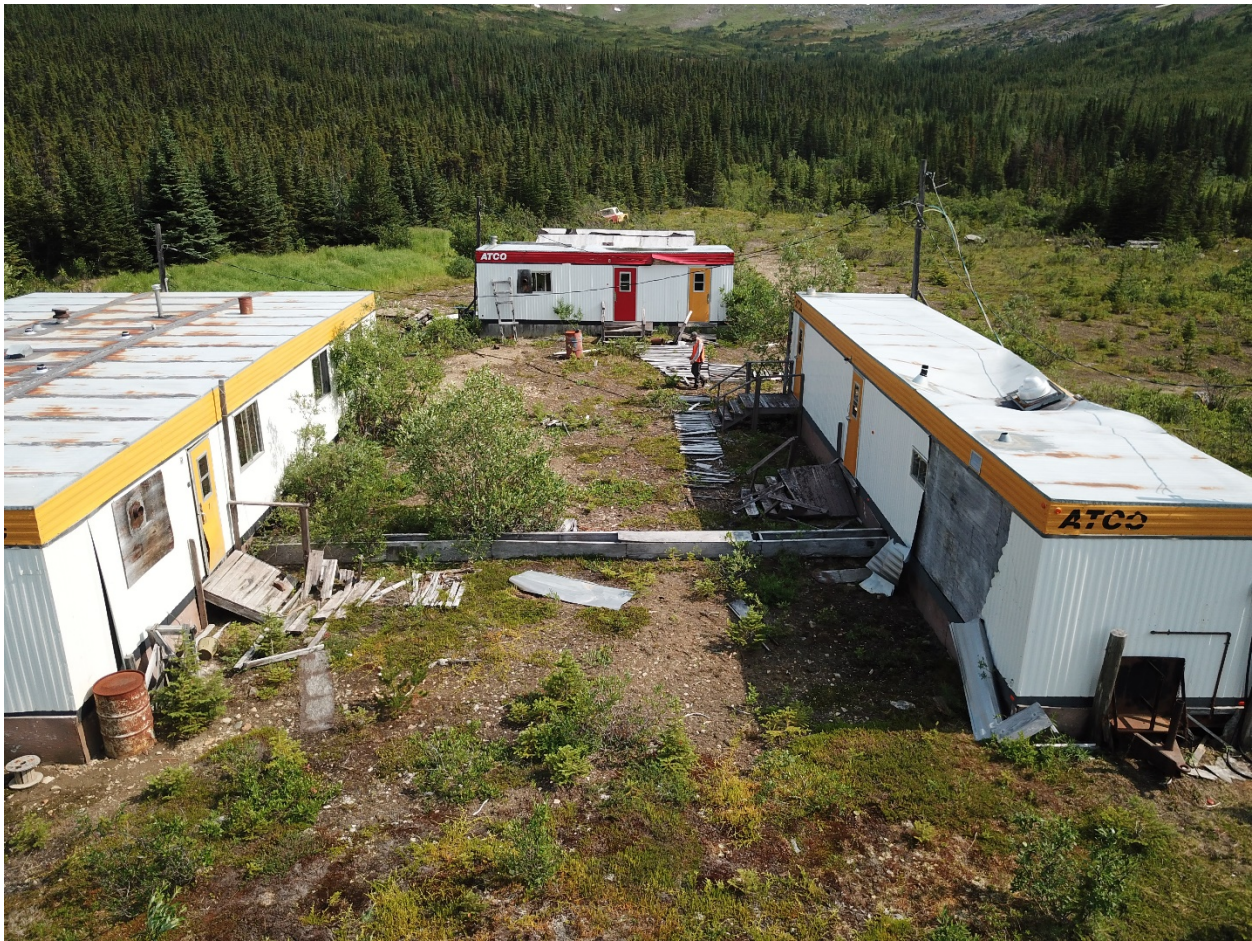
The trailer camp currently on site was installed in the 1980's and appears to have avoided general vandalism and theft. It has however been exposed to the elements and has deteriorated into a state of disrepair (Figure 4.6). The camp is not likely salvageable without great effort. Besides some lumber and empty fuel drums, the rest of the site is relatively tidy.

*Figure 4.6 The old trailer camp on the Logjam Property.*
