Report on Geotechnical Site Investigation

Red Mountain Project

July-September, 2006

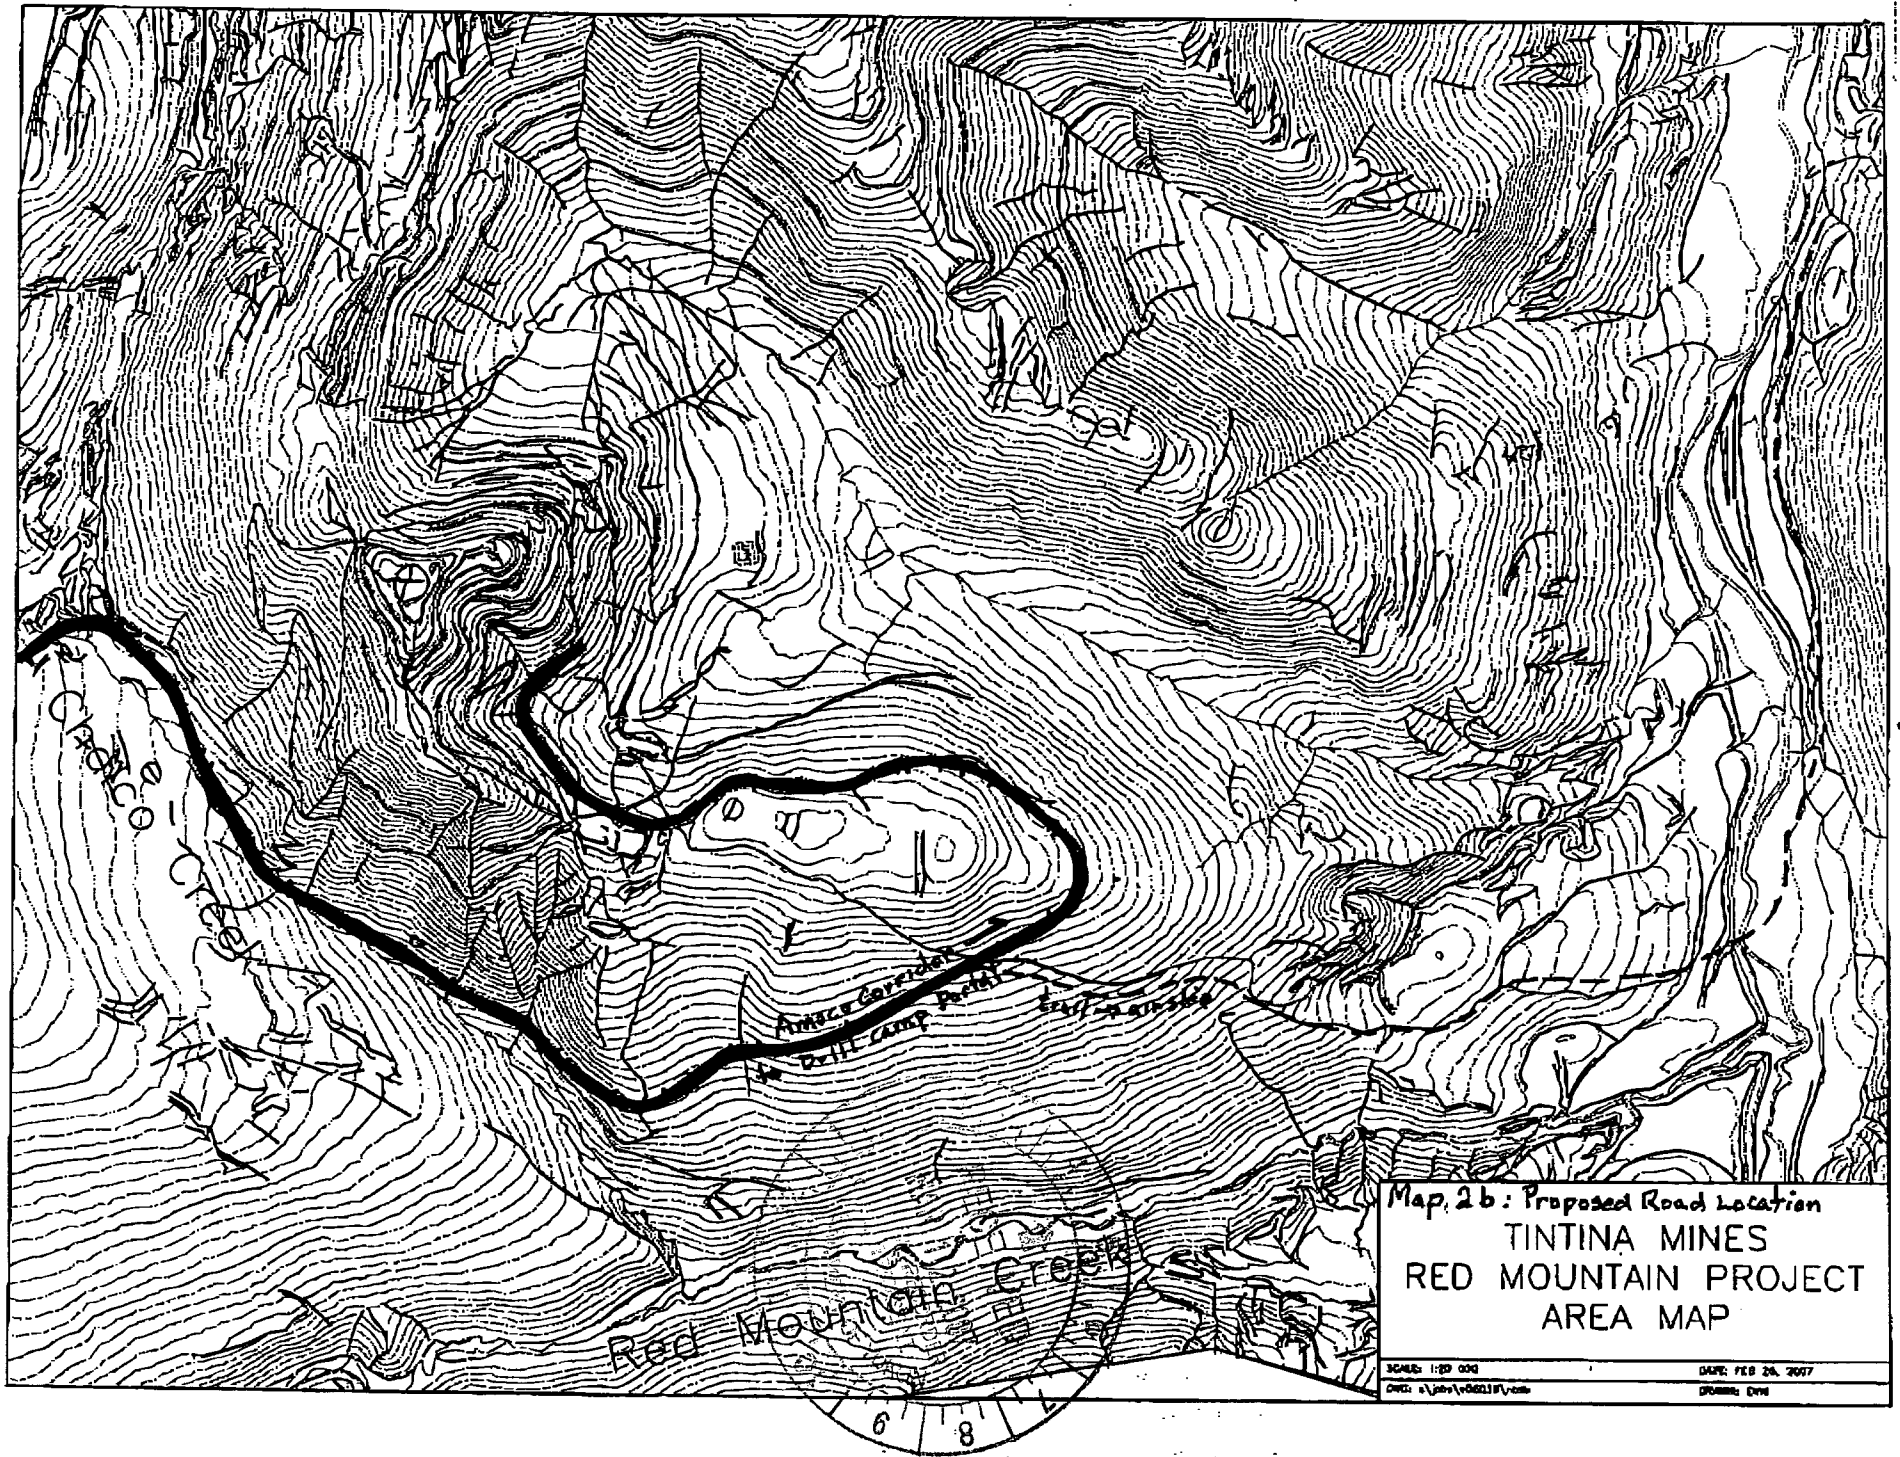
Map 2b: Proposed Road Location
 TINTINA MINES
 RED MOUNTAIN PROJECT
 AREA MAP

Ground stability on the eastern side of the Red Mountain Creek was generally poor and hence it was determined that the Amoco Corridor Route to the proposed portal at the Drill Camp location would be better located on the western side of Red Mountain Creek along the middle portion of the slope and wind northwestwards around the slope and then head southwards to Drill Camp (see Map 2 (b)).
