TIGER ZONE PROJECT YUKON TERRITORY, CANADA REPORT ON SCOPING LEVEL PIT SLOPE EVALUATION

Submitted To: ATAC Resources Ltd.
1016-510 West Hastings Street
Vancouver, BC V6B 1L8

Submitted By: Golder Associates Inc.
595 Double Eagle Court, Suite 1000
Reno, Nevada USA 89521

January 27, 2014

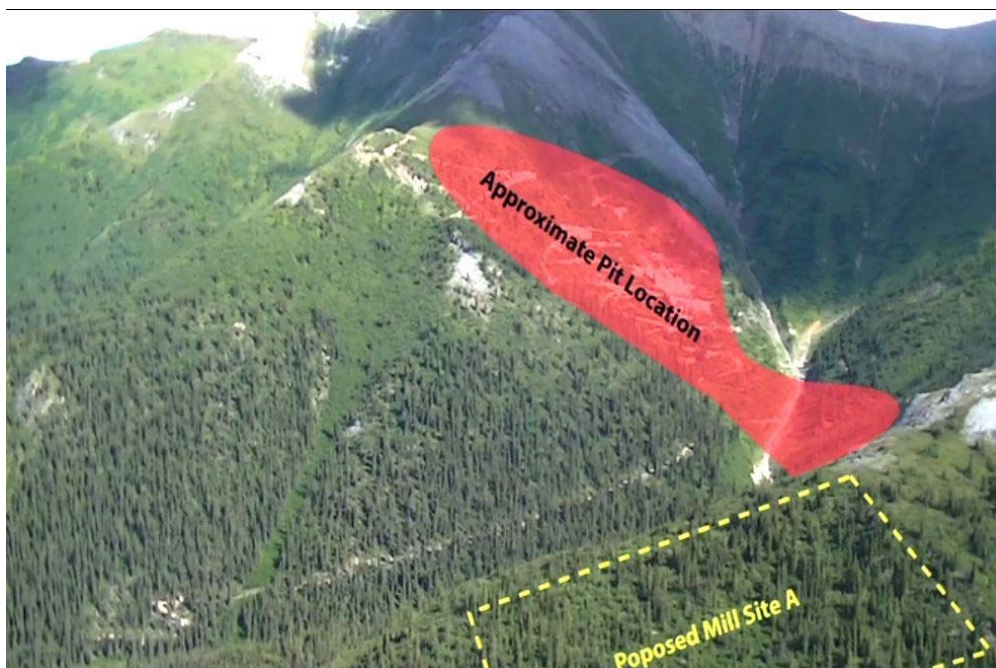
Figure 2.1
Site Photographs

Tiger Zone Deposit

Pit Location

Note: Photographs provided by ATAC Flyover on July 19, 2013

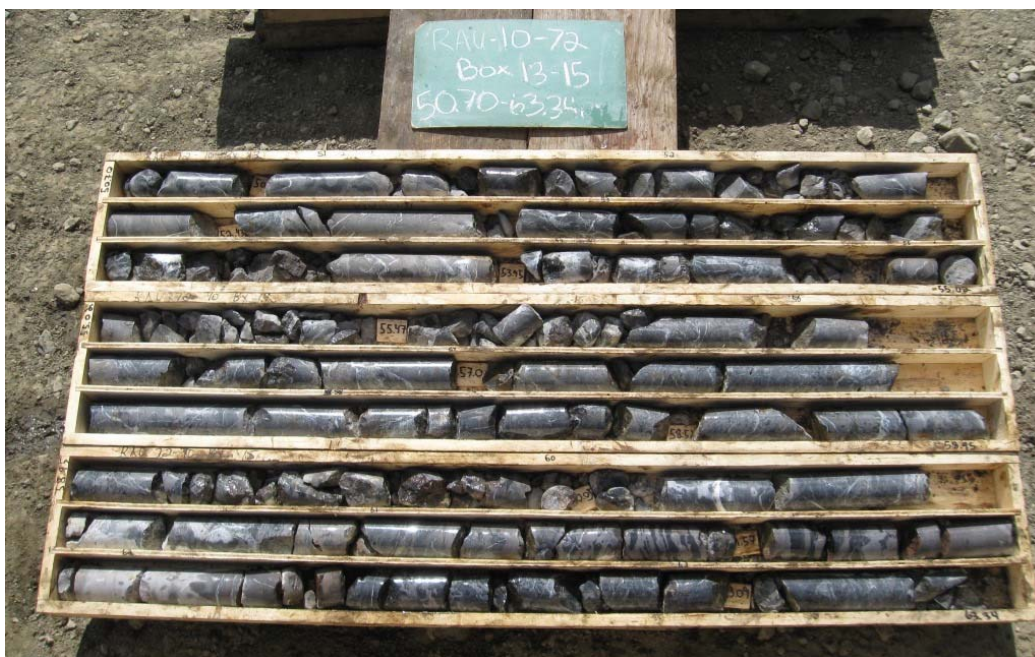
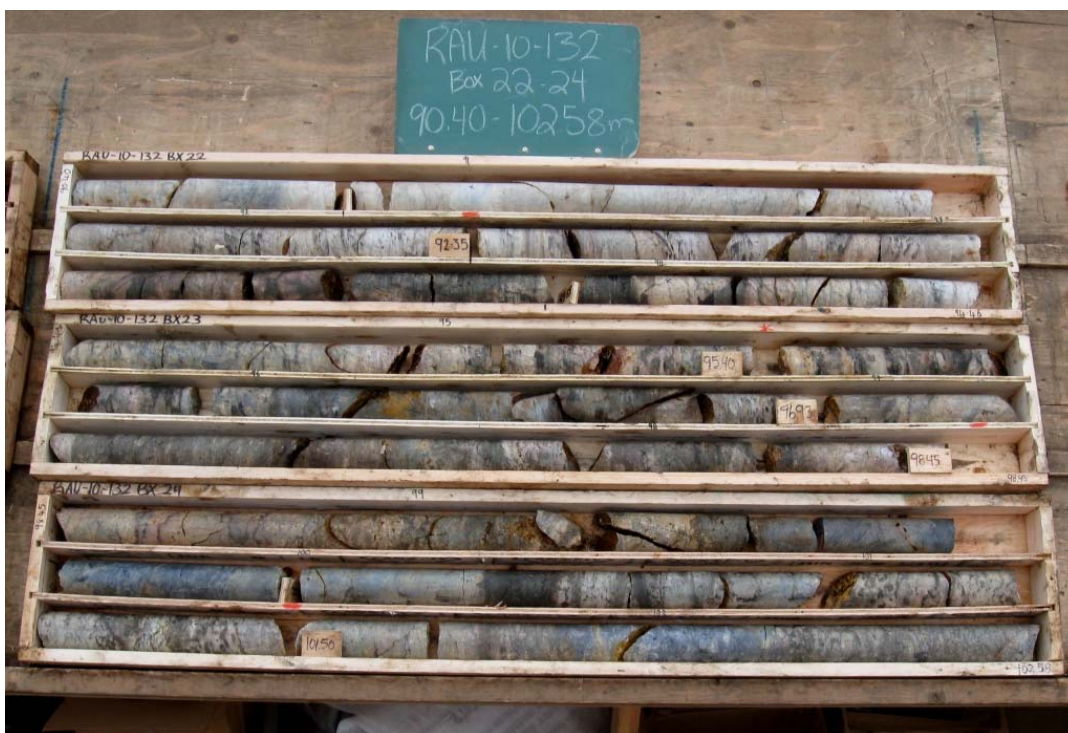
Figure 4.1
Core Photographs of Carbonate Rock

Limestone

Dolomite

The Carbonate Rock is typically a Medium Strong (R3, $25 < \text{UCS} < 50 \text{ MPa}$) rock with a variable degree of rock fracturing that will form a blocky rock mass. The RQD measurements (Table 4.6) indicate that its Rock Quality ranges from Poor ($25 < \text{RQD} < 50$) to Good ($75 < \text{RQD} < 90$), but is typically Fair ($50 < \text{RQD} < 75$). Where the limestone is dolomitized or marbleized, the rock strength will likely be higher strength and less fractured. Fair Quality Rock Masses consisting of Medium Strong Rock are characterized as typically having high shear strength relative to the slope height, so strength-controlled instability of inter-ramp and overall slopes is not anticipated. Given that the Rock Quality is greater than "Fair Quality" ($\text{RQD} = 50$ to 75) it may be difficult to pre-split the rock, which is essential for safely maximizing slope angles. It should be possible to form bench faces in this rock by trim blasting. Examples of typical core consisting of Carbonate rock are shown in Figure 4.1

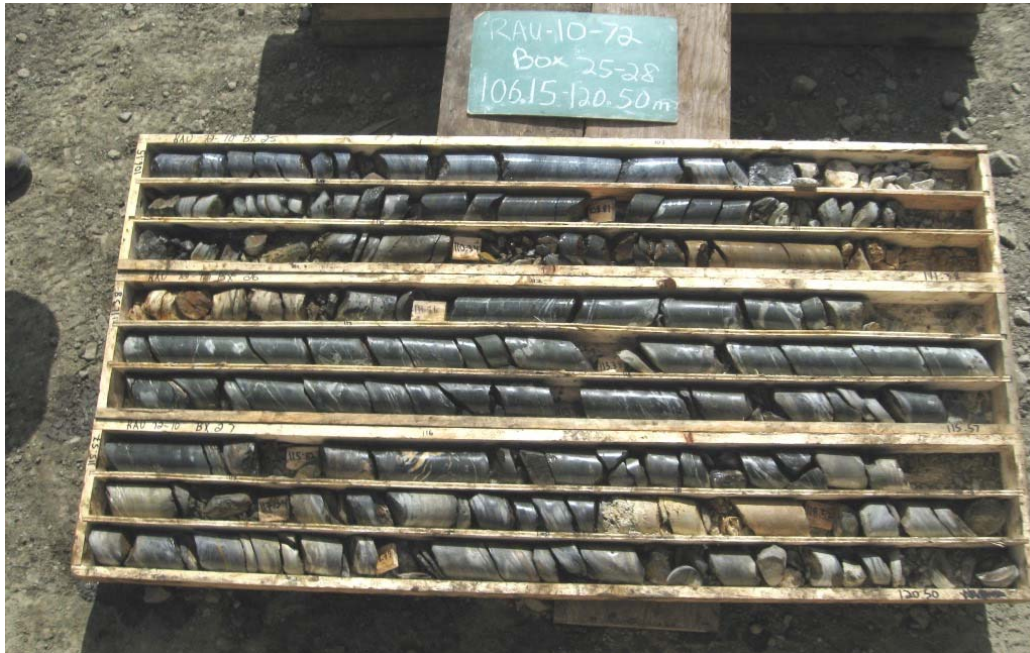
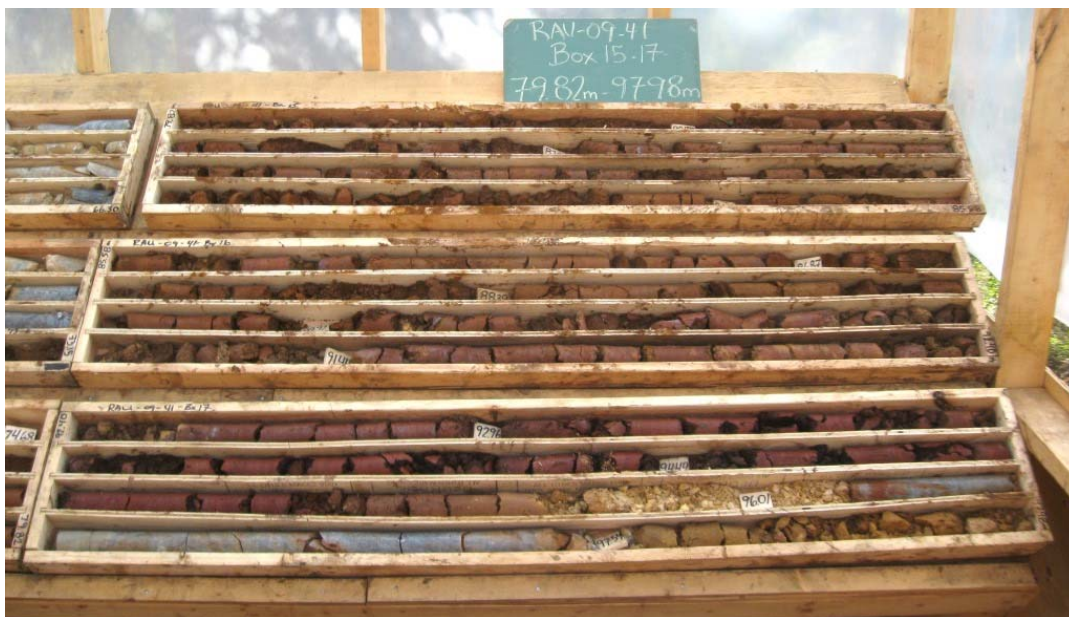
Figure 4.2
Core Photographs of Volcaniclastic Rock and Oxide

Volcaniclastic

Oxide

The Volcaniclastic Rock is a Medium Strong (R3, $25 < \text{UCS} < 50 \text{ MPa}$) rock with a variable degree of rock fracturing that will produce a blocky or seamy rock mass. Similar to the Carbonate Rock, the RQD measurements (Table 4.6) indicate that most of the rock consists of Poor ($25 < \text{RQD} < 50$) to Good ($75 < \text{RQD} < 90$) Quality rock, but it is typically Fair ($50 < \text{RQD} < 75$) Quality rock. The Volcaniclastic Rock appears as 10 to 20 meter thick layers in the cross sections shown in Figures 2.2 through 2.5, it and dips to the northeast. Based on geologic interpretations, the foliation in the Volcaniclastic Rock also dips to the northeast and into the bench faces, a favorable orientation for bench slope stability. The rock mass shear strength is high relative to the slope height, and the ability to form steep slopes will be dependent upon the steepness of stable bench faces that can be developed in this unit. Typical core from the Volcaniclastic Rock showing the foliation is shown in Figure 4.2

Where the water content of the Oxide is greater than about 20 percent, the Oxide is likely nearly saturated. That is, the voids in the soil mass are almost completely filled with water. The depth of seasonal frost penetration could range from about 1 to 2 meters on exposed surfaces. Silty sands and silts are susceptible to significant strength loss upon thawing in the summer months, particularly when they are nearly saturated. Degradation and erosion of benches excavated in Oxide should be anticipated during the summer thaw. Figure 4.2 shows typical core obtained in the Oxide.

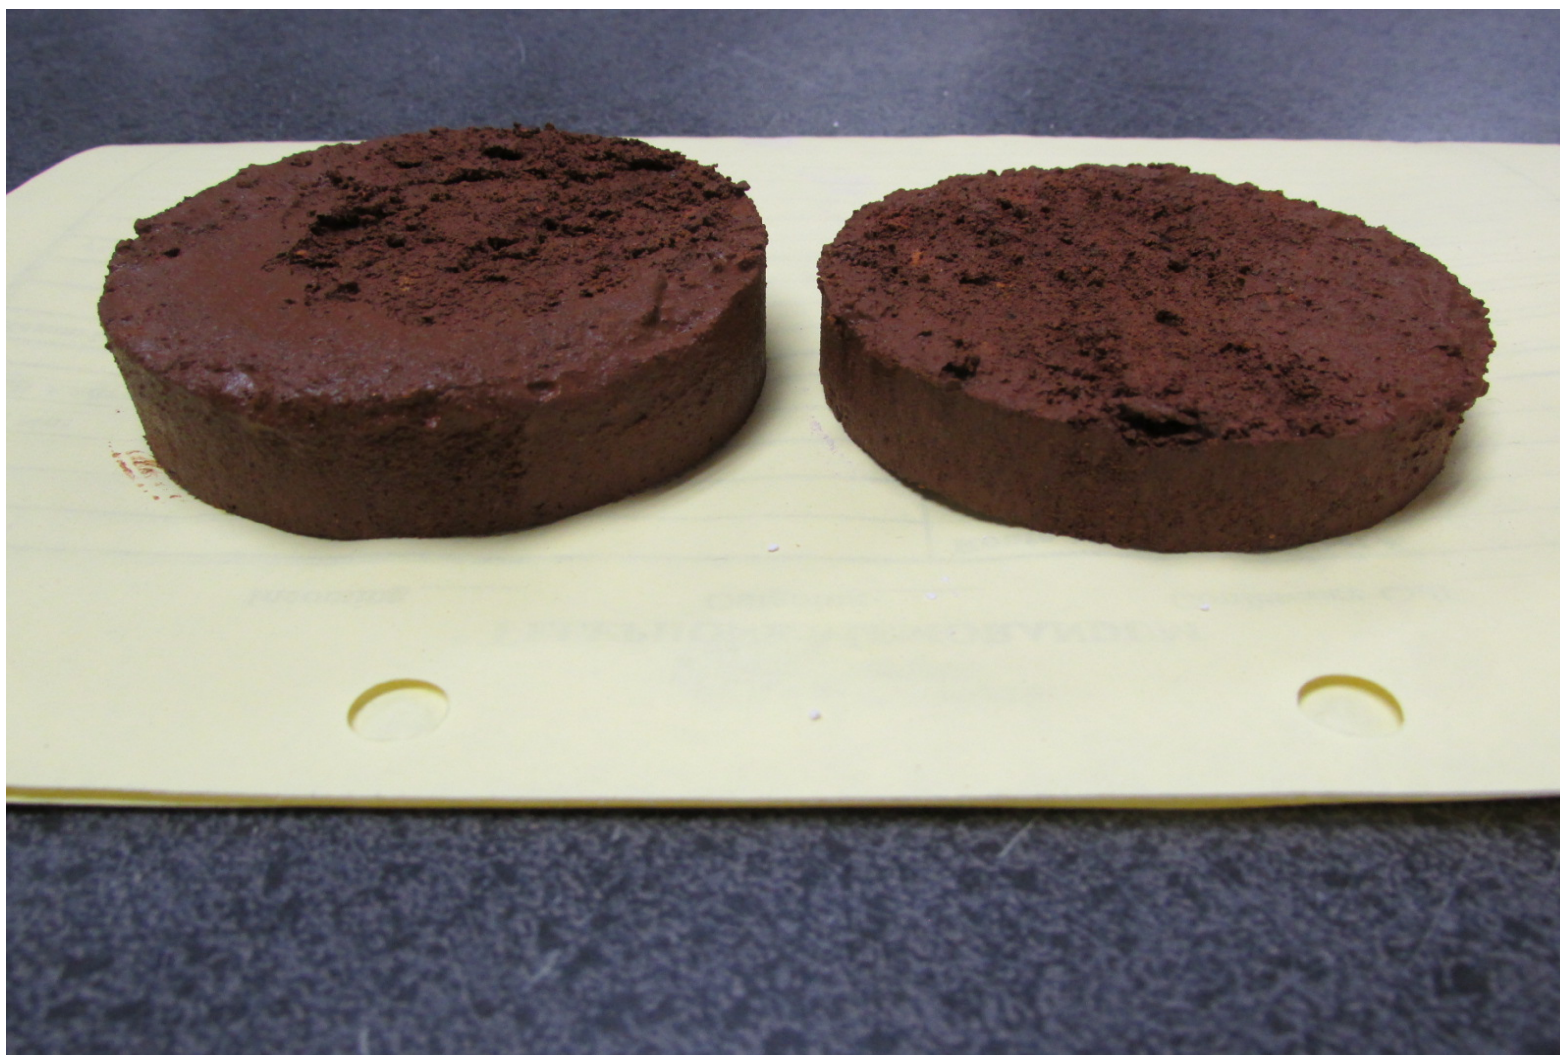
Title: ASTM D3080 CONSOLIDATED DRAINED DIRECT SHEAR TEST REPORT SHEAR DATA				
Job Short Title: ATAC/Pit Slope Study/BC						
Sample: A03-3 @ 23 - 28 ft.	Technician: PRH	Reviewed: CCS	Date: 12/23/2013	Job Number: 1302357.2	Figure: 4
