PhotoSat Stereo Satellite Surveying Project Report:

Ref. No: 3936
Previous Ref. No: 3848
Client: Metallic Minerals Corp
Project Area: Keno Lightning and Formo, Yukon
Project Datum: NAD83 (CSRS)
Project Projection: UTM zone 8N
Project Elevations: Orthometric HTV2.0 CGVD28

Project Overview:

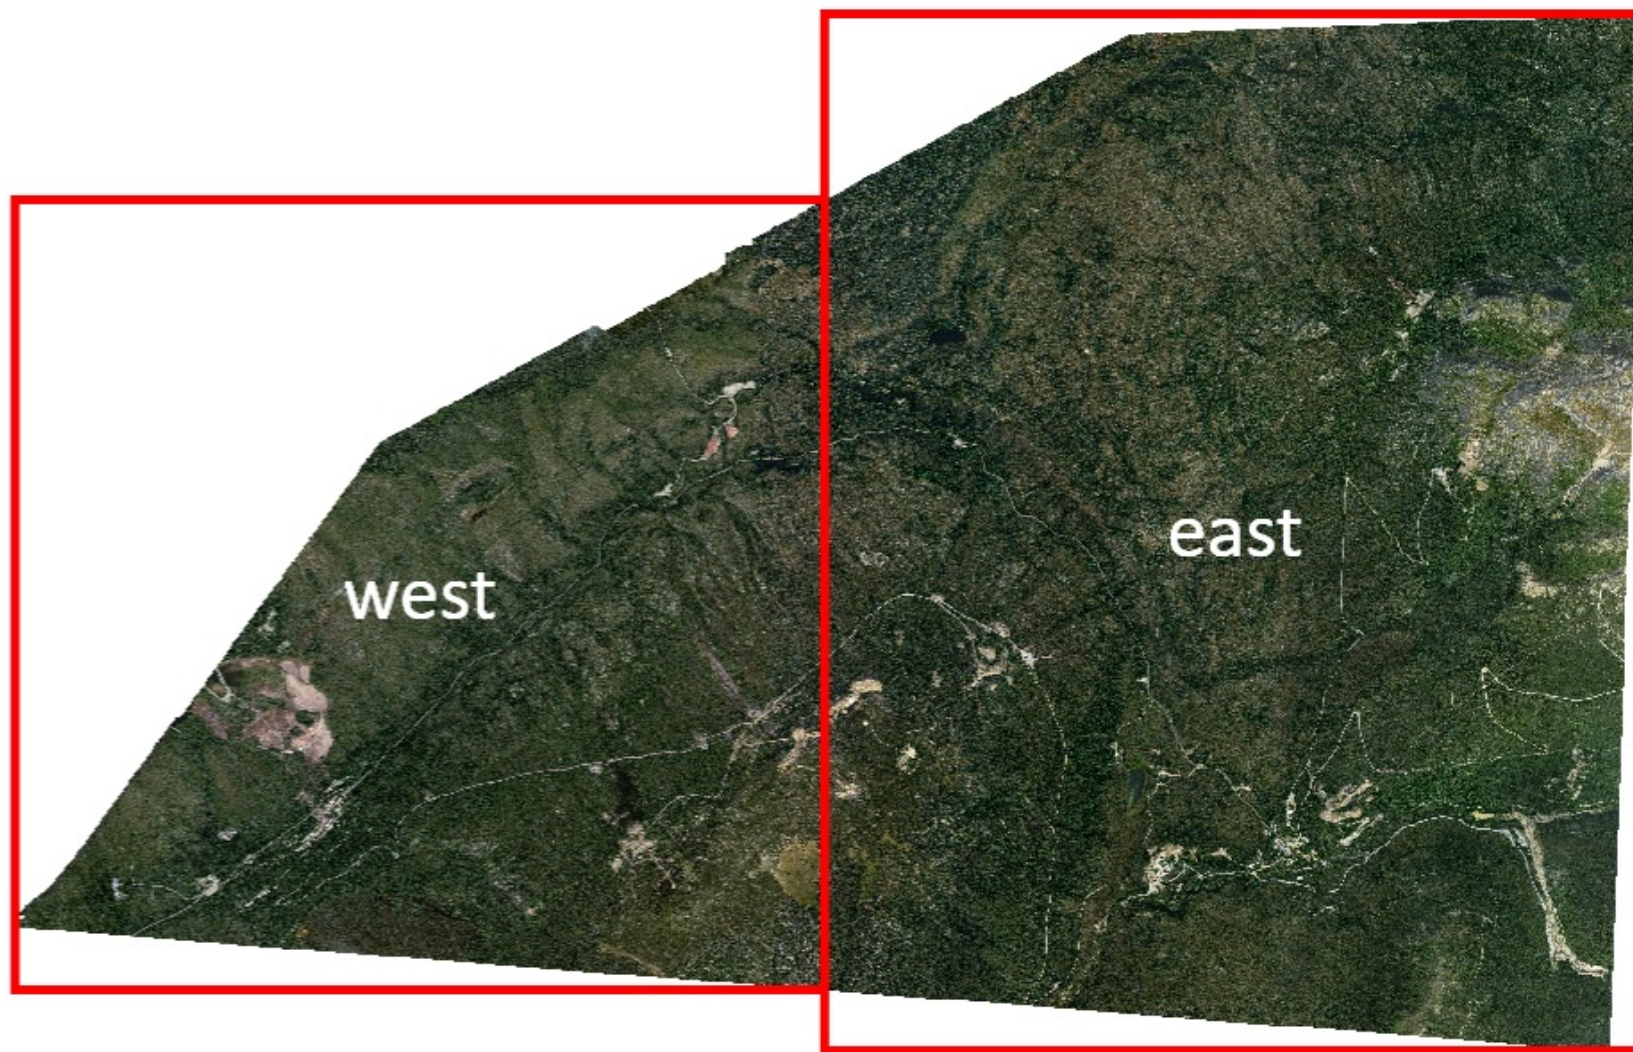
Figure 2: Formo orthophoto mosaic showing the tile index.

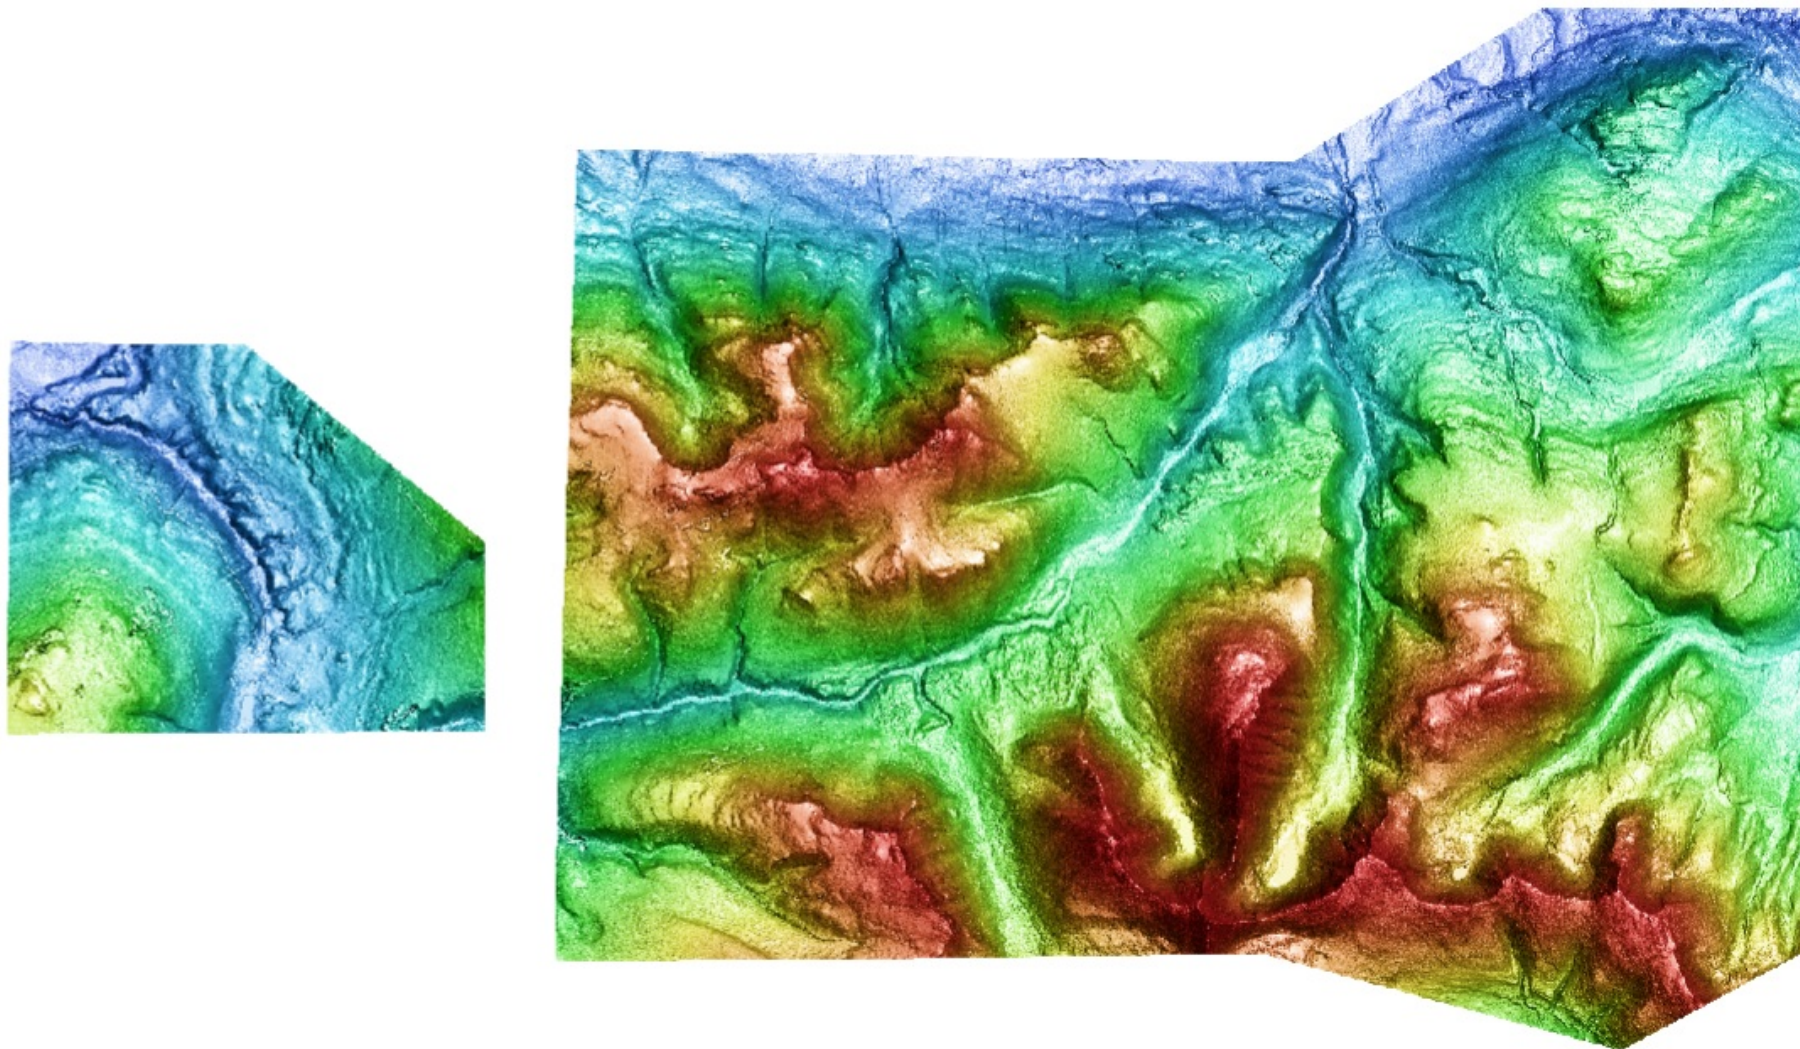
Figure 4: Colour elevation image of the satellite survey. Formo is the west area, Keno Lightning is the east area.

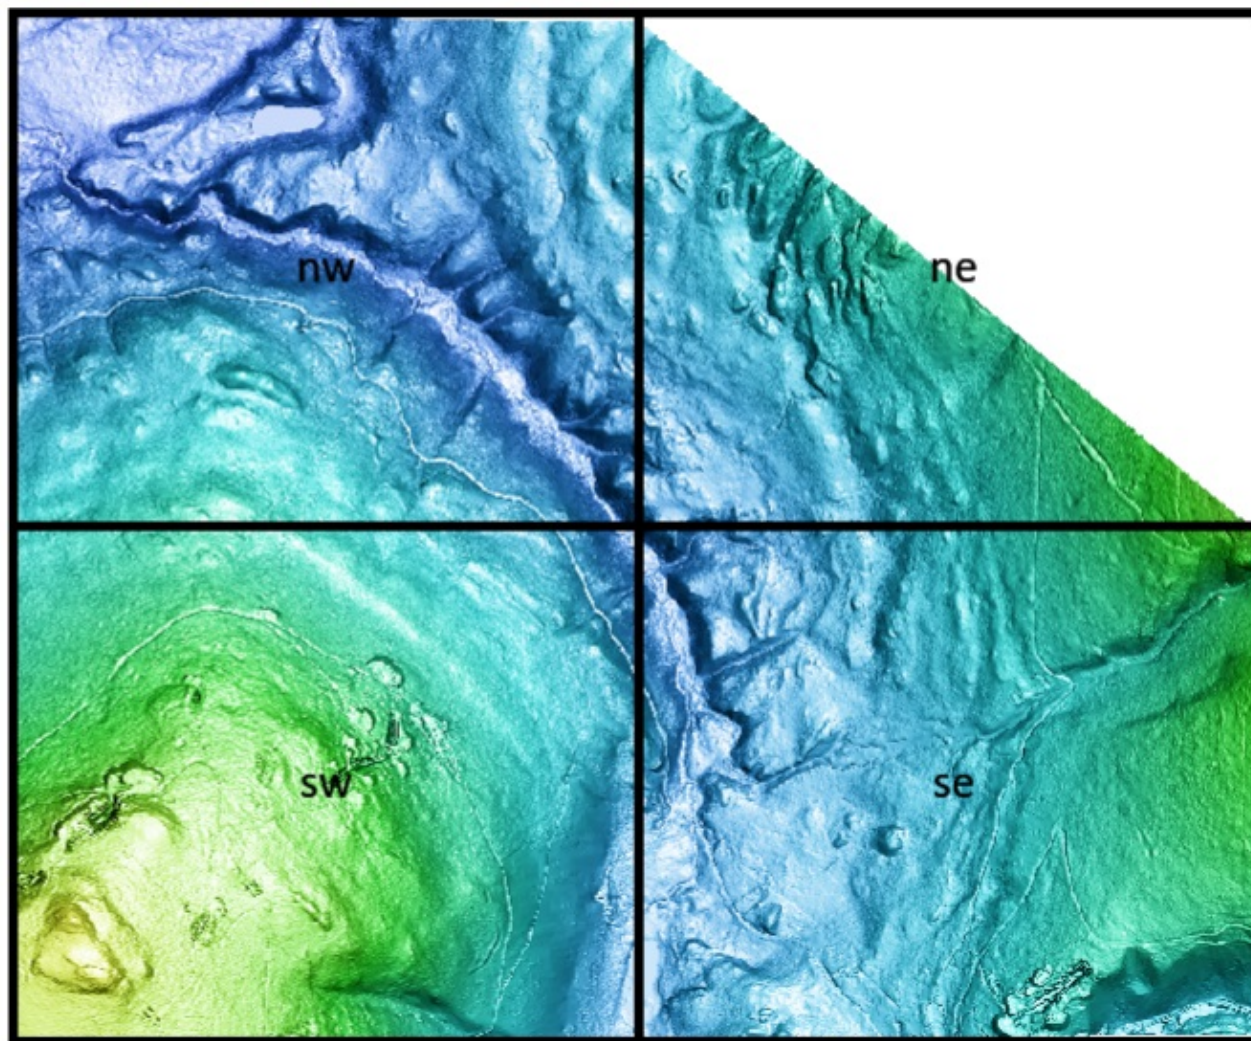
Figure 6: Colour elevation image of the Formo satellite survey showing the tile index.

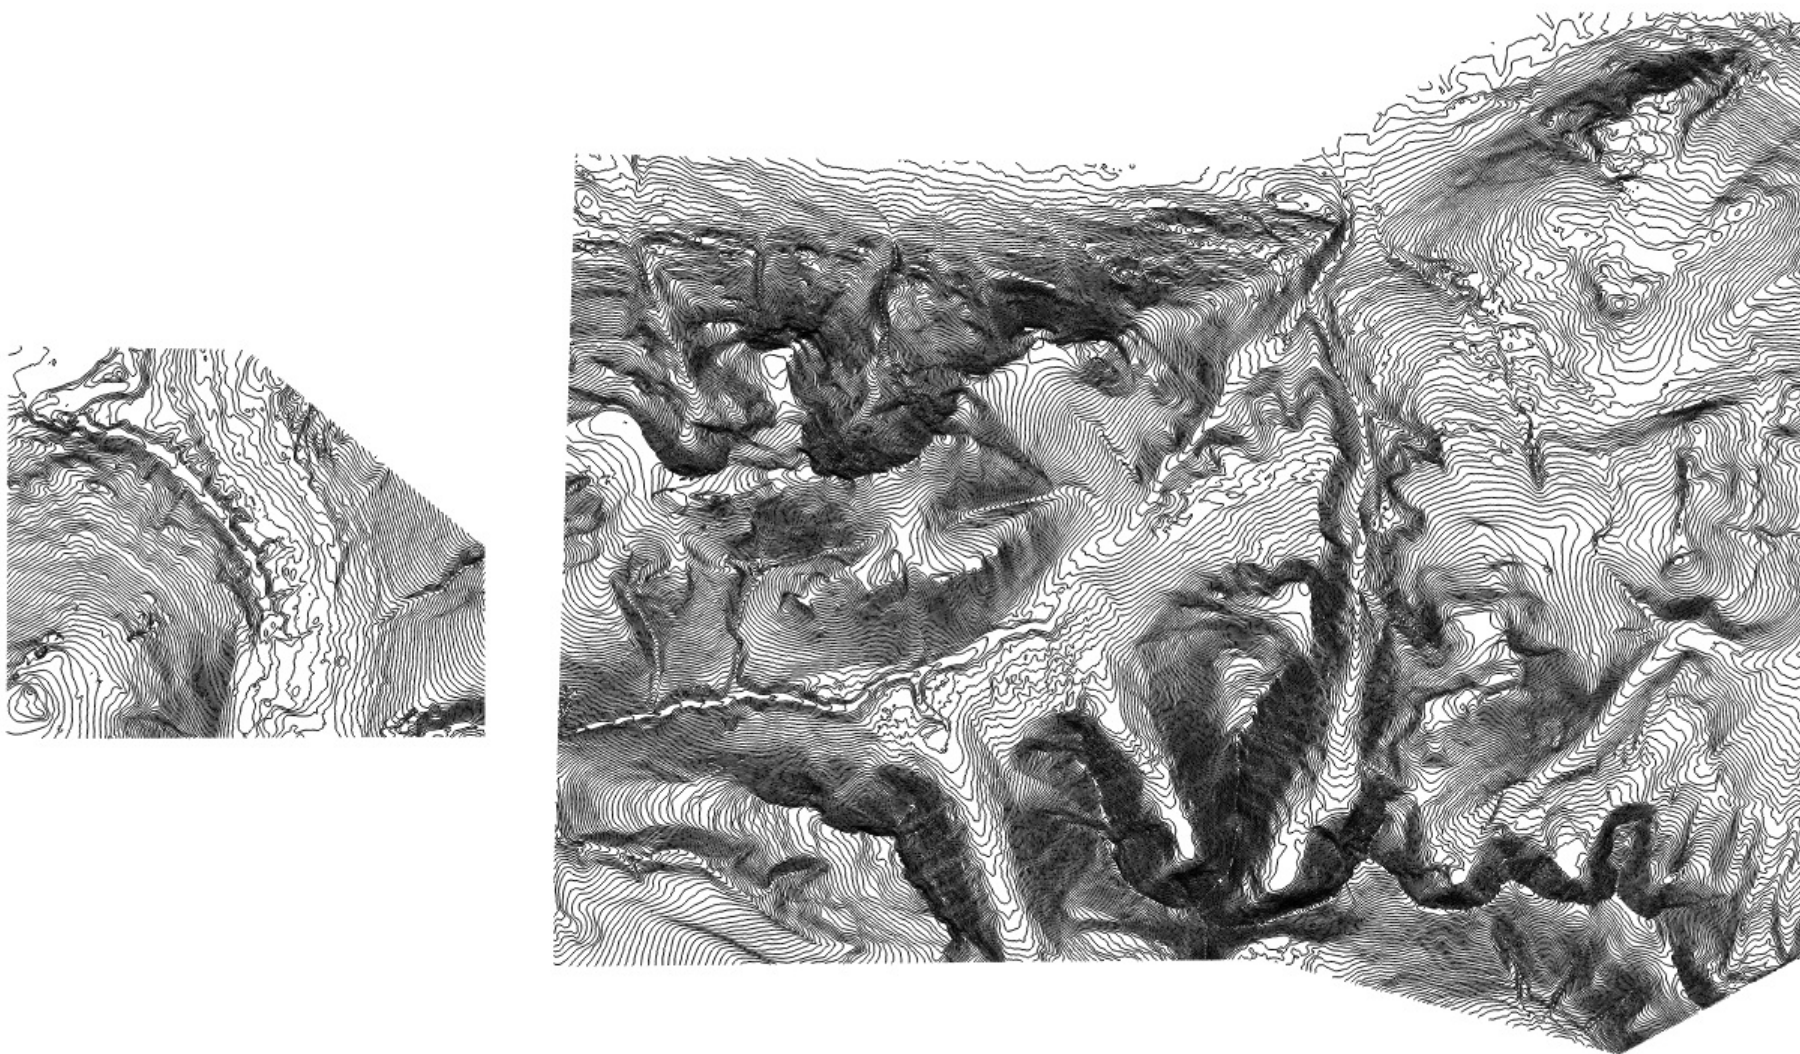
Figure 7: The 10 m contours. Formo is the west area, Keno Lightning is the east area
