**ASSESSMENT REPORT on YEAR-2015
Site Reclamation and Clean-up of Exploration Site
and Restoration of Drill Core**

NORTHERN DANCER PROPERTY

NTS Sheet 105B/4

January, 2016

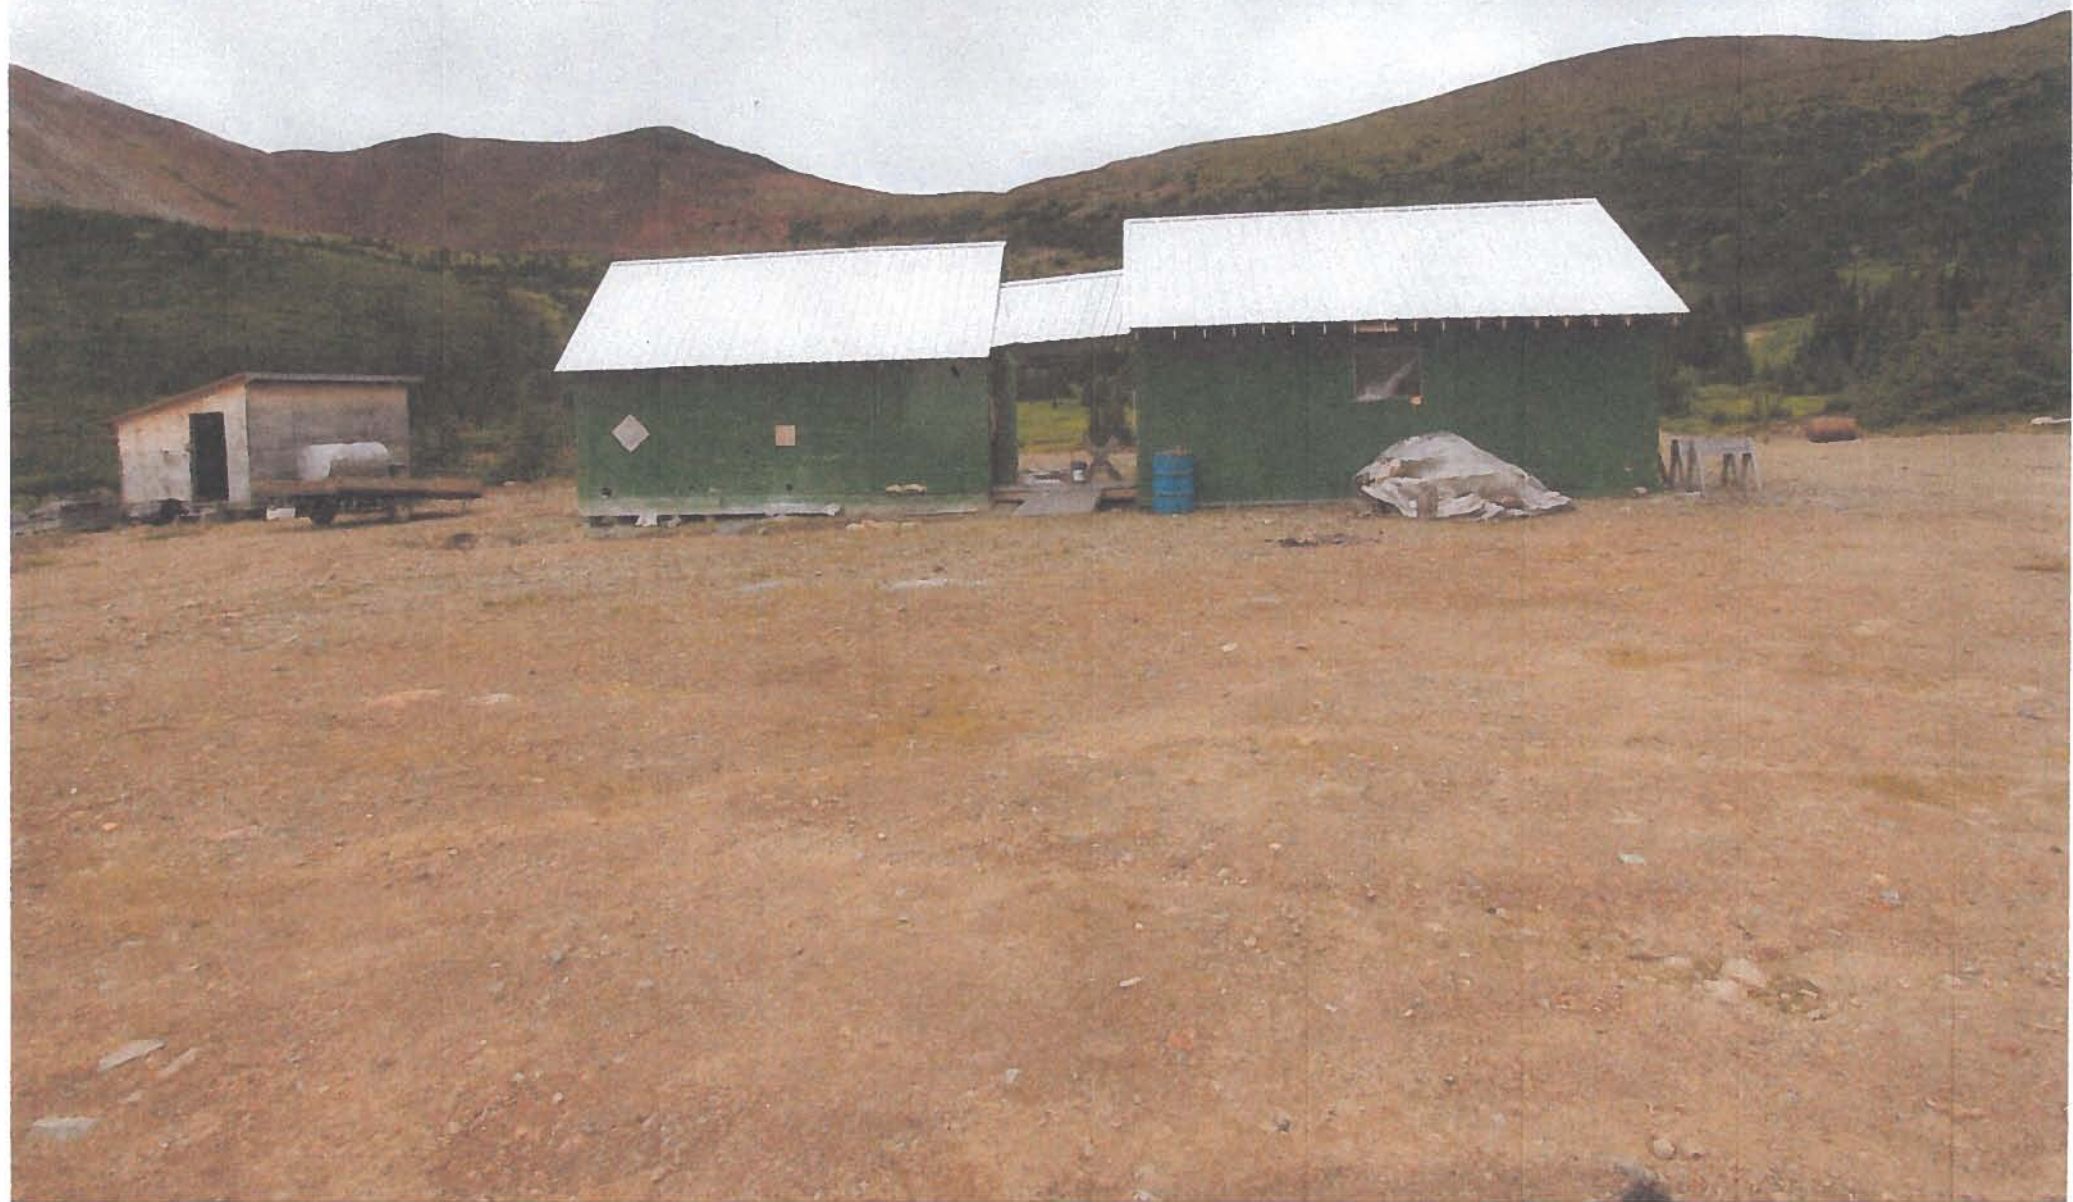
Backfilling of Adit

Largo hired Tescon Construction who provided the excavator, tandem truck and tractor used to gather aggregate materials to plug the entranceway. The foundation of the cover comprised of 0.25-0.5 meter diameter boulders backfilled into the adit and up to the roof level. A sump drain was constructed to allow for the continued drain of free flowing water from the adit so that the plug would not build up water pressure inside the tunnel. The boulder cover was then backfilled with smaller coarse gravels and sand as infill material and to provide an additional 3 meters of cover over the initial rock foundation. This material extended approximately 5 meters over the roof of the adit to provide extra precaution and fill cover in the case of possible slumping or settling of the aggregate cover. Further details and pictures are presented in Appendix 3.
