DIAMOND DRILLING ASSESSMENT REPORT
ON THE AMB CLAIMS (PART OF THE
ANDREW PROPERTY), MAYO MINING DISTRICT
YUKON TERRITORY

FOR WORK UNDERTAKEN IN JUNE-OCTOBER 2007
BY OVERLAND RESOURCES YUKON LTD.

AUTHOR: Jo van Randen, B.Sc.

DATE: February 2008

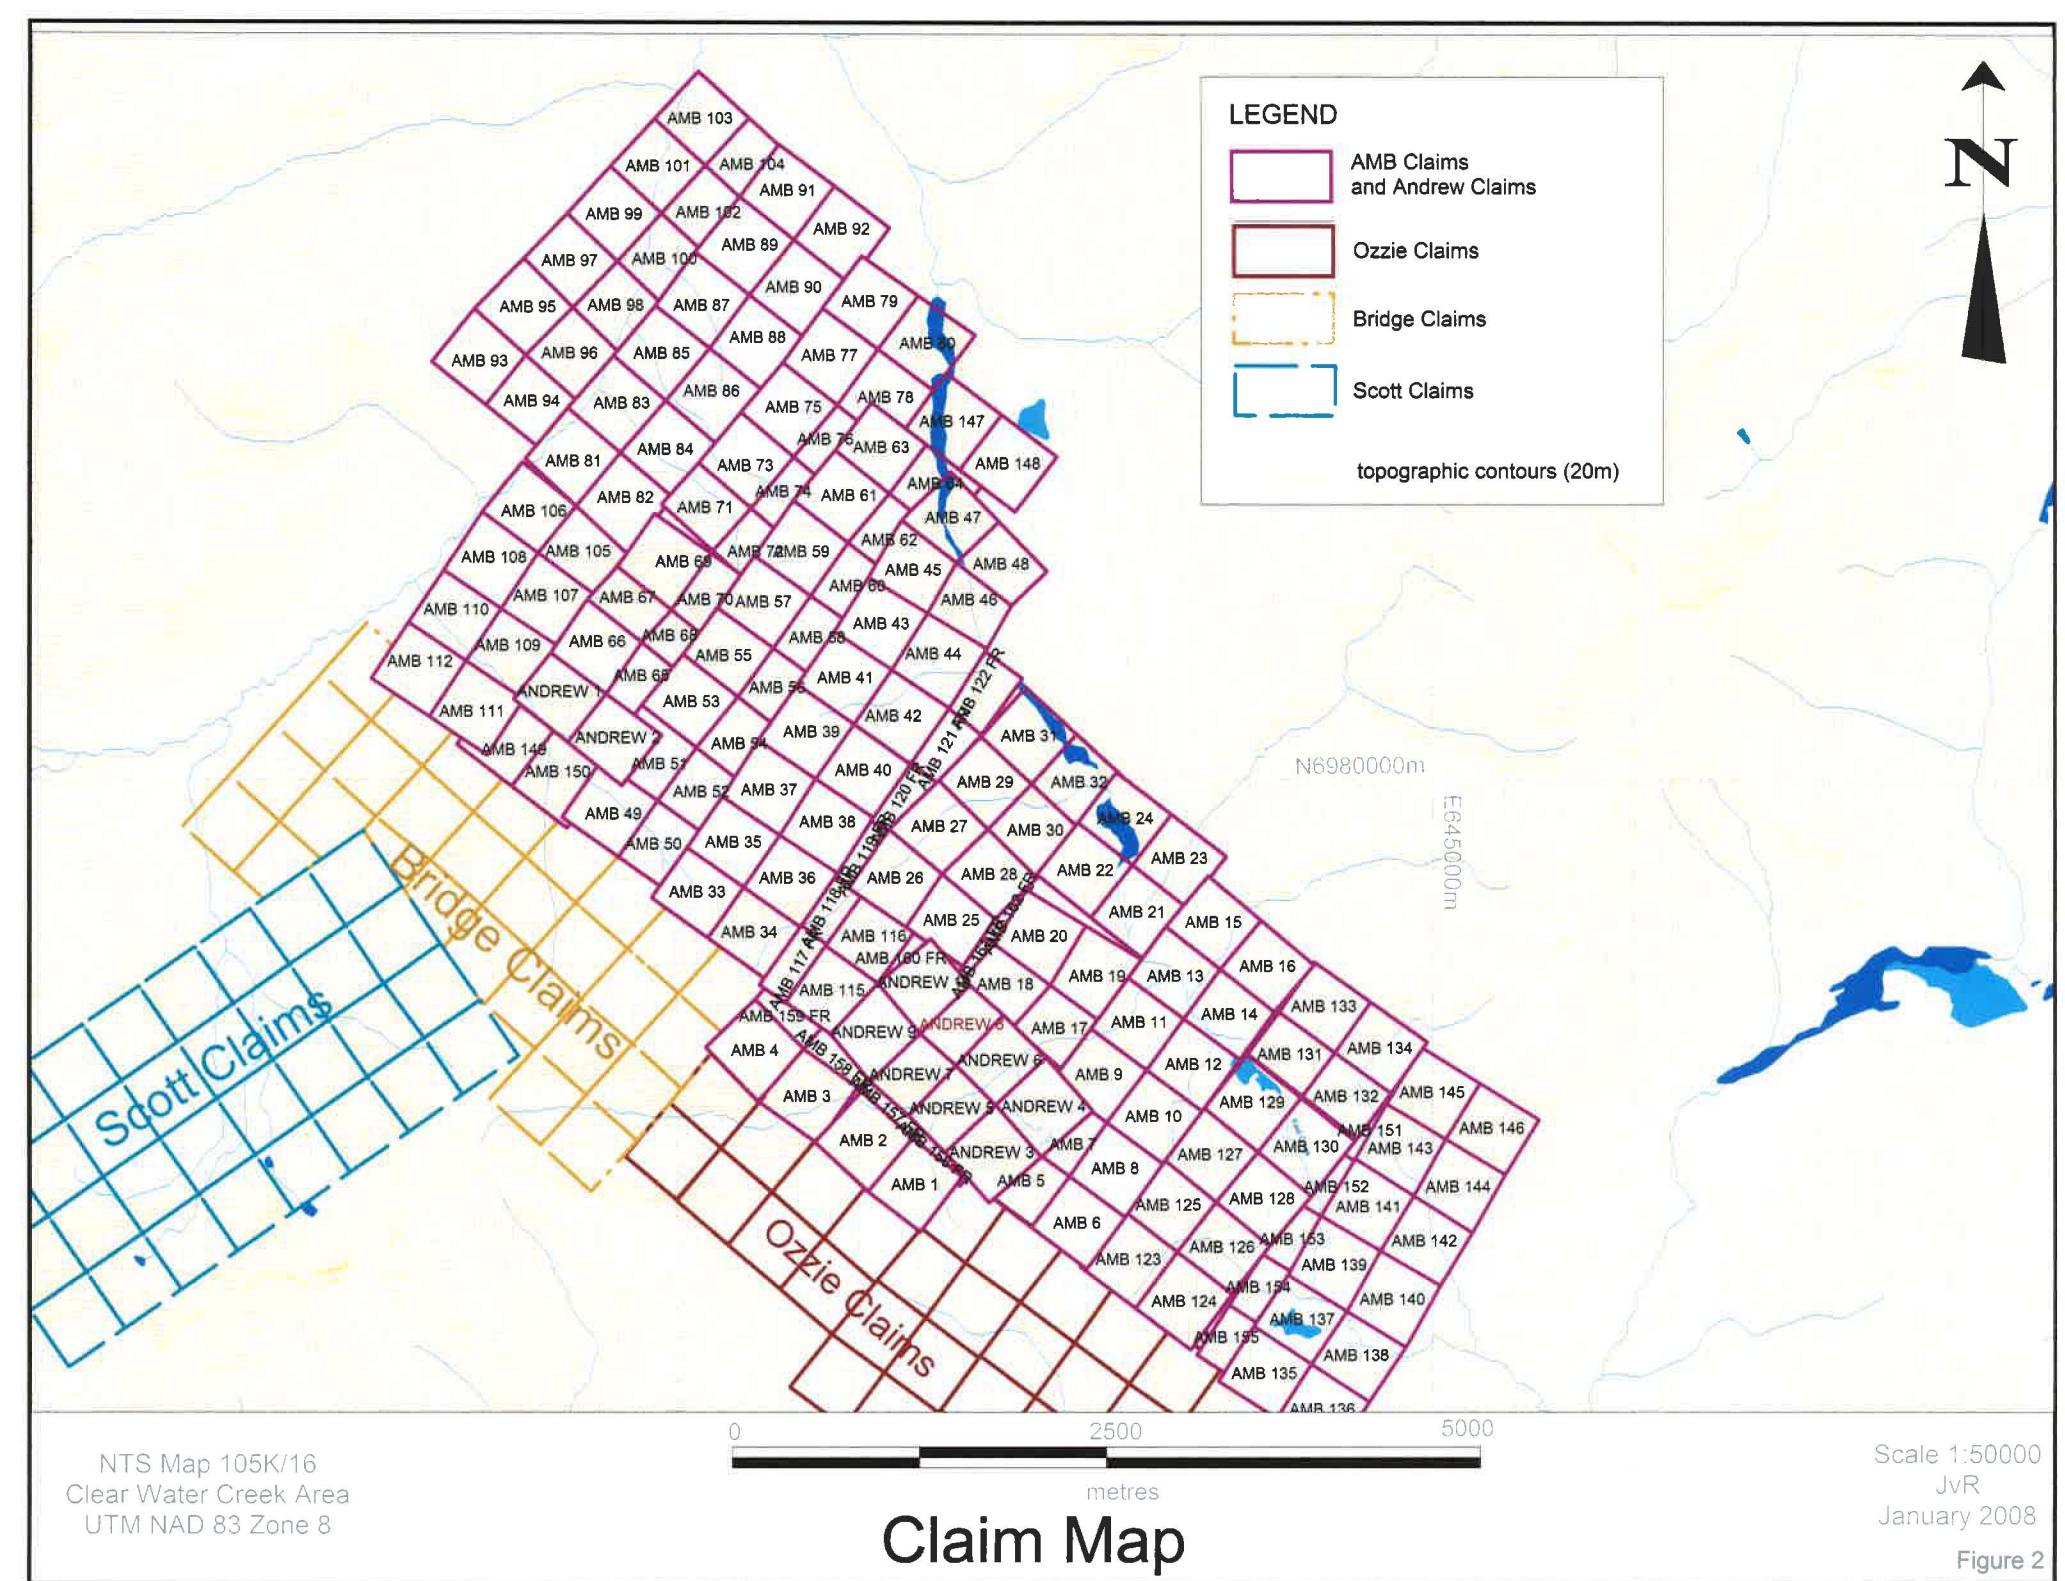
Note that the indicated expiry dates are based on the acceptance of this diamond drilling assessment report in accordance with the reporting requirements in the Schedule of Representation of Work under the Quartz Mining Act. Figure 2 displays the AMB area claim locations.

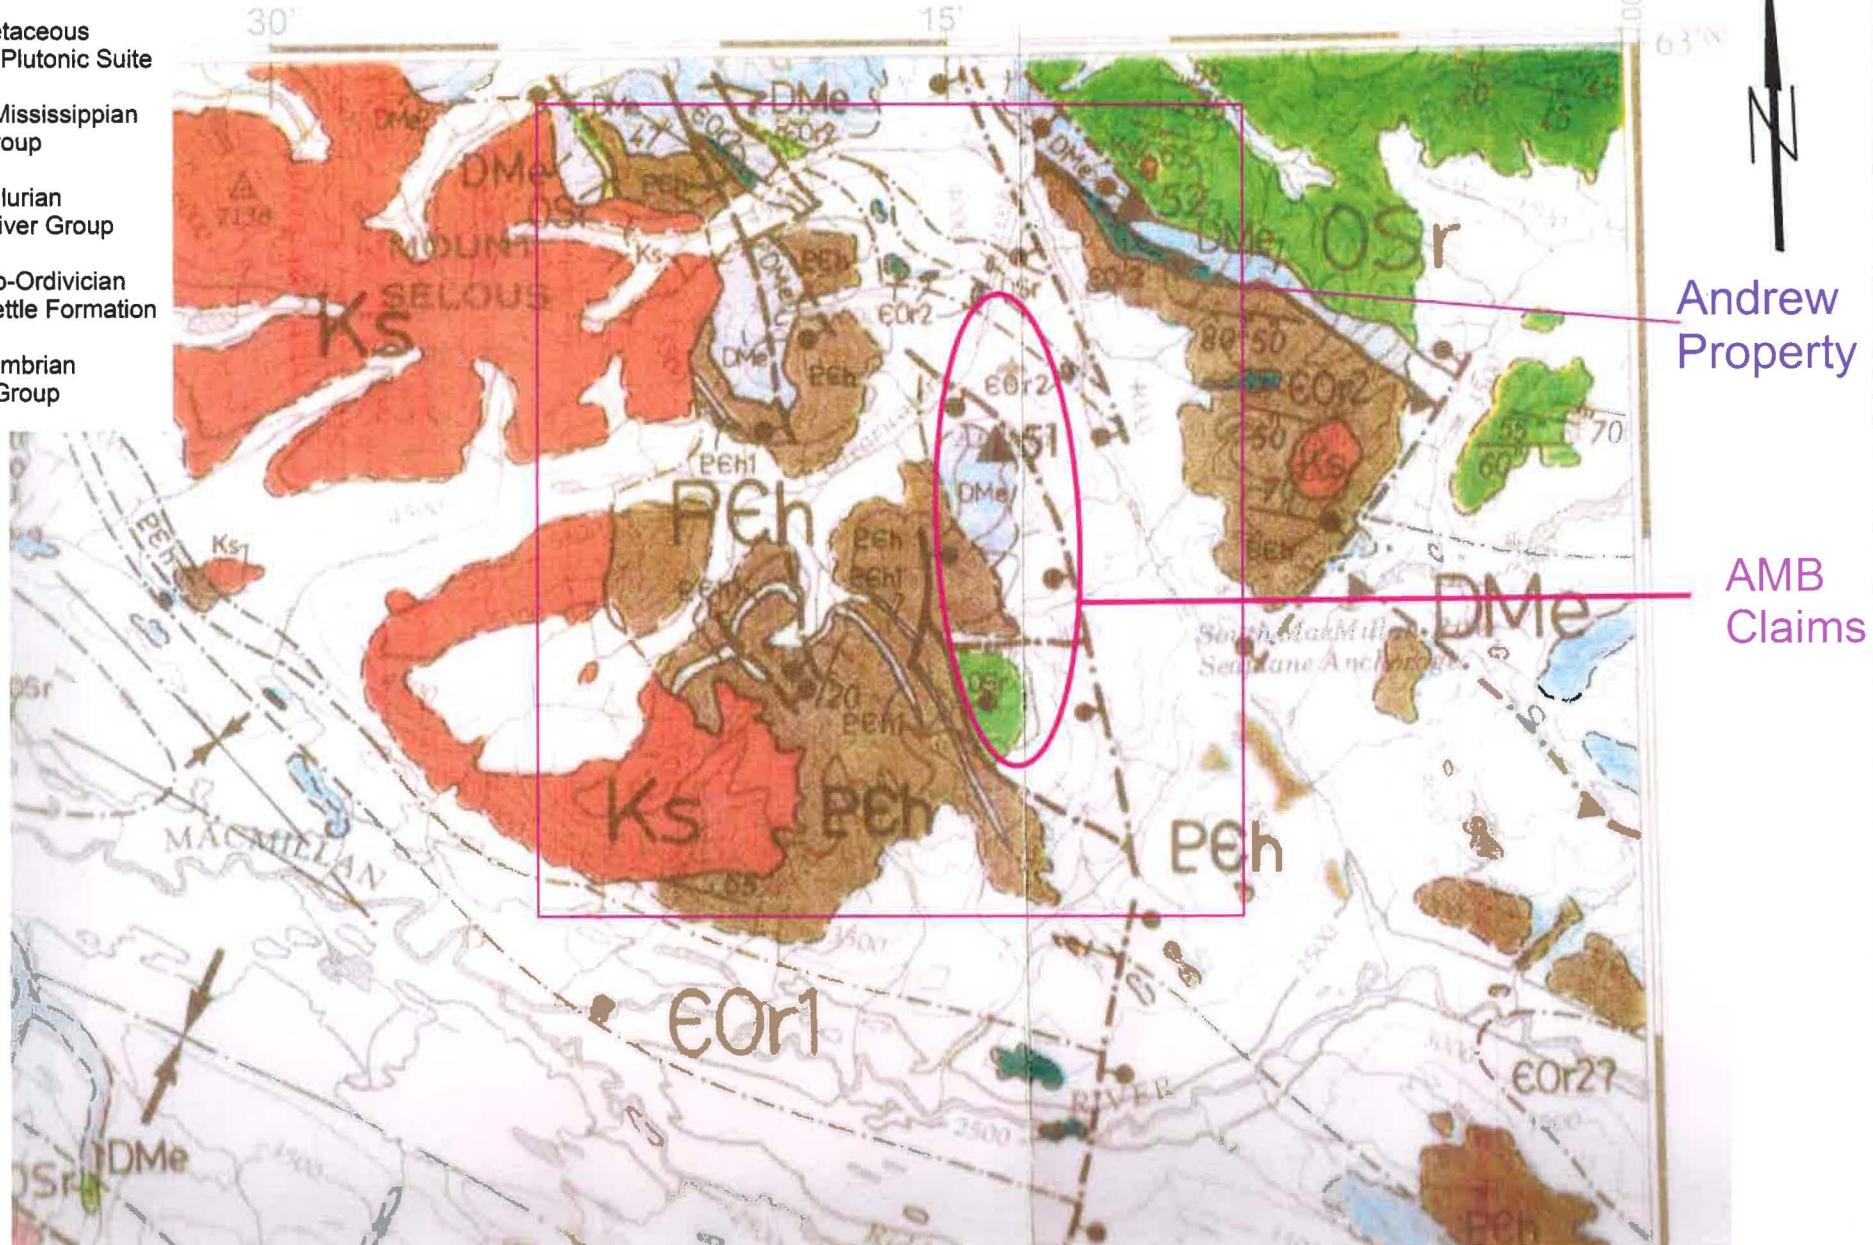
Andrew Property Regional Geology Map

Figure 3 shows the GSC geological Regional Geology for the Andrew Property area, with the AMB claims area covered in this report outlined as well on the modified regional geology map.

Noranda geologists reported that the rocks in general follow the regional strike of 120 to 160 degrees and dip steeply to the northeast, and Overland staff confirmed this. Folding along this regional trend was observable at several outcrops. Faulting is evident by the presence of linear gullies, creek trends, and rarely in outcrop. In addition, many structures are evident from airborne magnetics (see Figure 4). There are two preferential trends; the strike parallel trend at about 140 degrees and a cross-cutting trend at about 100 degrees.

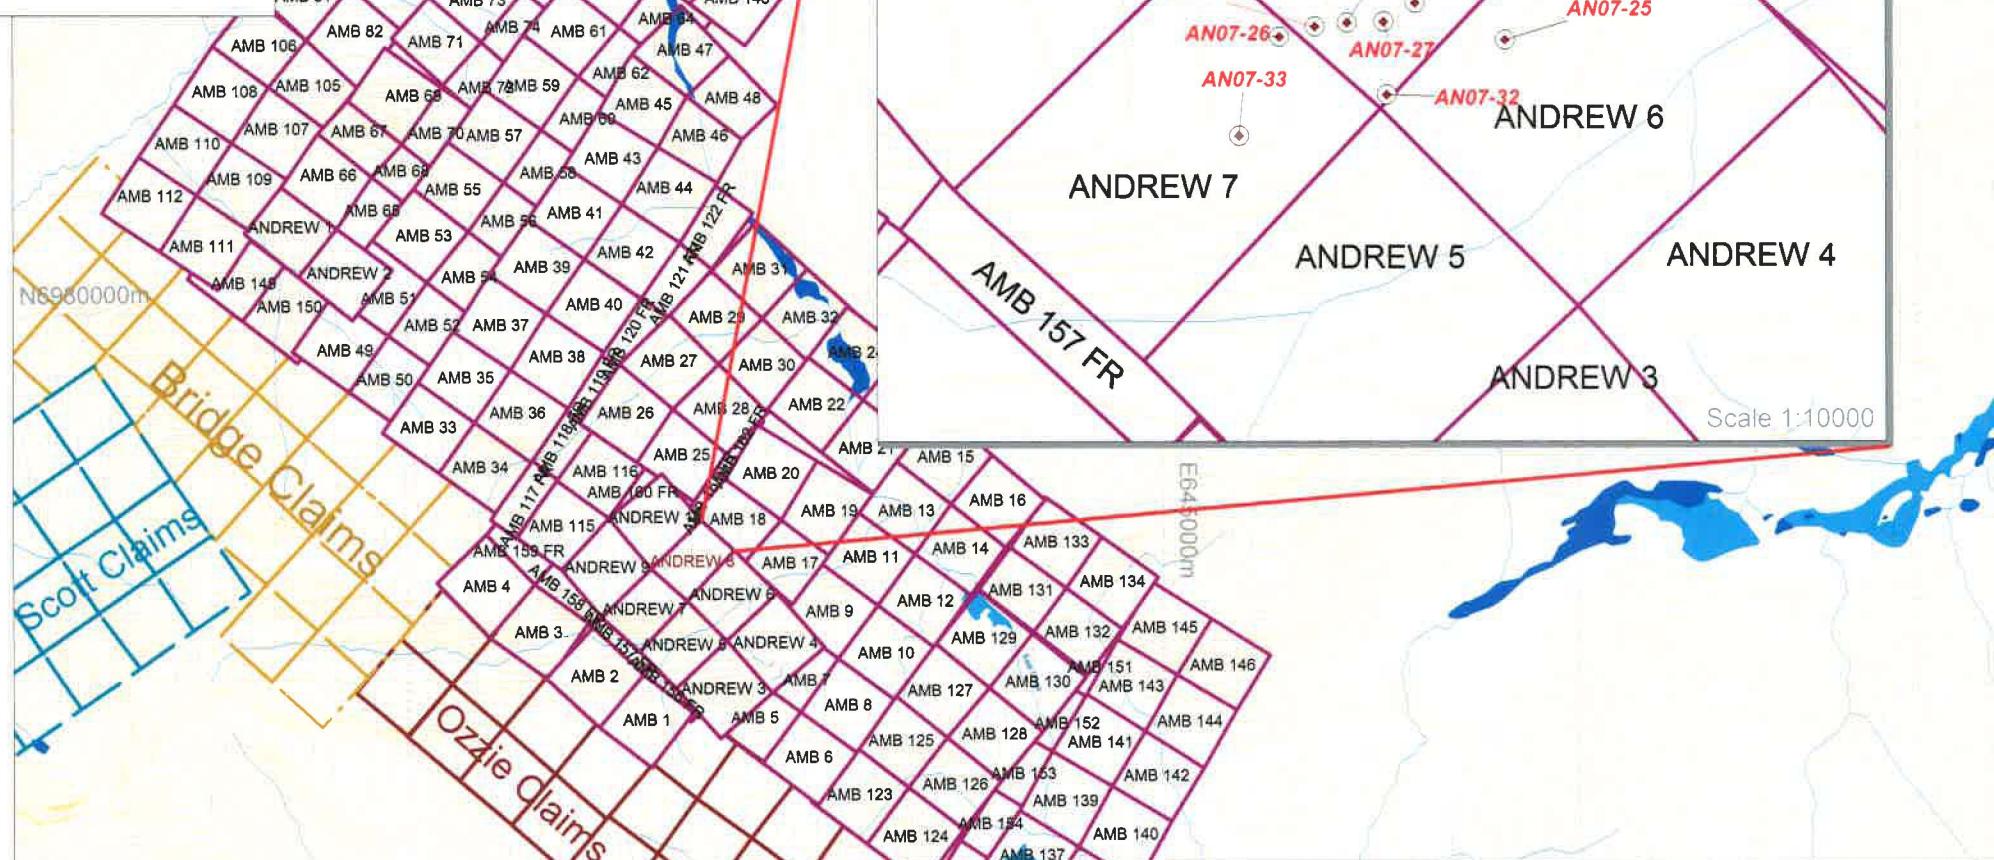
AN07-24 Collar Location Map

Drill hole AN07-24 was targeted to intersect mineralization at a higher elevation than that which was documented in Noranda's AN02-17 and below the reported intersection in AN01-11. AN07-24 consisted of a series of calcite veins and stockworks in variably altered silicified locally calcareous grey and black shales and dominantly quartzites. Sporadic coarse-grained brown sphalerite and lesser galena blebs occurs locally in quartz and calcite stockwork zones. Reported significant intersections from AN07-24 include 1.3m @ 0.51% Zn & 1.81% Pb from 202m and 1.4m @ 0.27% Zn & 1.29% Pb from 219.4m in an extensive breccia zone (Overland Resources Ltd. Australian Stock Exchange (ASX) press release dated 11 September, 2007). The hole was collared on the same drill pad as AN02-17 with surveyed UTM NAD 83 Zone 8 coordinates of E641650m/N6978398m; 180° azimuth, -50° dip angle and total length of 266.1m (Figure 4).

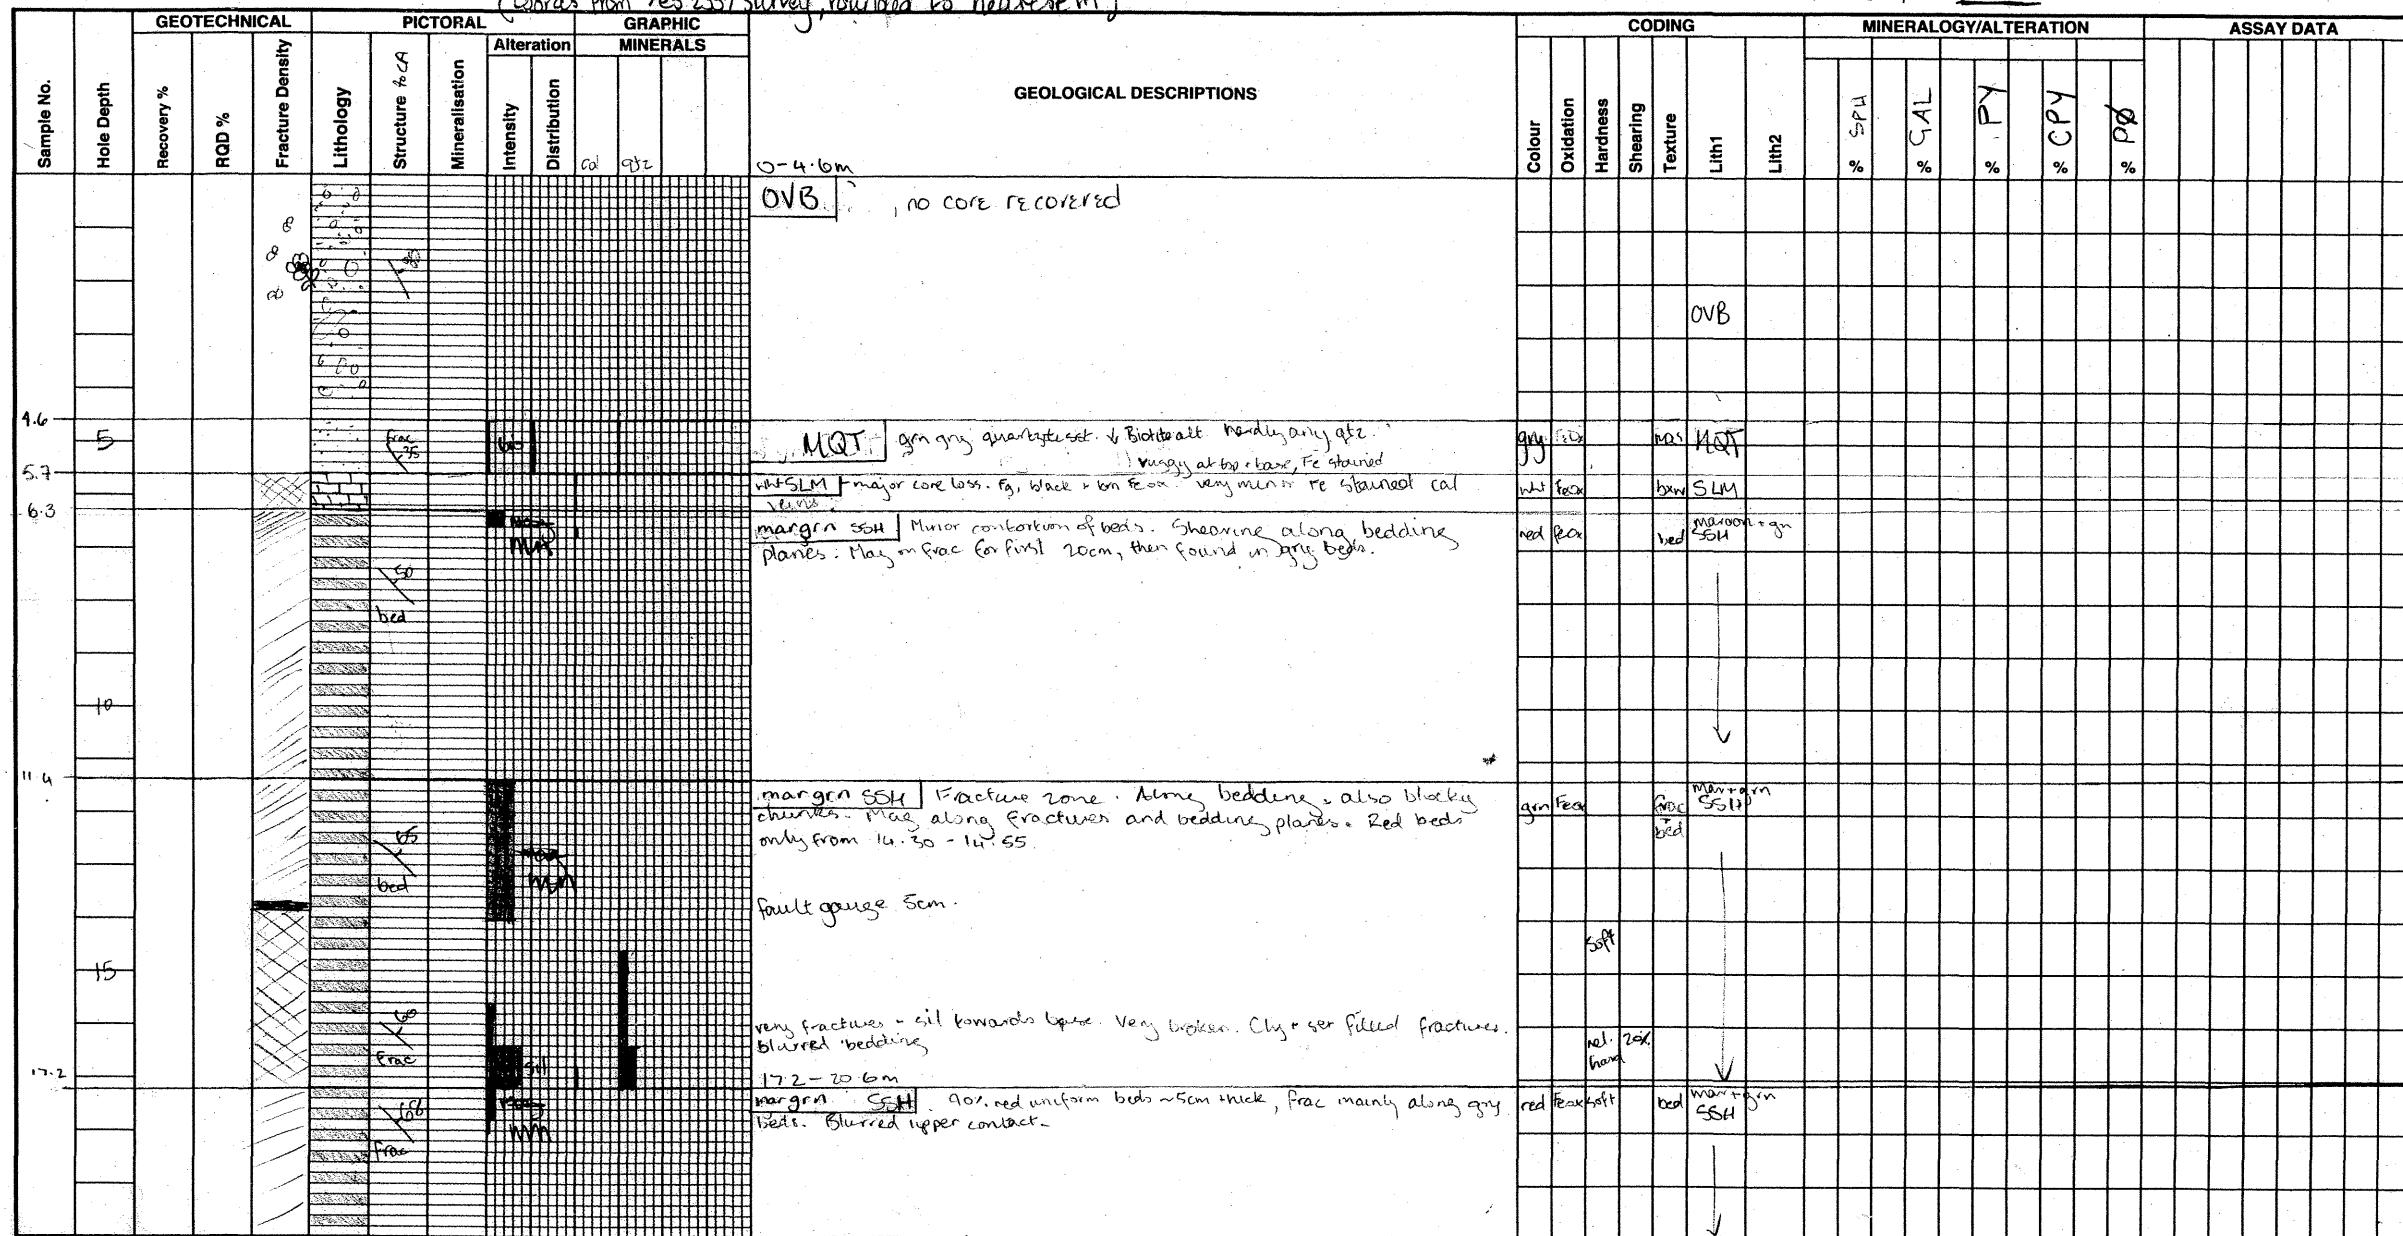
SHEET 1 OF 14

21.6-23.4 m: margin Sstt [subvertical veins of magpy + pyrr + gtz]
 23.4-25.5 m: Fault opaque (2-3cm) @ 23.5m.
 chl + pyr veins/unfilled frac from 23.5m. euhedral pyr. thin lamellar bedding
 margin Sstt [Fold hinge intersection. Very fine, harlike gtz mag veins ~45°, larger gtz veins 40°. Crenulation foliation & small at 25.5m. Pyr spots in grey beds. Smal dissolved out frac at 90° with chl alt.]
 Pyr unfilled, very fine brittle fractures.
 margin Sstt [Contorted + crenulated beds. Frac roughly along beds but they are generally more coherent/lss fissile.]
 Pure chl + gtz veins. Chl + clay on fracture surfaces
 Grey beds have darker lamellar bands towards base, chl banding due to alt.
 Thin gtz veins, unfilling fractures along bedding & cross-cutting Shearing in last m, thin brecciated zones with slickensides. Thin cal on frac surfaces
 margin Sstt [Hardly any red beds - they are very FeOx stained. Contorted folded beds]

minor granular brecciated fault, 20.1-21.6m, heavily frac ~20cm
 isolated fracture zone ~3cm, gtz stronger - ground maturation? FeOx
 (isochinal folding)
 grey Sstt [Unfilled fractures, gtz veins, in lower 50cm = later stage than older filled ones. Chalcocite + pyrr + pyr + sulphide matrix + calcite fractures. Hydrogen sulphide traces.]
 FeOx (grey Sstt) [mainly clay and breccia. Folded Sstt bedding still visible in middle section - grey + yellow beds. FeOx unfilled fractures. Chl + pyr unfilled veins + pyr + magnetite in beds]
 Pyr + mag veins towards base, euhedral pyr also overprinting structure
 green + grey Sstt [Bands of different meta pyr (as above unit) euhedral, FeOx. Tight isochinal foliation. Qtz veins with cal-filled veins]
 Pyr + mag filled fractures from 26.1-40.3 - small. Small cross-cutting faults offsetting bedding. Fractures coated with FeOx. Some small mag filled fractures towards base
