REPORT ON  
LIARD RIVER GOLD PLACER PROPERTY

located at  
60° 45' N 130° 20' W  
in the  
Watson Lake Mining Division  
Yukon Territory

for  
SAYYEA CREEK MINING COMPANY LIMITED

November 1, 1976

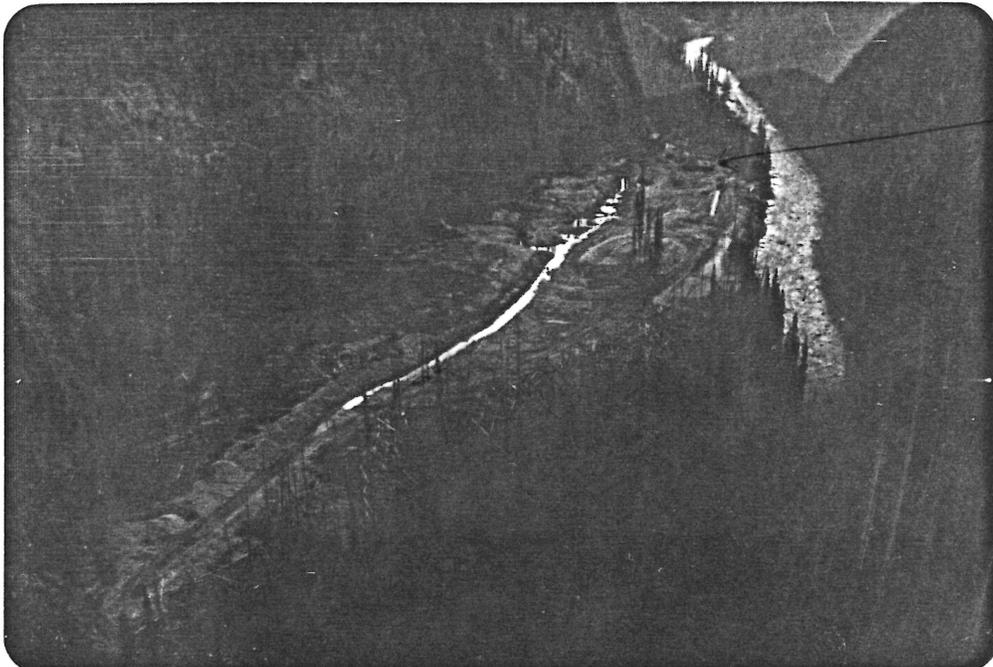
Facing southerly showing company camp on Cabin Creek, access road and placer operations.

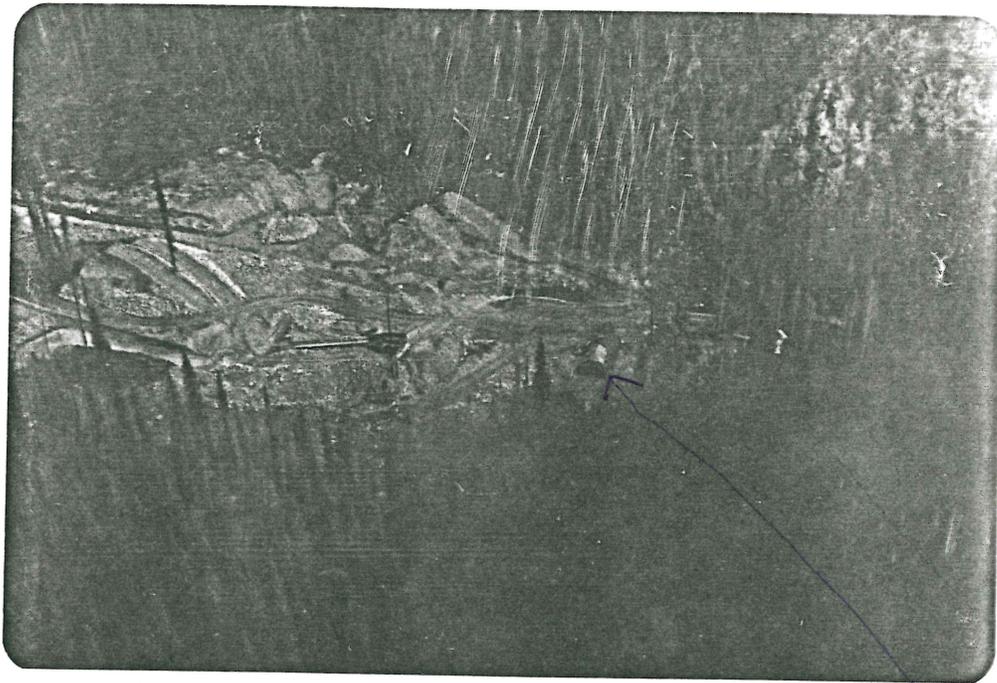
Shows company camp on Cabin Creek with holding pond and placer equipment.

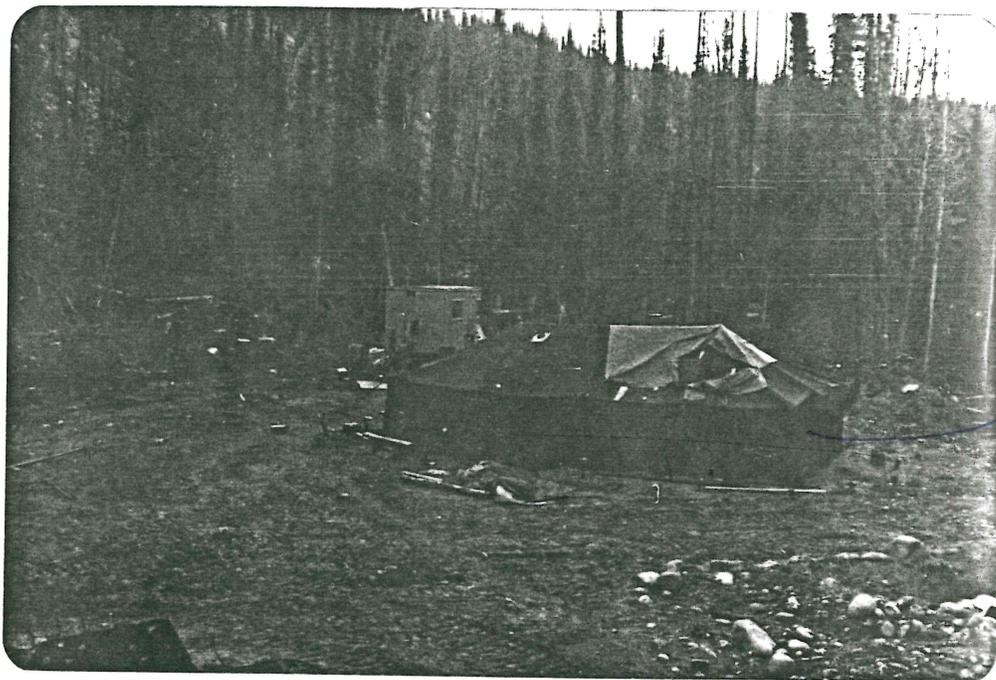
Ground view of company camp on Cabin Creek facing Southerly.

Tent is  
30' long
