YUKON TERRITORIAL GOVERNMENT
EXPLORATION INCENTIVES PROGRAM
PROJECT #93 - 034

**PLACER EXPLORATION ON
FORTYMILE RIVER**

April 1 - June 15, 1993

DREDGING LEASE 83/4
PLACER CLAIMS P23948, P23949, P23950

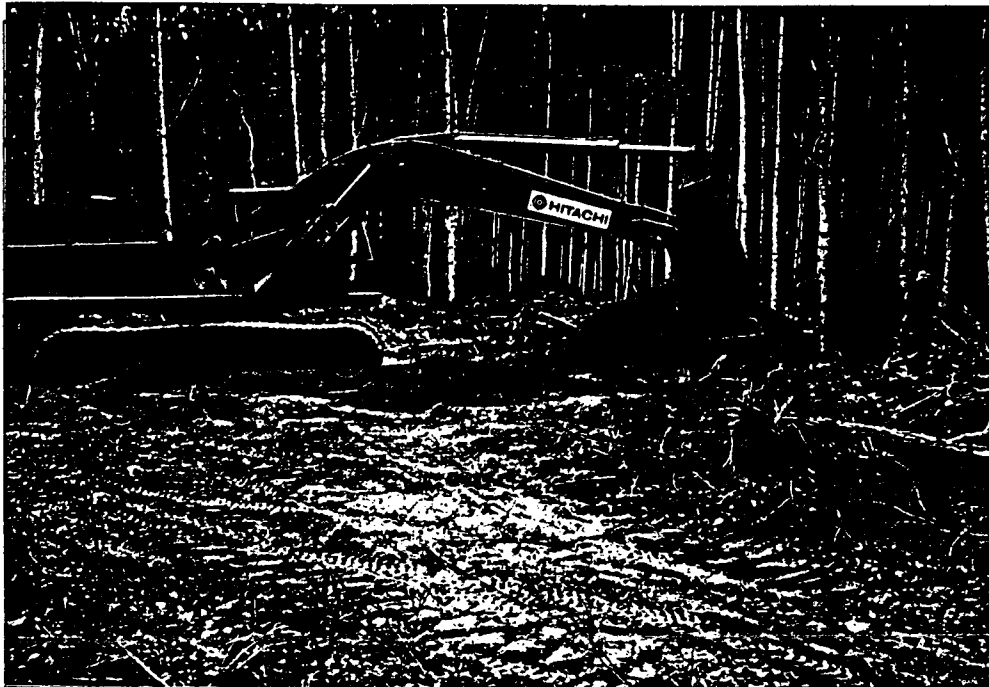
EXCAVATING PITS IN RIVER BANK GROUND

In April we cleared snow off of the access road which goes part way to the work site, so that the road would dry out quickly, allowing early access to the property. We used the dozer to extend the road into the work site. We excavated a series of pits in this area upstream of the old workings and against the rim of the valley floor. See Map 4 for the location of the work.
