WHITEHORSE COAL PROPERTY:

SUMMARY REPORT ON THE

1986 TEST PIT - BULK SAMPLING PROGRAM

**REPORT AUTHOR:
J.H. PERRY, P. GEOL. (COAL-EX)**

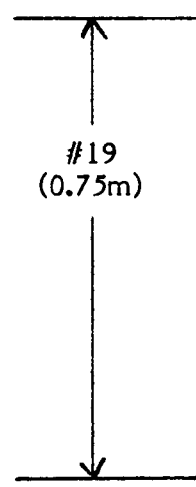
SAMPLE 19

<u>Sample No.</u>	<u>True Thickness (m)</u>	<u>Description</u>
		Roof - altered igneous rock (Sill).
	0.09	Baked Claystone.
	0.08	Carbonaceous Claystone.
	0.03	Boney Coal.
	0.03	Coal - hard.
	0.13	Coaly Claystone.
	0.34	Coal.
	0.05	Boney Coal.
		Altered igneous rock (Sill).

This sample is a channel sample taken across the coal and claystone band that lies between the middle sill and the sill that forms the roof of the seam. The coal in this section is equivalent to the peak on the densilog of hole 85-5 centred about the 120 ft. depth. This sample was obtained from the centre of the excavated area approximately 47.5 metres west of the east wall.
