**MOUNTAIN HIGHGRADE MINES LTD.**

**GEOPHYSICAL SURVEYS, TRENCHING  
AND UNDERGROUND REHABILITATION PROGRAM  
ON THE DALE PROPERTY, RANCHERIA AREA  
SOUTHERN YUKON TERRITORY**

M.A. Power M.Sc. P.Geo.

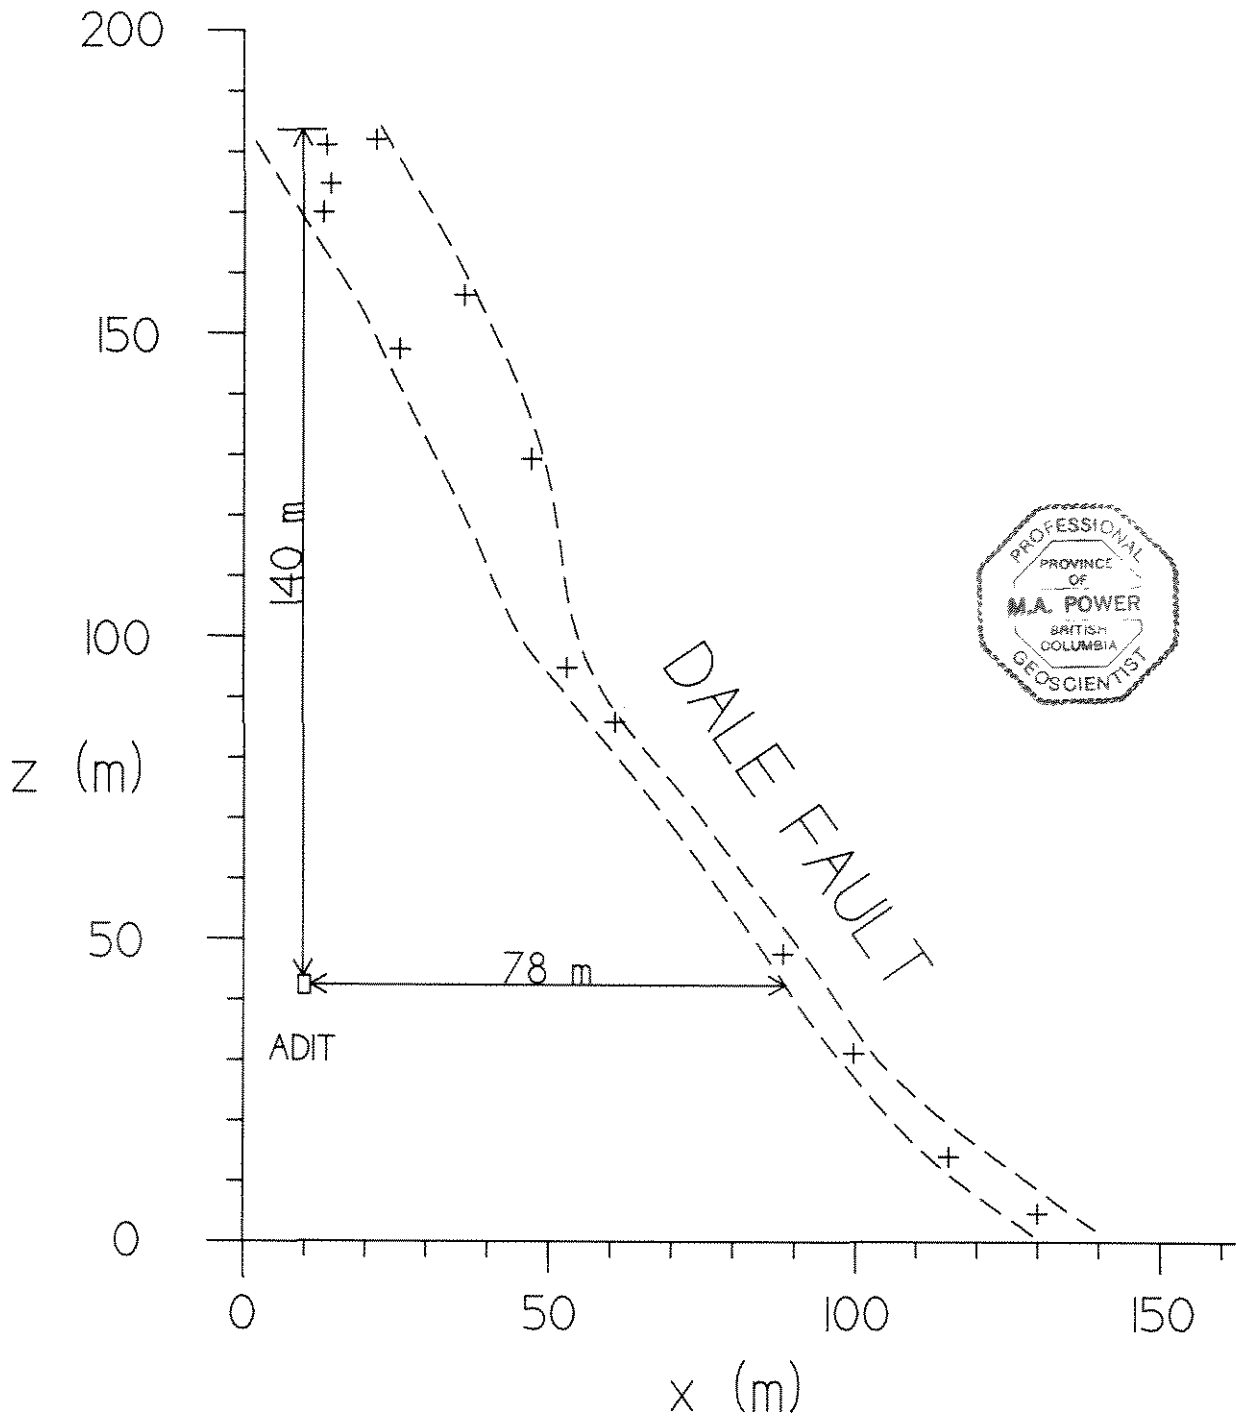
DALE PROPERTY	CLAIMS: FROSTBITE I-40
CONDUCTOR AXIS & ADIT ALONG STRIKE PROJECTION VERTICAL SECTION	MINING DISTRICT: WATSON LAKE
	NTS: 105 B 1   SCALE 1:250
MOUNTAIN HIGHGRADE MINES LTD.	SURVEYOR: G. LEE P.ENG.
	DATE: 23 MAR 95   FIGURE: 8

CONDUCTOR AND ADIT LOCATIONS  
PROJECTED ALONG BASELINE

The location of the underground workings with respect to the Dale Fault is shown in Figure 8. The base line orientation is parallel with the mean strike of the Dale Fault; consequently it is possible to visualize the fault in section by an along-strike projection of the conductor axis locations and mapped fault locations on the survey grid. Conductor axis locations were surveyed-in during the topographic survey and are known quite accurately. The depth of the source conductors is undoubtedly from 3 to 10 m beneath the ground surface but for the purposes of this projection, they were assumed to be at surface. Consequently, the projection is a "worst case" indication of the distance between the underground workings and the Dale Fault. As is apparent in the diagram, the current working face is 78 m south of the Dale Fault and 140 m beneath the main showing (uppermost conductor axis locations).

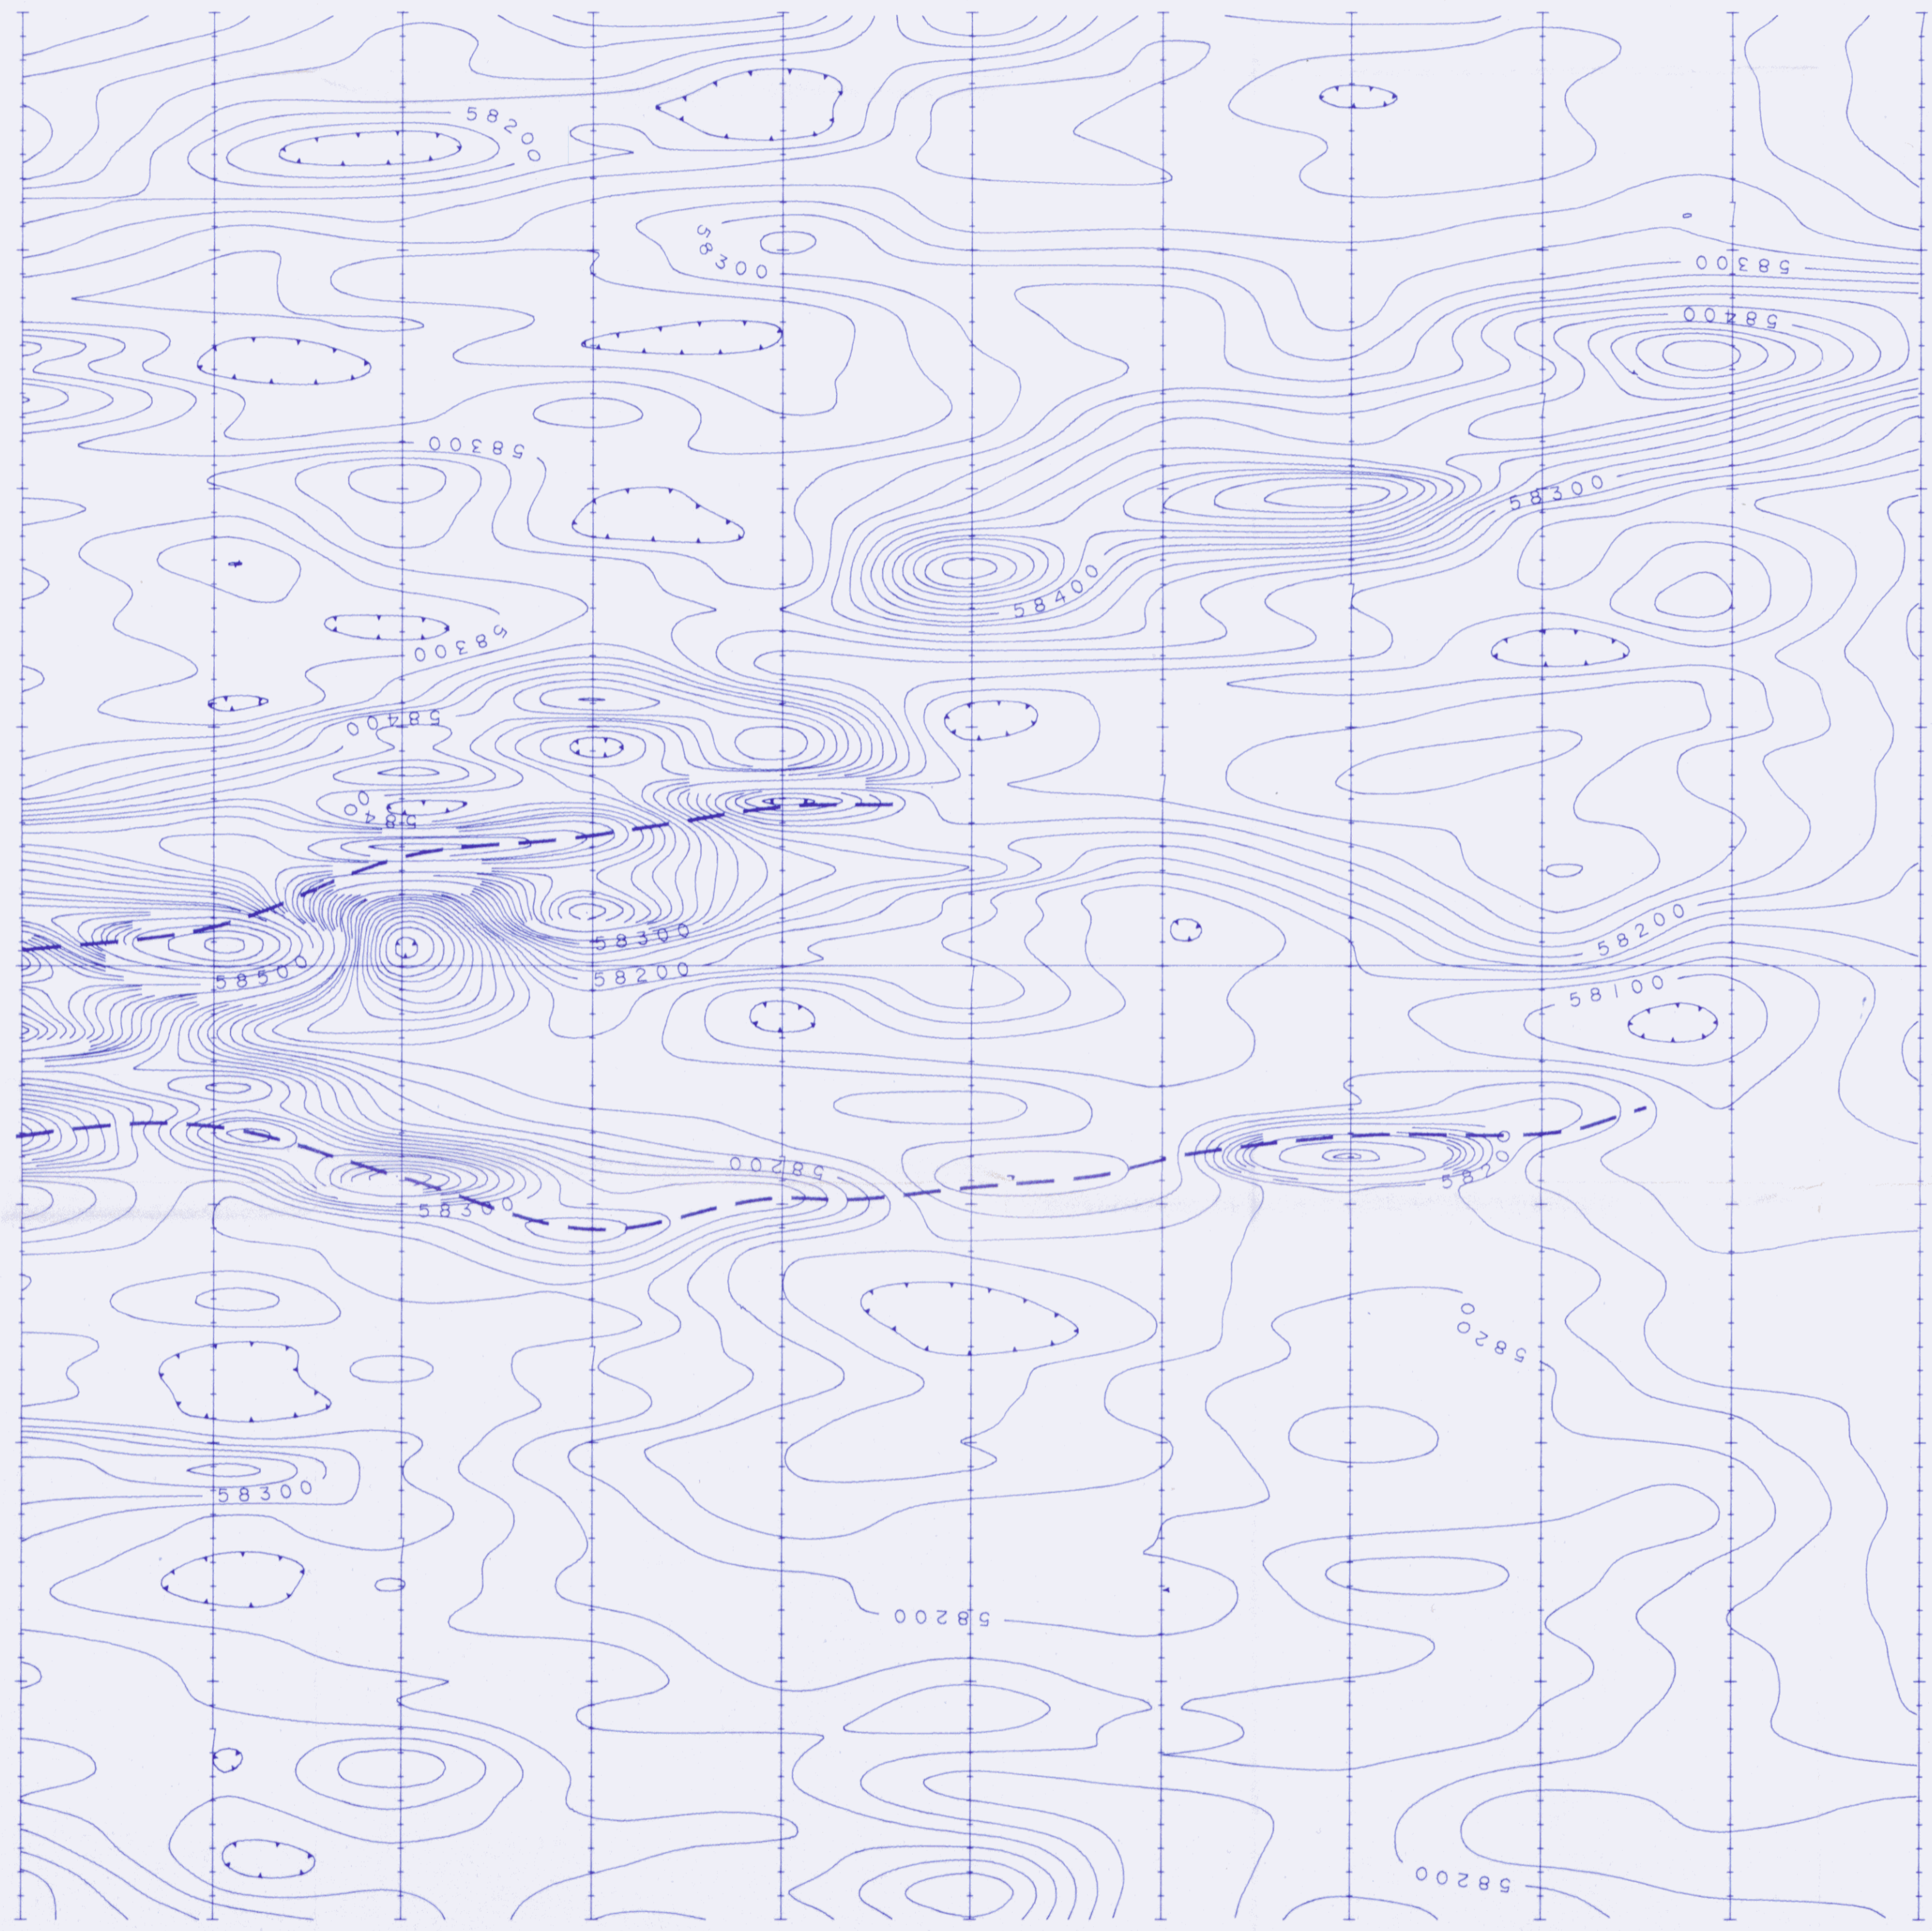
DALE PROPERTY	CLAIMS: FROSTBITE 1-40
TOTAL MAGNETIC FIELD	MINING DISTRICT: WATSON LAKE
CONTOUR MAP	NTS: 105 B   SCALE: 1:1000
MOUNTAIN HIGHGRADE MINES	OPERATOR: G. LEE / M. POWER
	DATE: 22 MAR 95   FIGURE: 5

CONTOUR INTERVAL: 20 nT

The total magnetic field survey was conducted with a synchronized pair of Omni IV proton precession magnetometers using a base station at approximately 5000N, 5000E and a base station cycling interval of 20 s. Measurements were taken at 5 m intervals along the survey lines. Figure 5 (in pocket) is a contour map of the total magnetic field readings with data contoured at a 20 nT interval. Mafic dykes in the footwall and hanging wall of the Dale Fault produce strong positive magnetic responses (Trends **A** and **B** - Figure 5). The fault zone itself is a broad relative magnetic low, perhaps caused by magnetite destruction during wall rock alteration.

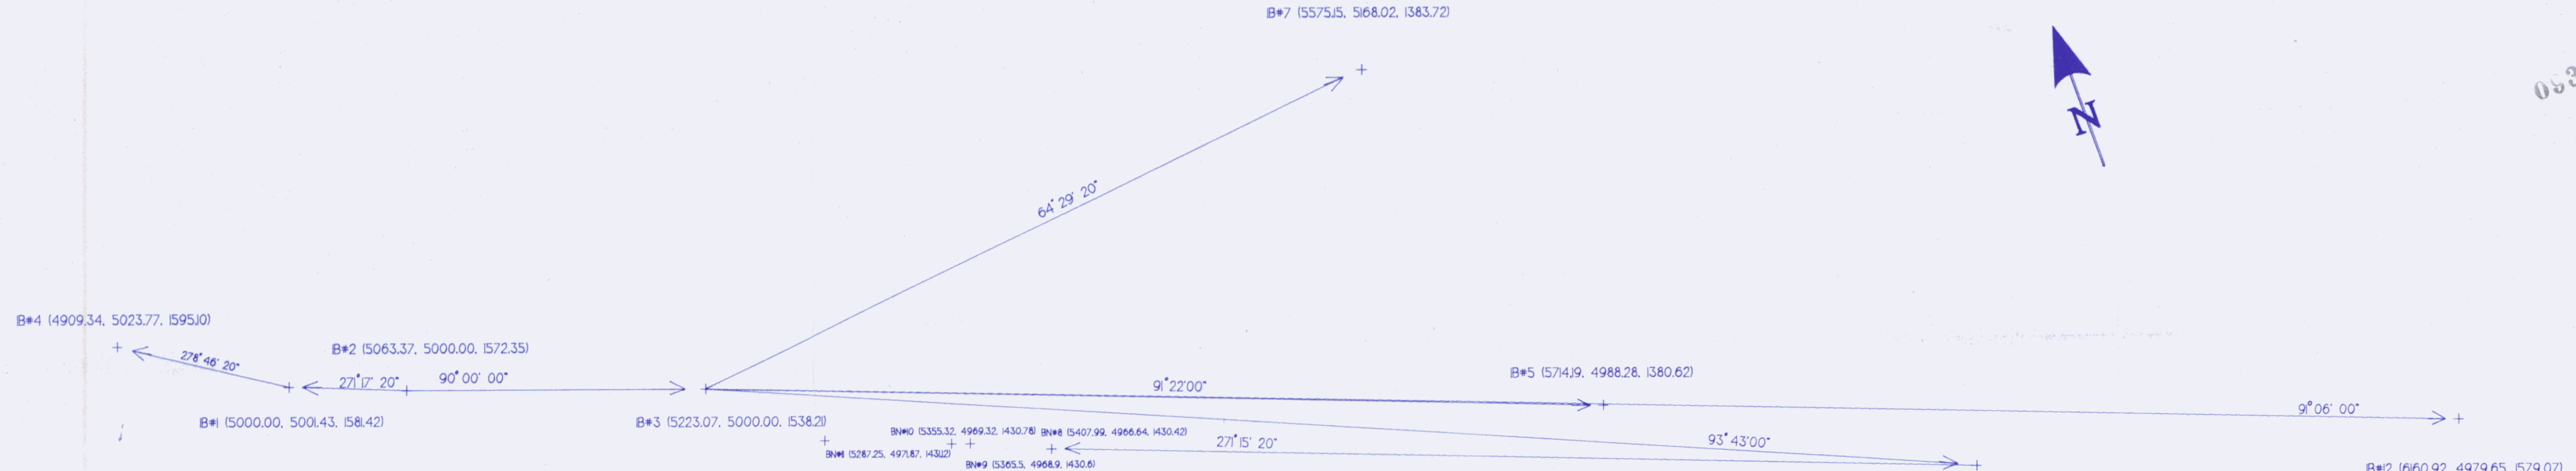
DALE PROPERTY	CLAIMS: FROSTBITE 1-40
TOPOGRAPHIC SURVEY	MINING DISTRICT: WHITEHORSE
MONUMENT LOCATION PLAN	NTS: 105 B 1 SCALE 1:2,000
MOUNTAIN HIGHGRADE MINES LTD.	SURVEYOR: G. LEE P'ENG
	DATE: 23 MAR 95 FIGURE: 6

- NOTES:
- 90° 00' 00" is the angle between B#2 and B#3.
  - All coordinates (X,Y,Z) in metres.
  - Elevations (Z) are referenced to road intersection near B#3 from which elevations were tied into MSL elevations.
  - Back nails (BN) in the drift, with the exception of BN#8 were surveyed from an unmarked turning point.

In order to determine the precise location of the underground workings with respect to the known mineralization and to the Dale Fault, a topographic survey of the property was conducted with a Nikon TD-1 total station survey instrument by Gary Lee, P.Eng. Survey monuments consisted of 50 cm long sections of sharpened rebar driven into the ground and capped with drilled and painted wooden posts to which identification tags were nailed. Underground survey markers consisted of nails driven into the back of the drift. The plan location of the survey monuments is shown in Figure 6 (in pocket). Rebar monuments and nails in the back of the drift are prefixed by **IB** and **BN** respectively.

Elevations shown are best estimates of true elevation above mean sea level. No NTS elevation control points were near the survey area and consequently a road junction near grid coordinate 5160E 4960N at an elevation of 4100 feet on NTS map 105 B 1 was used as the elevation datum. Coordinates shown in the survey plan are in XYZ format, in metres and referenced to the grid origin at 5000E 5000N (**IB #1**). Figure 7 is a survey plan of the underground workings as found in February 1995. Although the drift is almost 40 years old, the timbers near the portal are in good condition and only minor caving near the end of the drift has occurred.
