STRIP LOG: DNE-061

Selwyn Chihong Mining Ltd.  
Selwyn Project  
DNE-061  
Vert. Scale 1:2000

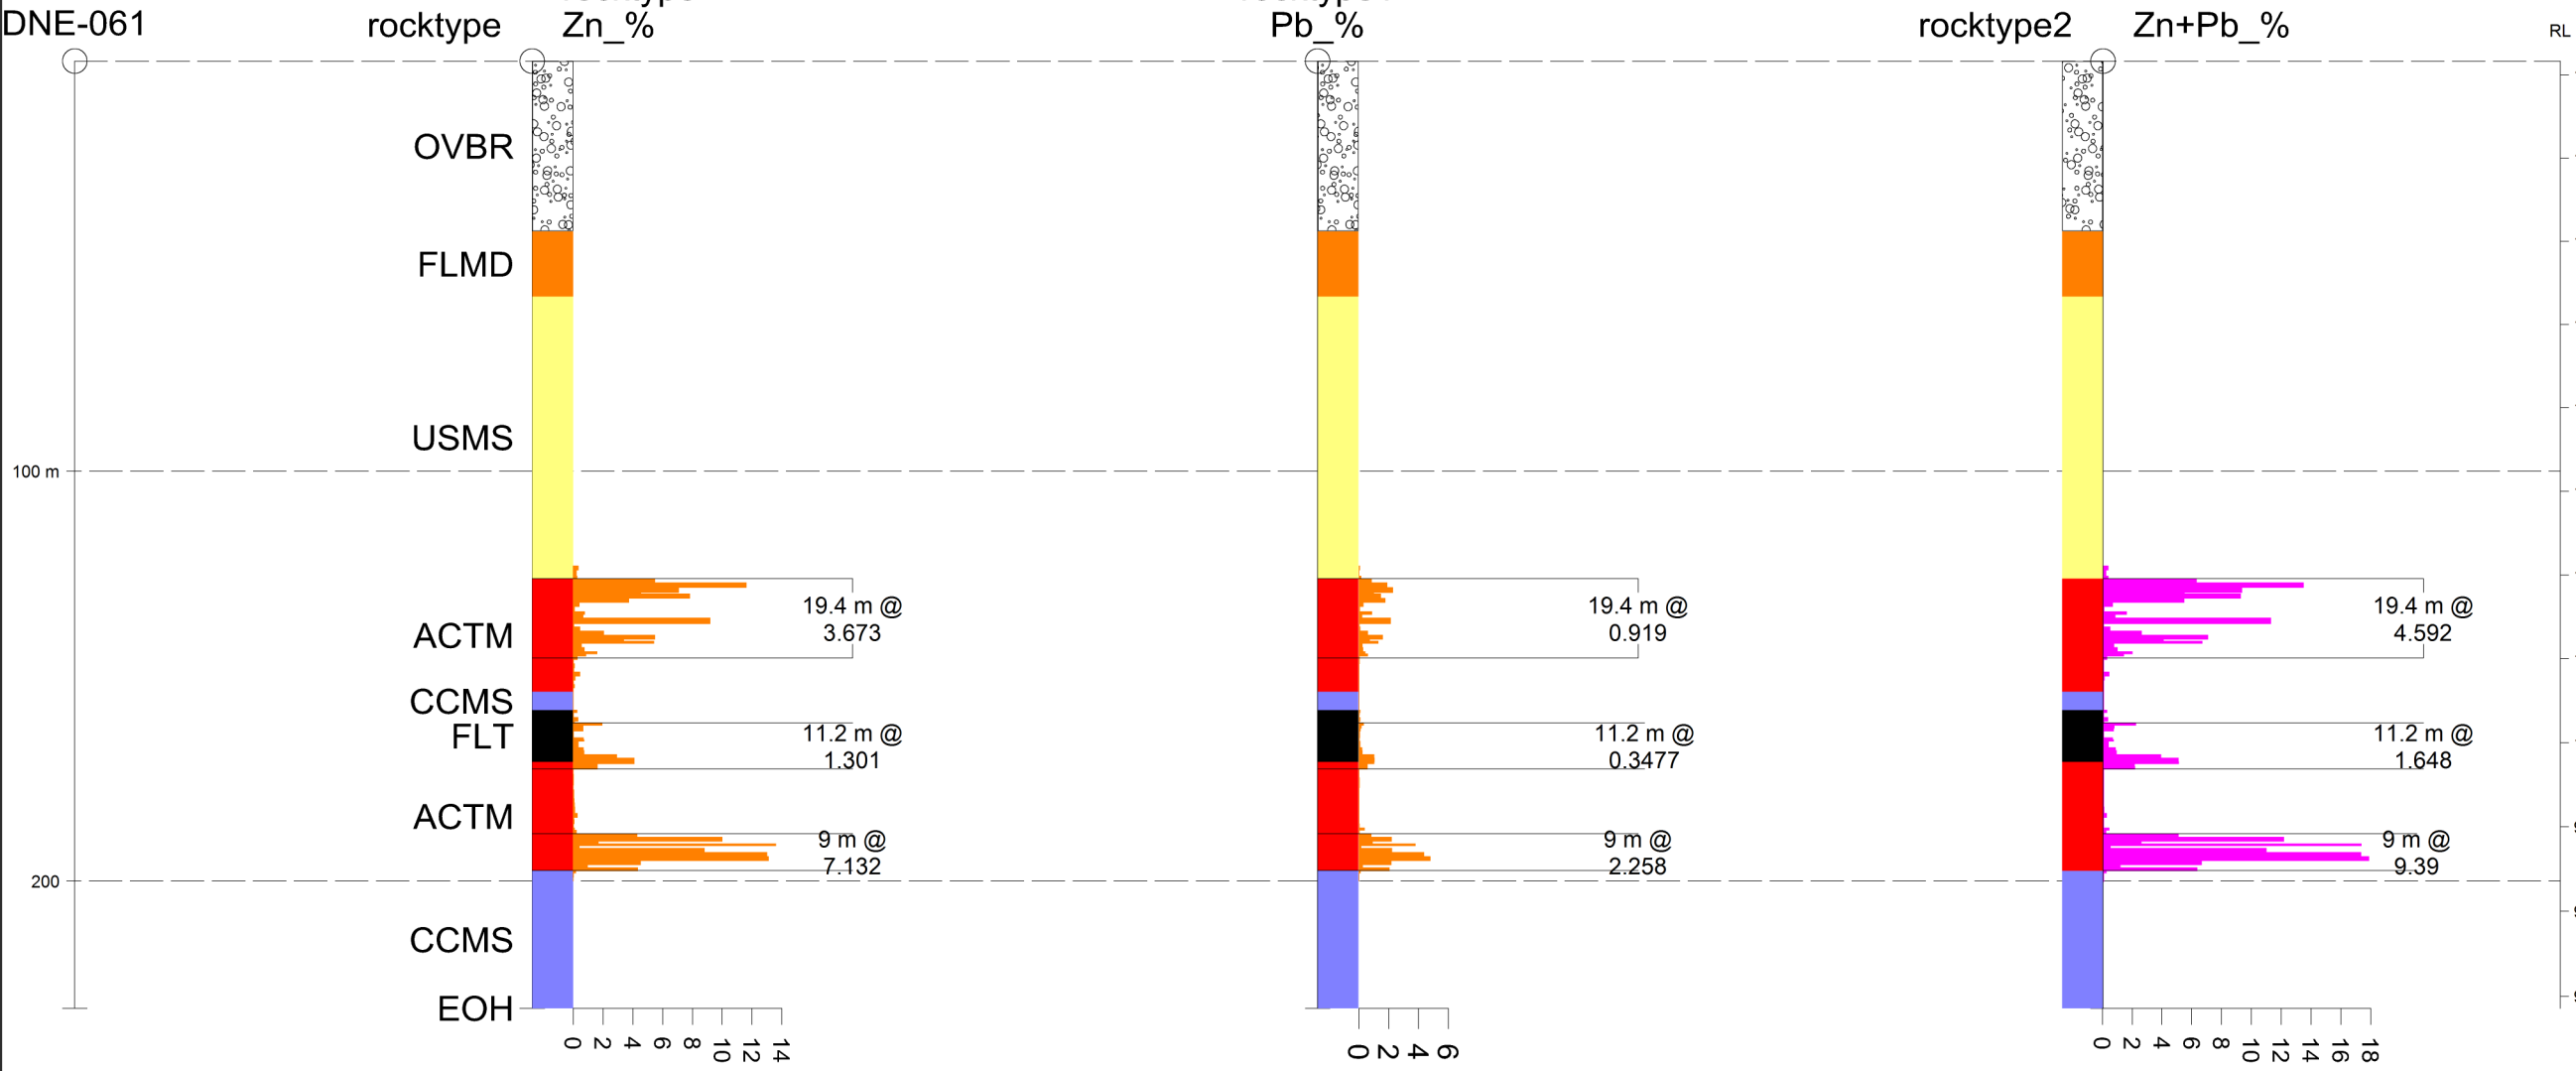
Easting	Northing	RL	Azimuth	Dip	Depth
478861.6	6933427.3	1163.3	208.0	-80.0	231.0

PAT	LABEL	DESCRIPTION
	OVBR	Overburden
	FLMD	Flaggy Mudstone
	USMS	Upper Siliceous Mudstone
	ACTM	Active Member
	CCMS	Calcareous Mudstone
	FLT	Fault

PAT	CODE	DESCRIPTION
	OVBR	Overburden
	FLMD	Flaggy Mudstone
	USMS	Upper Siliceous Mudstone
	ACTM	Active Member
	CCMS	Calcareous Mudstone
	FLT	Fault
