STRIP LOG: DNE-076

Easting 478626.0 Northing 6933535.1 RL 1146.1 Azimuth 245.0 Dip -68.0 Depth 219.0

Selwyn Chihong Mining Ltd.
Selwyn Project
DNE-076
Vert. Scale 1:2000

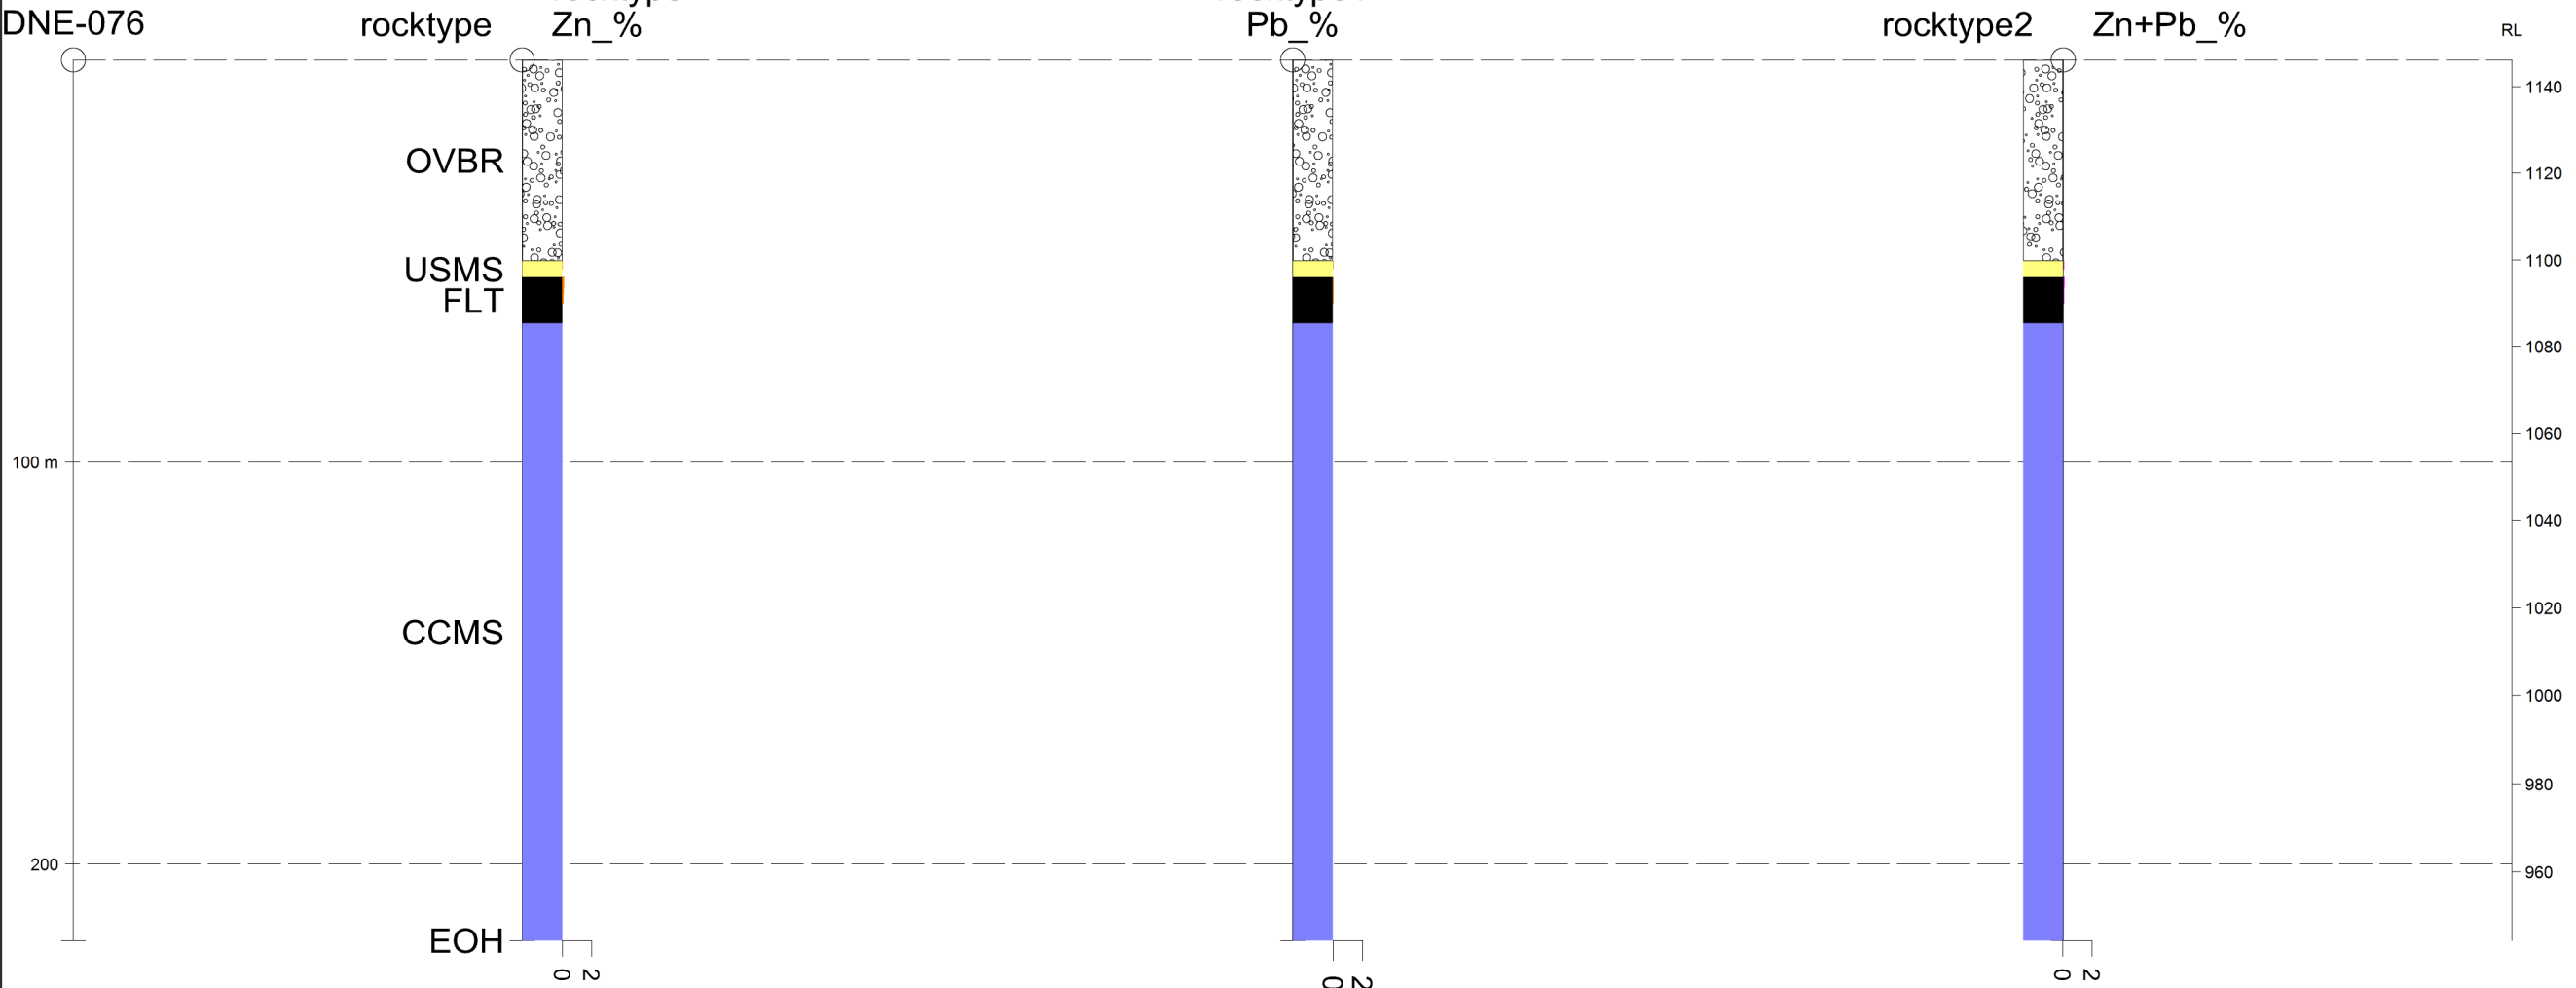
rocktype

OVBR

Overburden

USMS

Upper Siliceous
Mudstone

CCMS

Calcareous
Mudstone

FLT

Fault
