STRIP LOG: DNE-081

Selwyn Chihong Mining Ltd.
Selwyn Project
DNE-081
Vert. Scale 1:2000

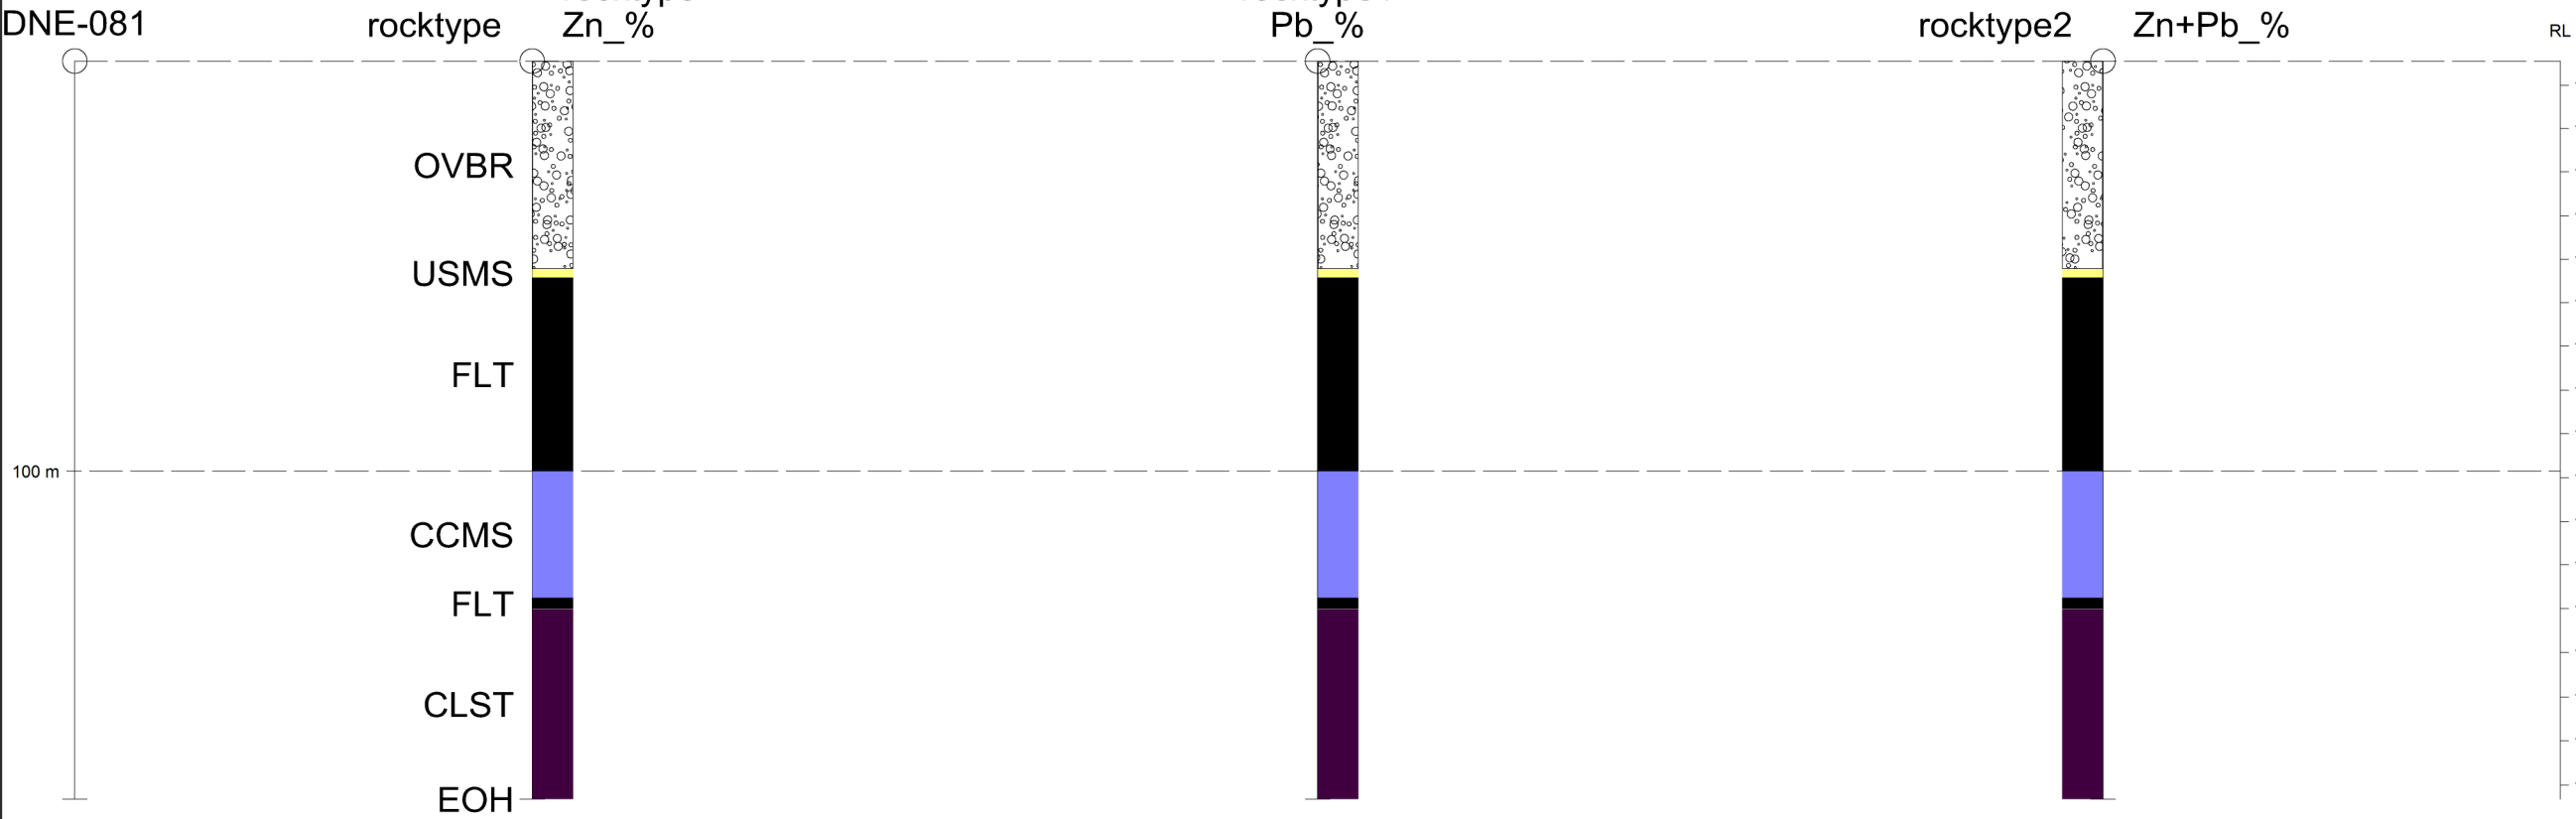
Easting	478553.3	Northing	6933477.3	RL	1165.5	Azimuth	205.0	Dip	-70.0	Depth	180.0
---------	----------	----------	-----------	----	--------	---------	-------	-----	-------	-------	-------

STRIP				
1	rocktype	PAT	LABEL	DESCRIPTION
			OVBR	Overburden
			USMS	Upper Siliceous Mudstone
			CCMS	Calcareous Mudstone
			CLST	Cambrian Limestone
			FLT	Fault
2	rocktype1	PAT	CODE	DESCRIPTION
			OVBR	Overburden
			USMS	Upper Siliceous Mudstone
			CCMS	Calcareous Mudstone
			CLST	Cambrian Limestone
			FLT	Fault
3	rocktype2	PAT	LABEL	DESCRIPTION
			OVBR	Overburden
			USMS	Upper Siliceous Mudstone
			CCMS	Calcareous Mudstone
			CLST	Cambrian Limestone
			FLT	Fault
