STRIP LOG: DNE-086

SELWYN CHIHONG
MINING LTD.

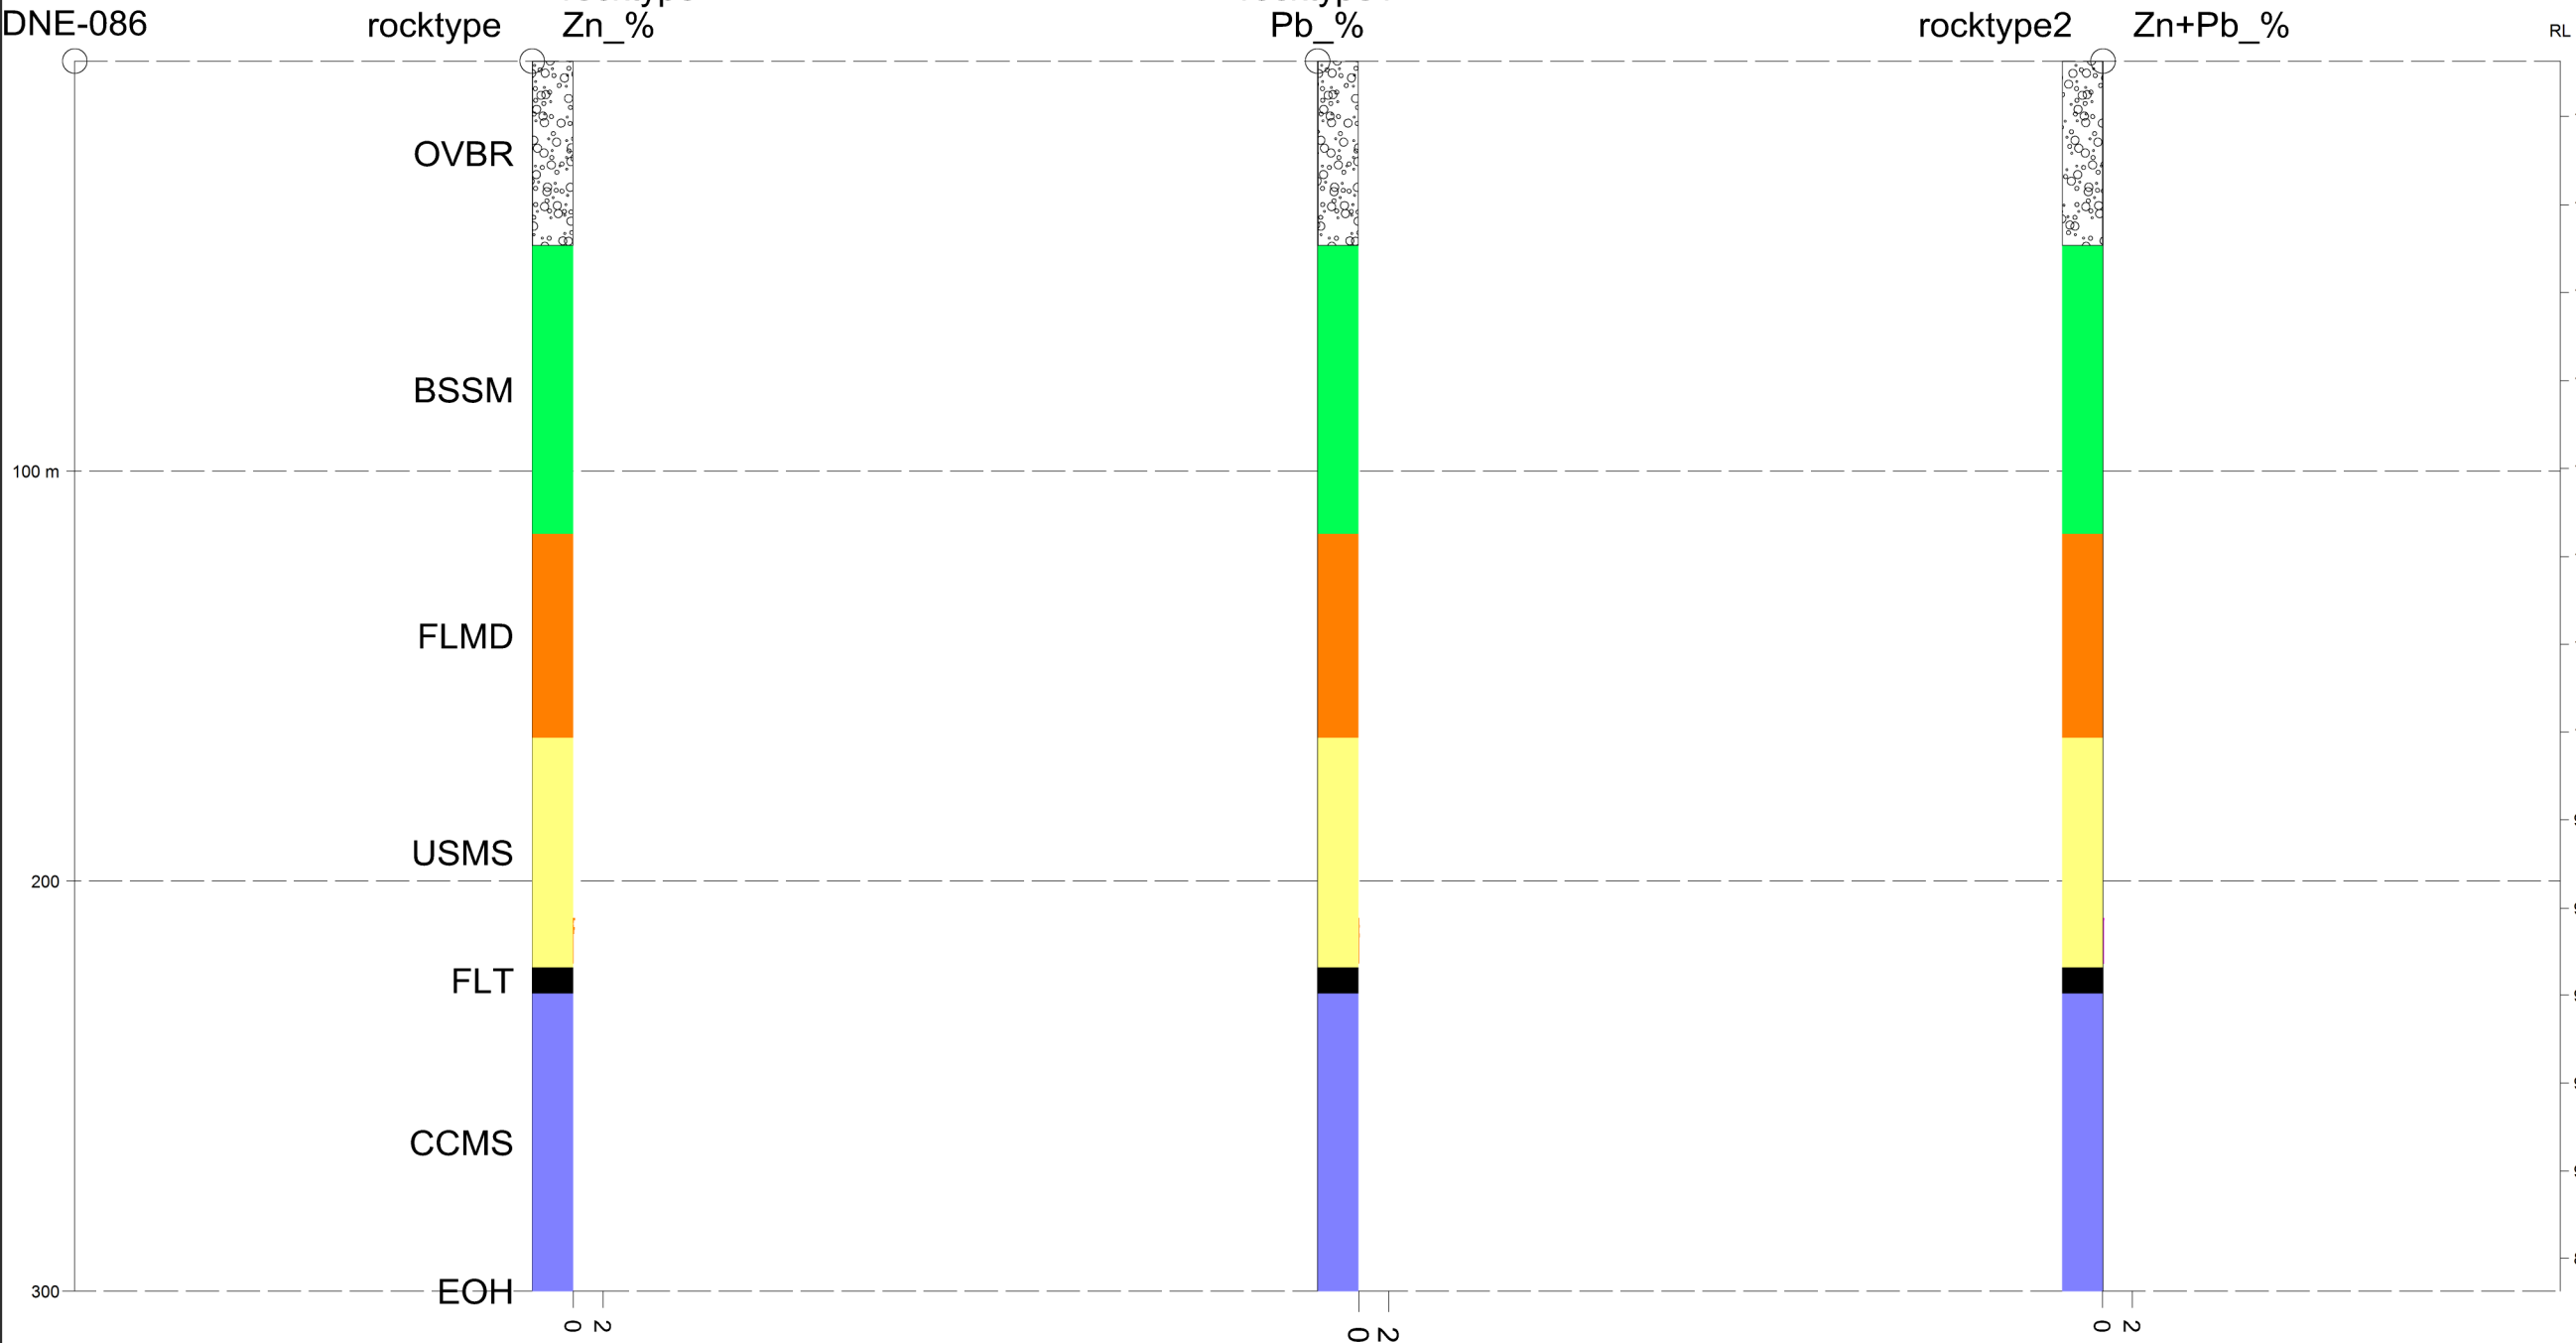
| Easting | Northing | RL | Azimuth | Dip | Depth |
| 479480.8 | 6933177.0 | 1152.7 | 258.0 | -69.0 | 300.0 |
