STRIP LOG: DNE-113

Selwyn Chihong Mining Ltd.
Selwyn Project
DNE-113
Vert. Scale 1:2000

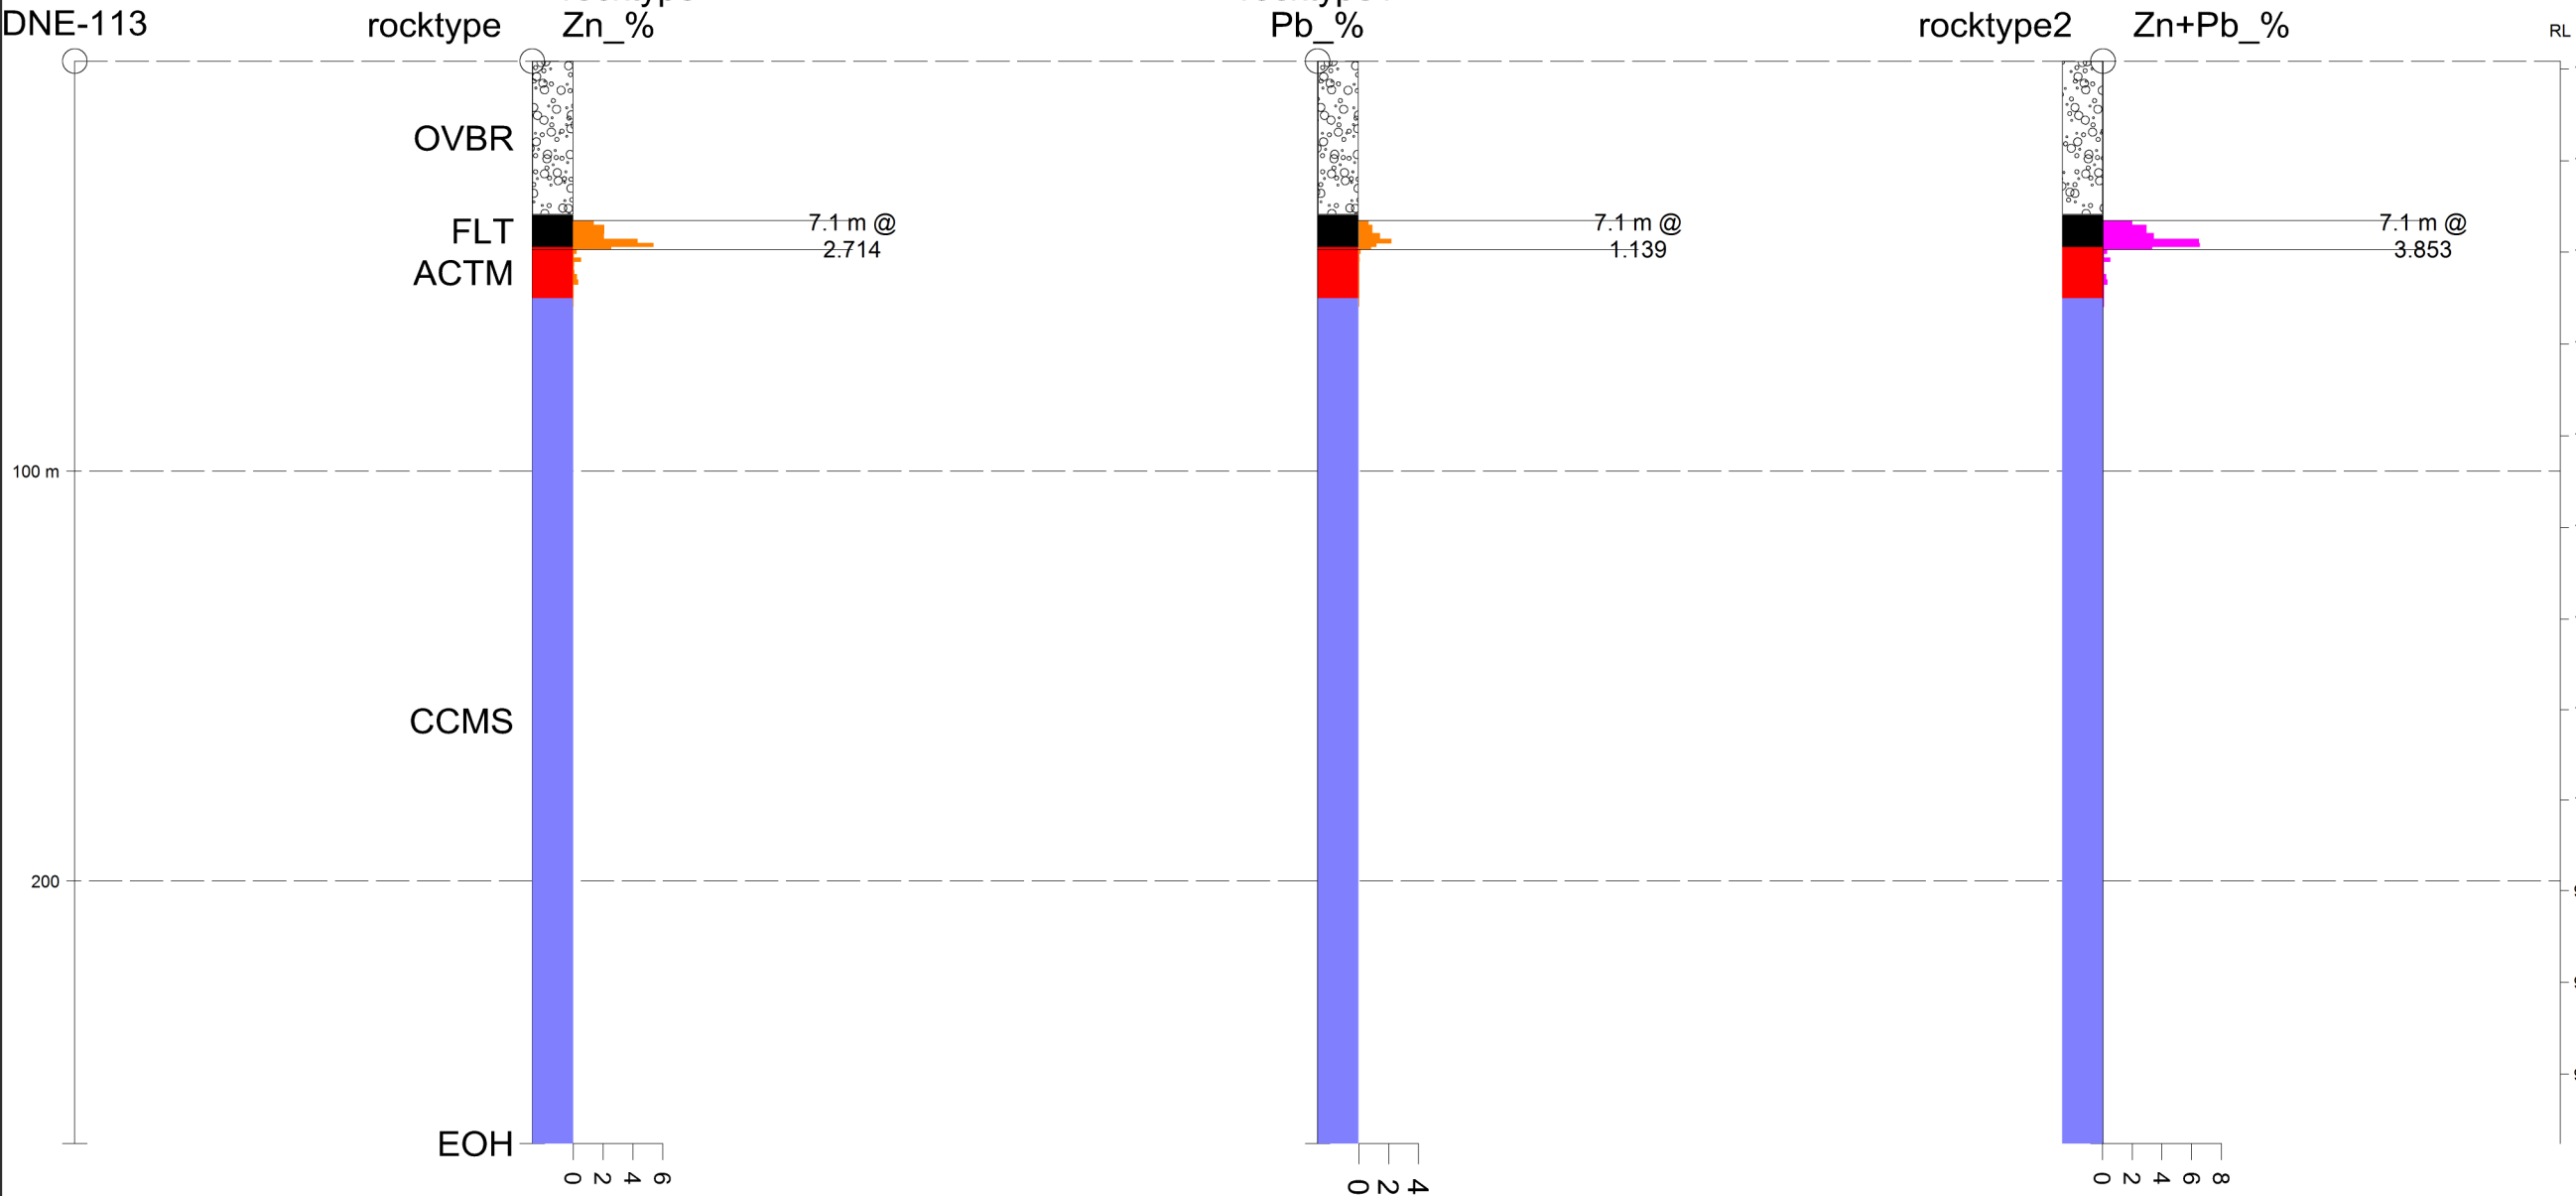
Easting	Northing	RL	Azimuth	Dip	Depth
479169.0	6933167.7	1161.9	200.0	-64.0	264.0

STRIP	rocktype	PAT	LABEL	DESCRIPTION
1	rocktype		OVBR	Overburden
			ACTM	Active Member
			CCMS	Calcareous Mudstone
			FLT	Fault
