STRIP LOG: DNE-114

Easting	Northing	RL	Azimuth	Dip	Depth
479382.1	6933231.0	1146.5	41.0	-68.0	339.0

Selwyn Project

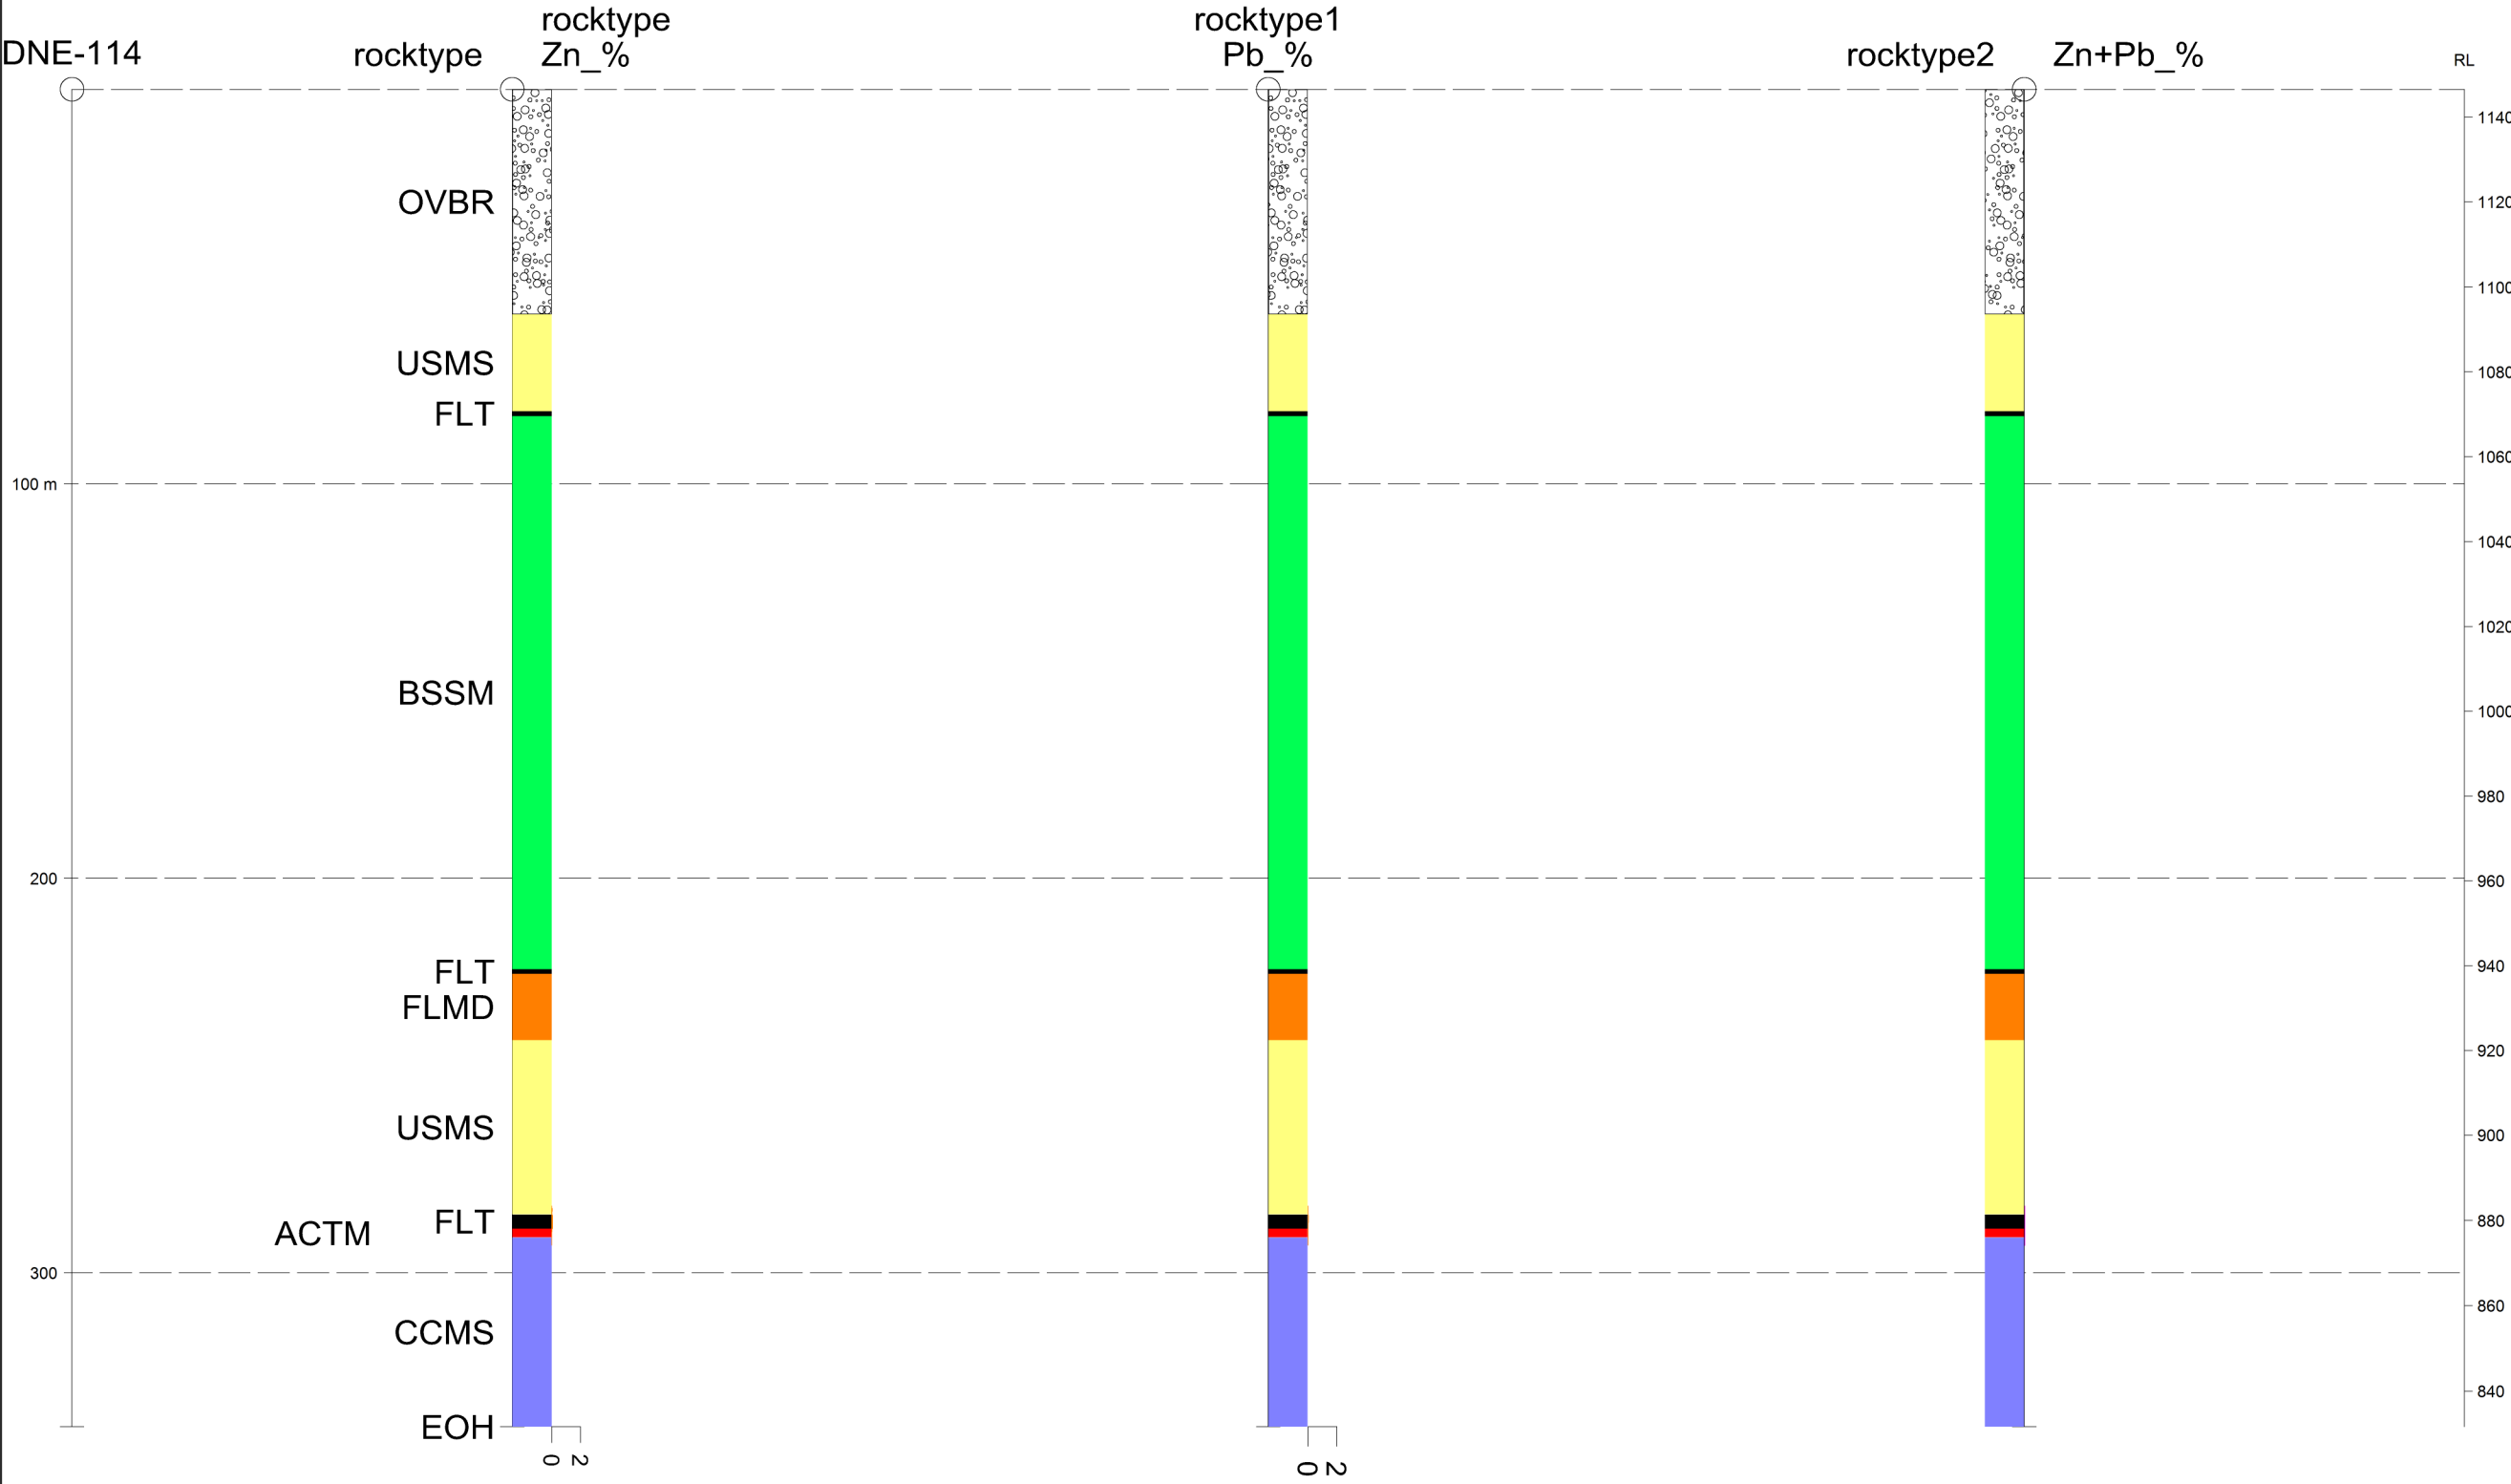
rocktype	PAT	LABEL	DESCRIPTION
	OVBR	Overburden	
	BSSM	Backside	
		Siliceous	
		Mudstone	
	FLMD	Flaggy	
		Mudstone	
	USMS	Upper Siliceous	
		Mudstone	
	ACTM	Active Member	
	CCMS	Calcareous	
		Mudstone	
	FLT	Fault

rocktype1	PAT	CODE	DESCRIPTION
	OVBR	Overburden	
	BSSM	Backside	
		Siliceous	
		Mudstone	
	FLMD	Flaggy	
		Mudstone	
	USMS	Upper Siliceous	
		Mudstone	
	ACTM	Active Member	
	CCMS	Calcareous	
		Mudstone	
	FLT	Fault

rocktype2	PAT	LABEL	DESCRIPTION
	OVBR	Overburden	
	BSSM	Backside	
		Siliceous	
		Mudstone	
	FLMD	Flaggy	
		Mudstone	
	USMS	Upper Siliceous	
		Mudstone	
	ACTM	Active Member	
	CCMS	Calcareous	
		Mudstone	
	FLT	Fault
