STRIP LOG: DNE-118

Easting	Northing	RL	Azimuth	Dip	Depth
478557.2	6933474.6	1165.7	300.0	-70.0	300.0

SELWYN CHIHONG MINING LTD.

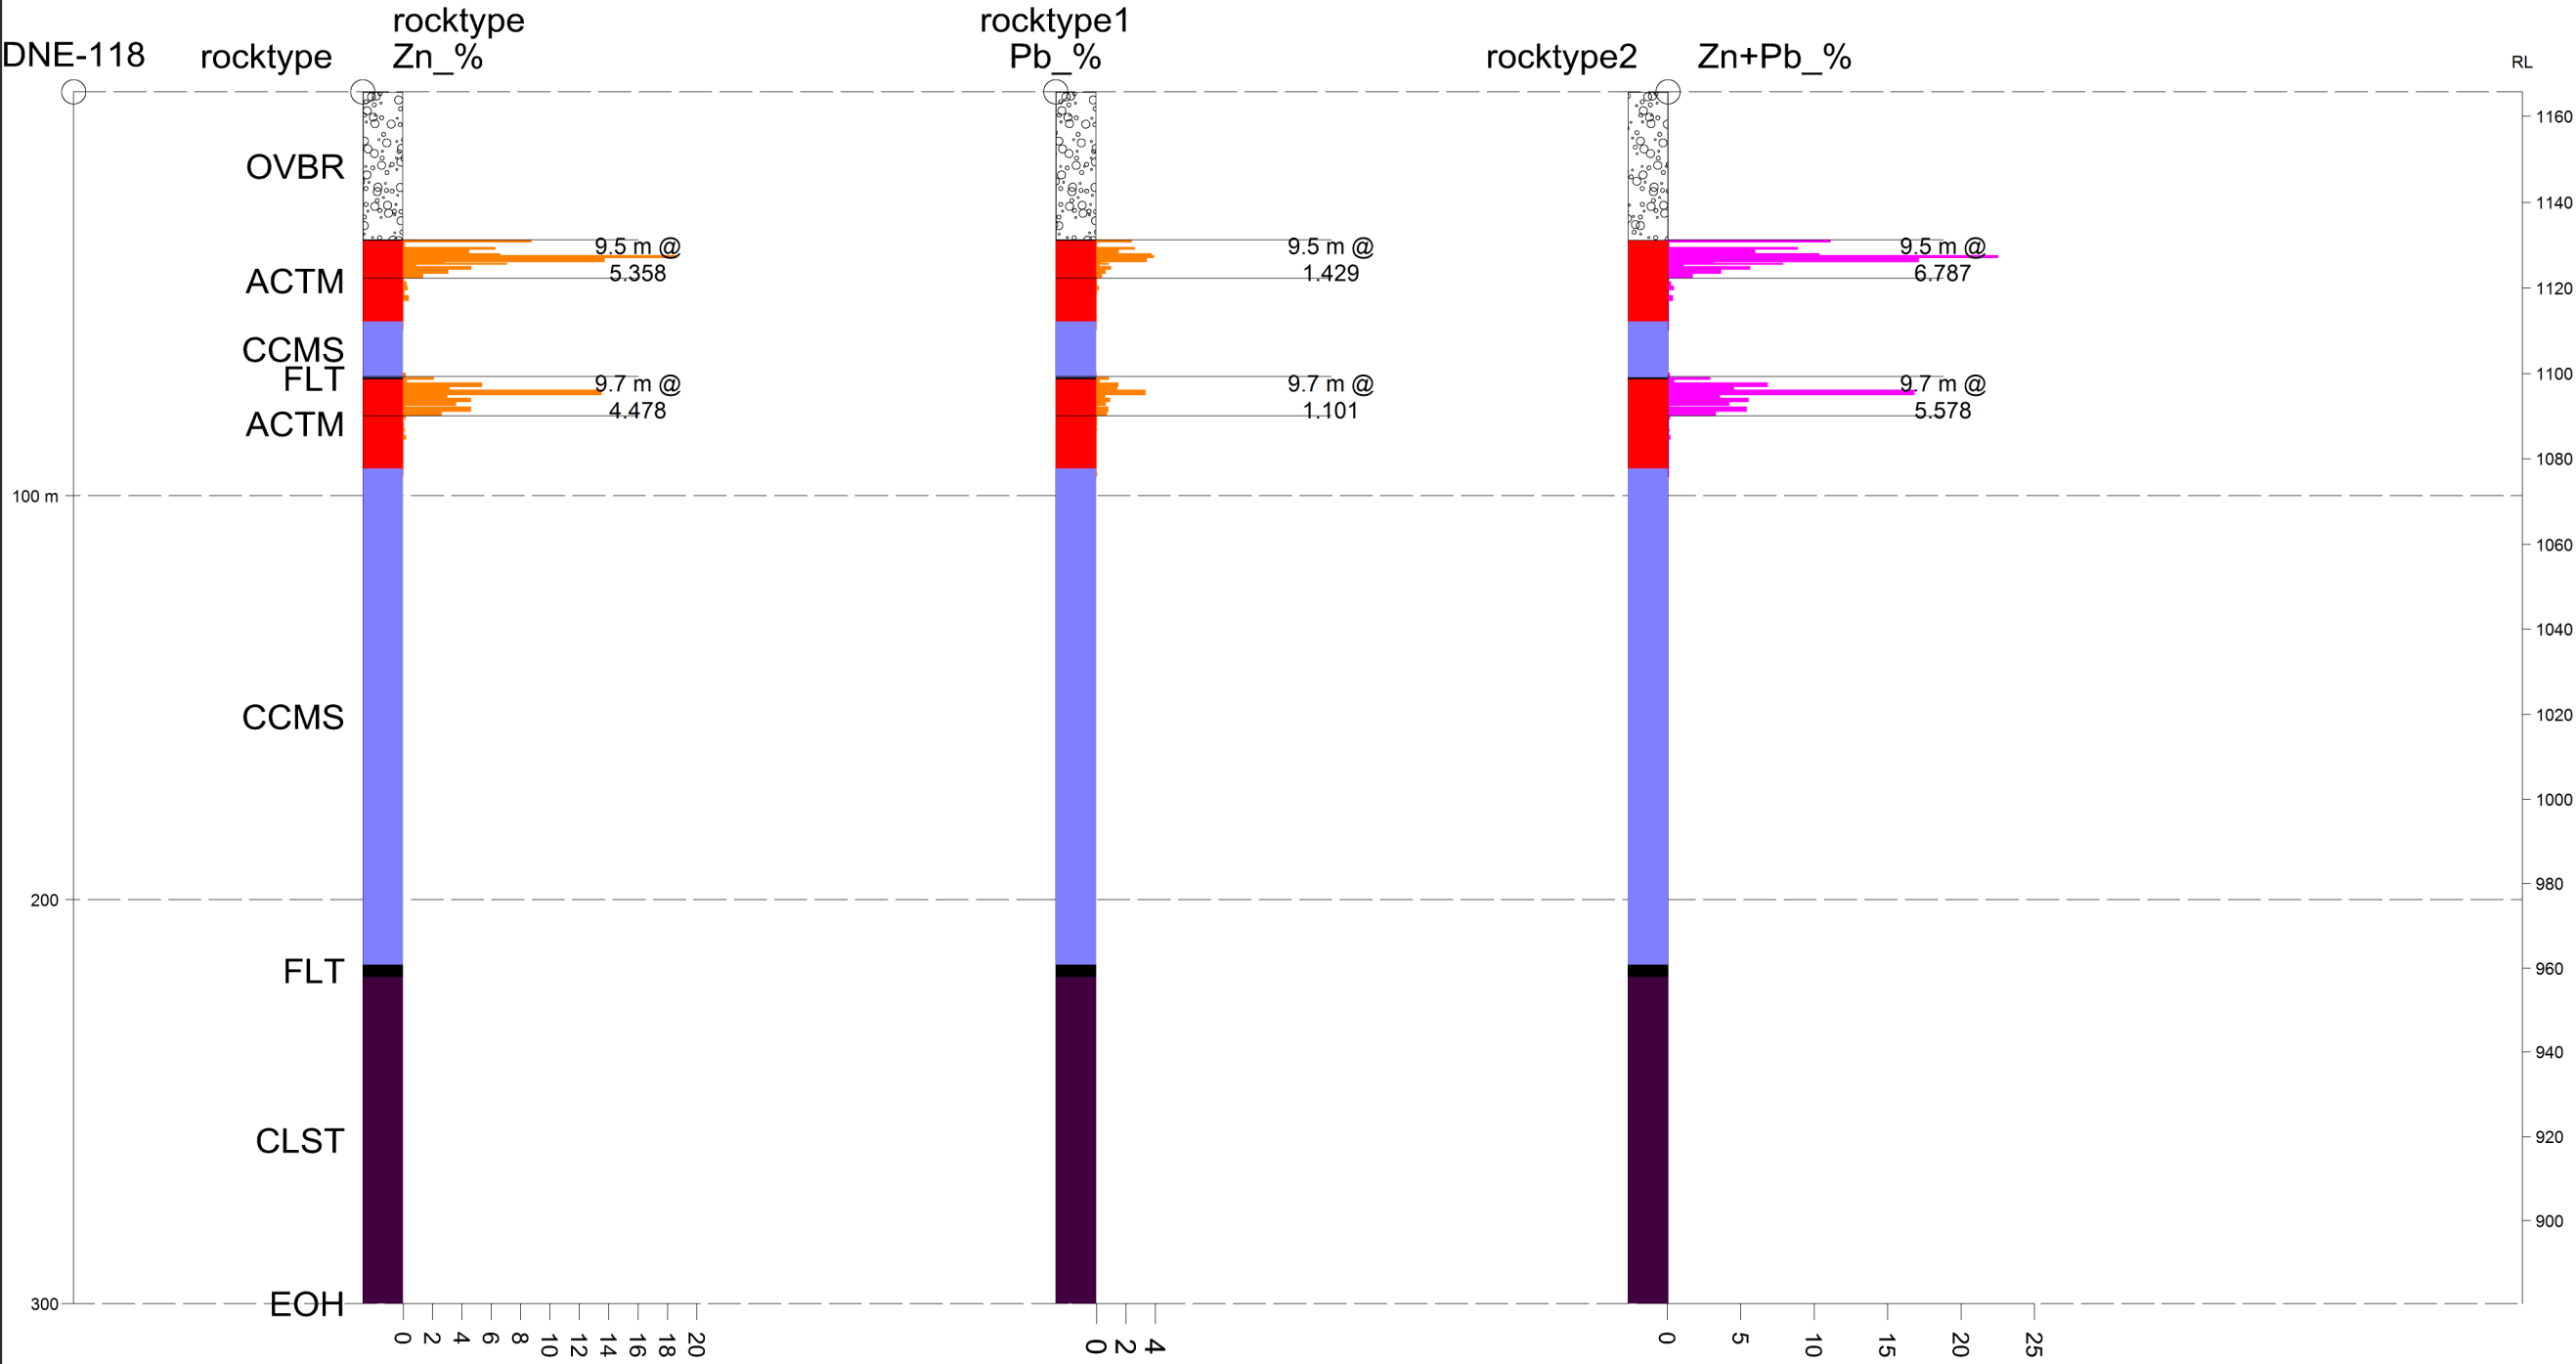
Vertical scale 1:2000

rocktype	PAT	LABEL	DESCRIPTION
	OVBR	Overburden	
	ACTM	Active Member	
	CCMS	Calcareous Mudstone	
	CLST	Cambrian Limestone	
	FLT	Fault
