STRIP LOG: DNE-128

Easting	Northing	RL	Azimuth	Dip	Depth
	479406.0	6933075.9	1160.5	197.0	-73.0	321.0

Selwyn Chihong Mining Ltd.
Selwyn Project
DNE-128
Vert. Scale 1:2000

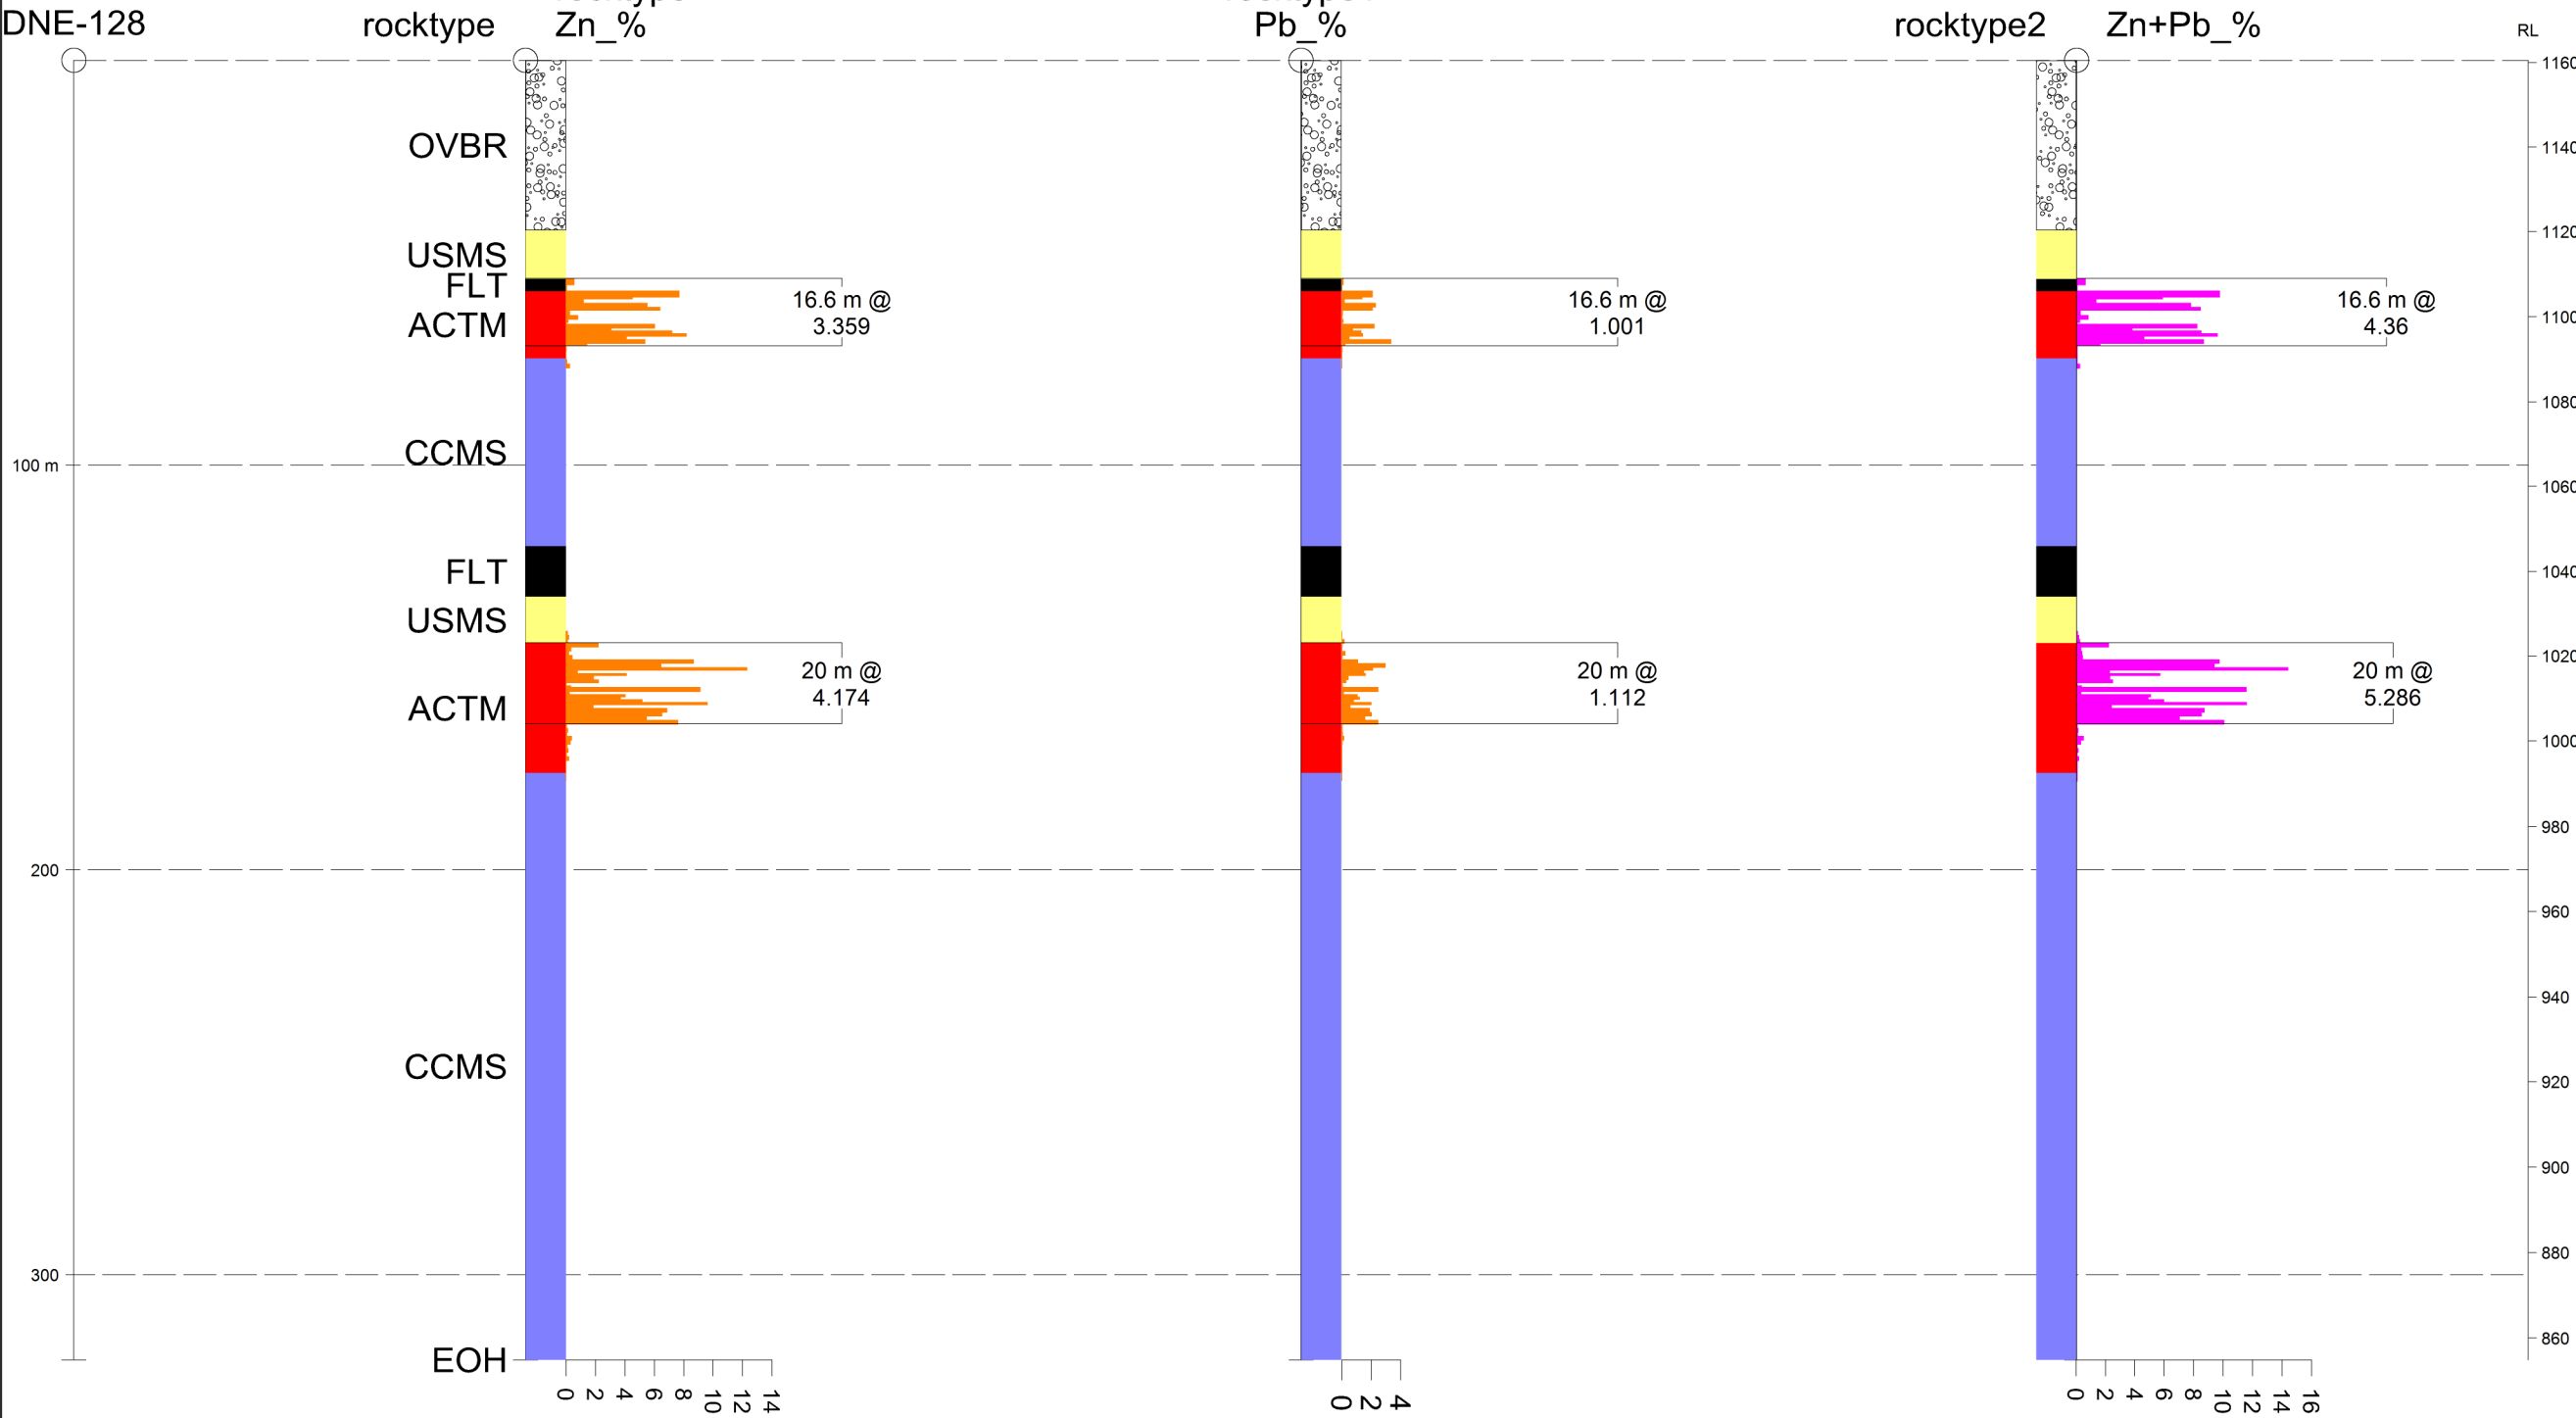
STRIP	rocktype	PAT	LABEL	DESCRIPTION
1	rocktype		OVBR	Overburden
			USMS	Upper Siliceous Mudstone
			ACTM	Active Member
			CCMS	Calcareous Mudstone
			FLT	Fault
